City of Turlock

PRoW - Pedestrian Signals

Access Compliance Survey Report

July 2014

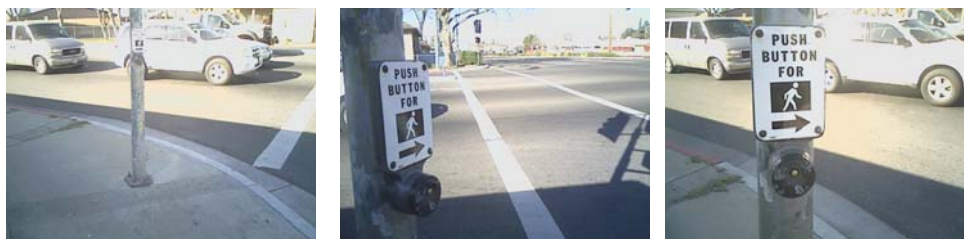
SSW Clear Floor Space

Accessible Path	(y/n)	YES
Clear Floor Space	(y/n)	NO
Clear Floor Slope	(%)	3.2
Clear Floor X Slope	(%)	1.0
Button Ht.	(in)	47.5
Button Reach	(in)	0
Button Diameter	(in)	0.5
Button Pressure	(lbs)	8
Closed Fist Operation	(y/n)	NO
Visual Contrast	(y/n)	NO
Contrasting Color Bands	(y/n)	NO
Audible Walk Indicator	(y/n)	NO
Button Locator Tone	(y/n)	NO
Directional Info	(y/n)	YES

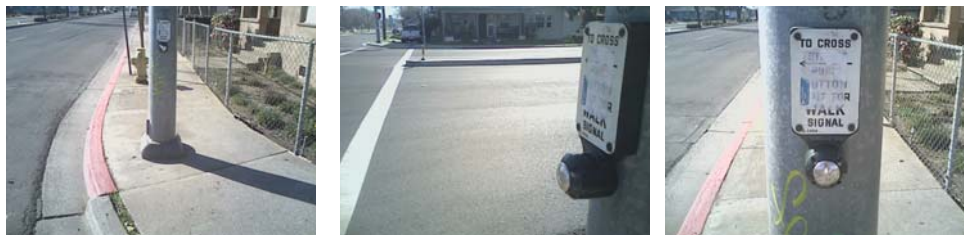
PCODE	PA20
ADAPROW	R404.3
ADA-1991	4.2.4.1
CSAS	1118B.4.1
Unit Cost	\$2650.00
Priority	4
Severity	4

Accessible Path	(y/n)	YES
Clear Floor Space	(y/n)	NO
Clear Floor Slope	(%)	0.5
Clear Floor X Slope	(%)	0.3
Button Ht.	(in)	46.5
Button Reach	(in)	0
Button Diameter	(in)	2
Button Pressure	(lbs)	5
Closed Fist Operation	(y/n)	YES
Visual Contrast	(y/n)	YES
Contrasting Color Bands	(y/n)	NO
Audible Walk Indicator	(y/n)	NO
Button Locator Tone	(y/n)	NO
Directional Info	(y/n)	YES

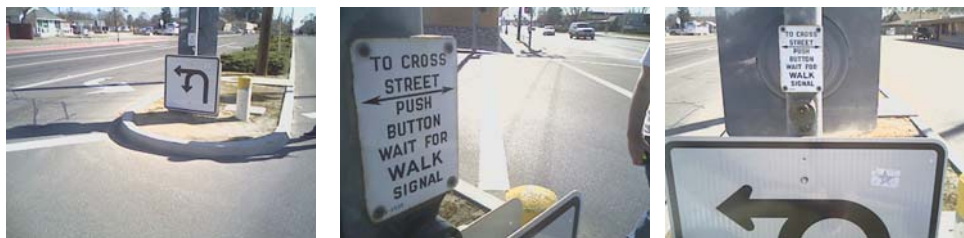
ESE Clear Floor Space

Accessible Path	(y/n)	YES
Clear Floor Space	(y/n)	YES
Clear Floor Slope	(%)	0.9
Clear Floor X Slope	(%)	0.9
Button Ht.	(in)	48
Button Reach	(in)	51
Button Diameter	(in)	0.5
Button Pressure	(lbs)	10
Closed Fist Operation	(y/n)	YES
Visual Contrast	(y/n)	NO
Contrasting Color Bands	(y/n)	NO
Audible Walk Indicator	(y/n)	NO
Button Locator Tone	(y/n)	NO
Directional Info	(y/n)	YES

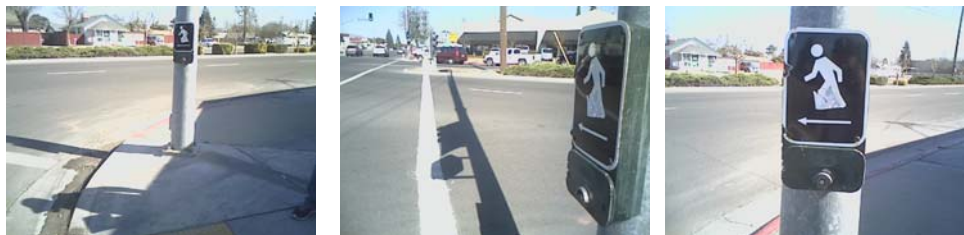
PCODE	PA19A
ADAPROW	R404.2
ADA-1991	4.3.7
CSAS	1118B.4.1
Unit Cost	\$2650.00
Priority	3
Severity	3

Accessible Path	(y/n)	YES
Clear Floor Space	(y/n)	NO
Clear Floor Slope	(%)	10.0
Clear Floor X Slope	(%)	6.2
Button Ht.	(in)	44.5
Button Reach	(in)	0
Button Diameter	(in)	0.5
Button Pressure	(lbs)	8
Closed Fist Operation	(y/n)	NO
Visual Contrast	(y/n)	NO
Contrasting Color Bands	(y/n)	NO
Audible Walk Indicator	(y/n)	NO
Button Locator Tone	(y/n)	NO
Directional Info	(y/n)	YES

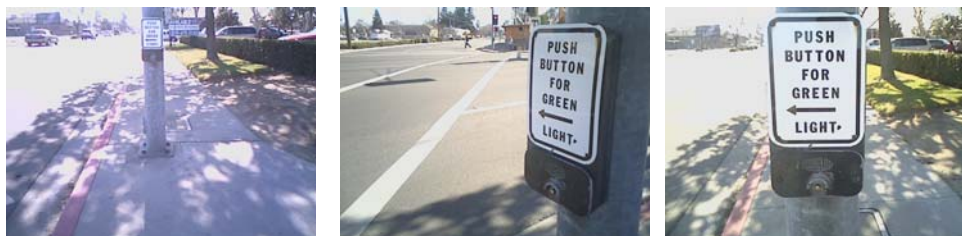
W Clear Floor Space

PCODE PA39A
 ADAPROW **R403.4**
 ADA-1991 **4.27.4**
 ADA-2010 **309.4**
 CSAS **1117B.6.4**
 Unit Cost **\$2150.00**
 Priority **4** Severity **4**

Accessible Path	(y/n)	YES
Clear Floor Space	(y/n)	YES
Clear Floor Slope	(%)	1.0
Clear Floor X Slope	(%)	1.7
Button Ht.	(in)	43
Button Reach	(in)	0
Button Diameter	(in)	0.5
Button Pressure	(lbs)	8
Closed Fist Operation	(y/n)	NO
Visual Contrast	(y/n)	NO
Contrasting Color Bands	(y/n)	NO
Audible Walk Indicator	(y/n)	NO
Button Locator Tone	(y/n)	NO
Directional Info	(y/n)	YES

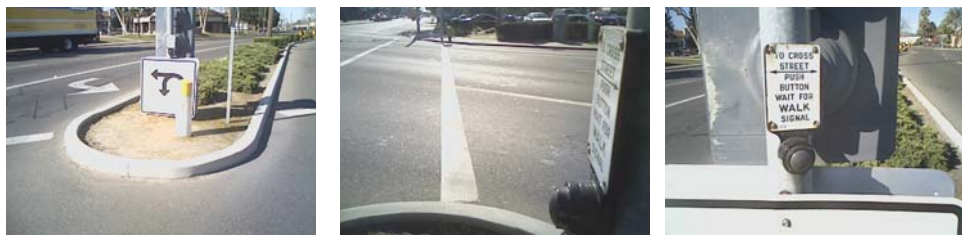
PCODE PA19A
 ADAPROW **R404.2**
 ADA-1991 **4.3.7**
 CSAS **1118B.4.1**
 Unit Cost **\$2650.00**
 Priority **4** Severity **4**

Accessible Path	(y/n)	YES
Clear Floor Space	(y/n)	YES
Clear Floor Slope	(%)	2.6
Clear Floor X Slope	(%)	0.9
Button Ht.	(in)	48
Button Reach	(in)	72
Button Diameter	(in)	2
Button Pressure	(lbs)	5
Closed Fist Operation	(y/n)	YES
Visual Contrast	(y/n)	YES
Contrasting Color Bands	(y/n)	NO
Audible Walk Indicator	(y/n)	NO
Button Locator Tone	(y/n)	NO
Directional Info	(y/n)	YES

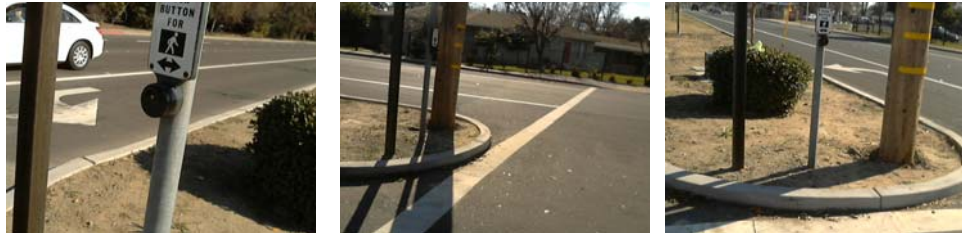
ENE - E Clear Floor Space

PCODE	PA17A
ADAPROW	R406.3
ADA-1991	4.2.6
CSAS	1118B.6
Unit Cost	\$2050.00
Priority	2
Severity	3

Accessible Path	(y/n)	YES
Clear Floor Space	(y/n)	YES
Clear Floor Slope	(%)	1.1
Clear Floor X Slope	(%)	0.4
Button Ht.	(in)	48
Button Reach	(in)	25
Button Diameter	(in)	0.5
Button Pressure	(lbs)	2
Closed Fist Operation	(y/n)	NO
Visual Contrast	(y/n)	YES
Contrasting Color Bands	(y/n)	NO
Audible Walk Indicator	(y/n)	NO
Button Locator Tone	(y/n)	NO
Directional Info	(y/n)	YES

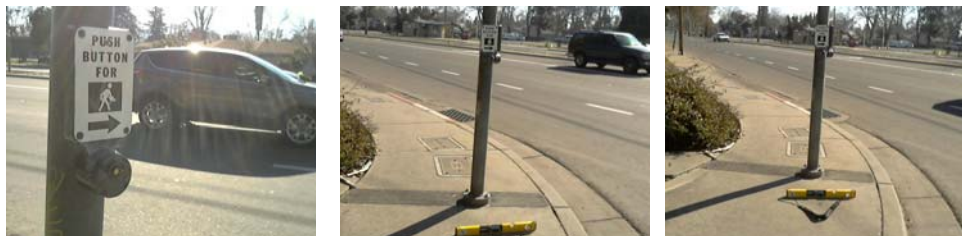
PCODE	PA19A
ADAPROW	R404.2
ADA-1991	4.3.7
CSAS	1118B.4.1
Unit Cost	\$2650.00
Priority	2
Severity	3

Accessible Path	(y/n)	YES
Clear Floor Space	(y/n)	NO
Clear Floor Slope	(%)	6.2
Clear Floor X Slope	(%)	0.9
Button Ht.	(in)	47
Button Reach	(in)	0
Button Diameter	(in)	0.5
Button Pressure	(lbs)	2
Closed Fist Operation	(y/n)	NO
Visual Contrast	(y/n)	NO
Contrasting Color Bands	(y/n)	NO
Audible Walk Indicator	(y/n)	NO
Button Locator Tone	(y/n)	NO
Directional Info	(y/n)	YES

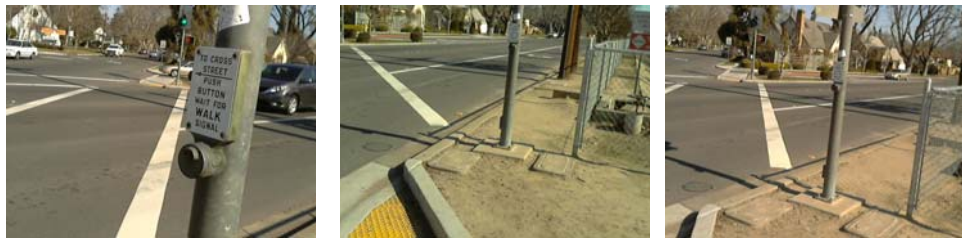
E - Island - S Clear Floor Space

Accessible Path	(y/n)	YES
Clear Floor Space	(y/n)	YES
Clear Floor Slope	(%)	1.2
Clear Floor X Slope	(%)	0.9
Button Ht.	(in)	52.75
Button Reach	(in)	68
Button Diameter	(in)	0.5
Button Pressure	(lbs)	2
Closed Fist Operation	(y/n)	NO
Visual Contrast	(y/n)	NO
Contrasting Color Bands	(y/n)	NO
Audible Walk Indicator	(y/n)	NO
Button Locator Tone	(y/n)	NO
Directional Info	(y/n)	YES

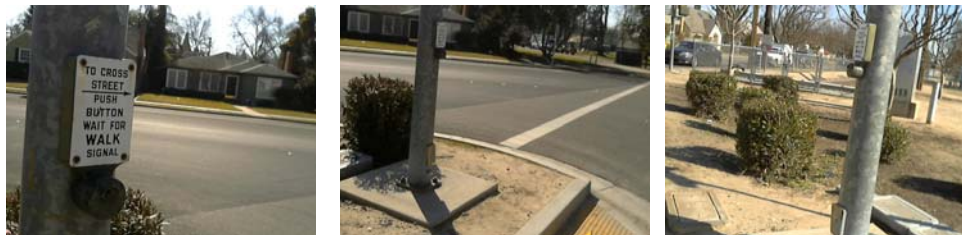
PCODE	PA19B
ADAPROW	R404.2
ADA-1991	4.3.7
CSAS	1118B.4.1
Unit Cost	\$2650.00
Priority	2
Severity	3

Accessible Path	(y/n)	YES
Clear Floor Space	(y/n)	YES
Clear Floor Slope	(%)	1.3
Clear Floor X Slope	(%)	2.9
Button Ht.	(in)	43
Button Reach	(in)	42
Button Diameter	(in)	0.5
Button Pressure	(lbs)	2
Closed Fist Operation	(y/n)	NO
Visual Contrast	(y/n)	NO
Contrasting Color Bands	(y/n)	NO
Audible Walk Indicator	(y/n)	NO
Button Locator Tone	(y/n)	NO
Directional Info	(y/n)	YES

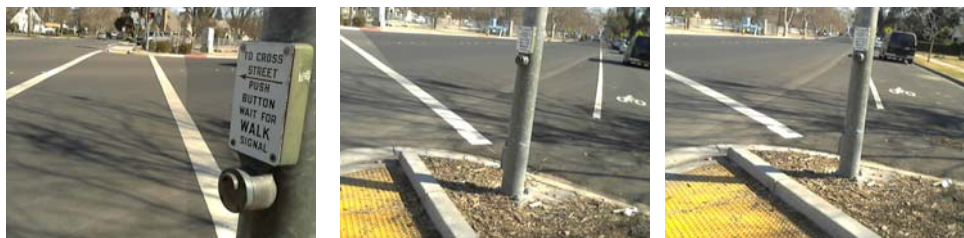
NE Island N Clear Floor Space

Accessible Path	(y/n)	YES
Clear Floor Space	(y/n)	YES
Clear Floor Slope	(%)	0.4
Clear Floor X Slope	(%)	1.6
Button Ht.	(in)	50
Button Reach	(in)	31
Button Diameter	(in)	0.5
Button Pressure	(lbs)	2
Closed Fist Operation	(y/n)	NO
Visual Contrast	(y/n)	NO
Contrasting Color Bands	(y/n)	NO
Audible Walk Indicator	(y/n)	NO
Button Locator Tone	(y/n)	NO
Directional Info	(y/n)	YES

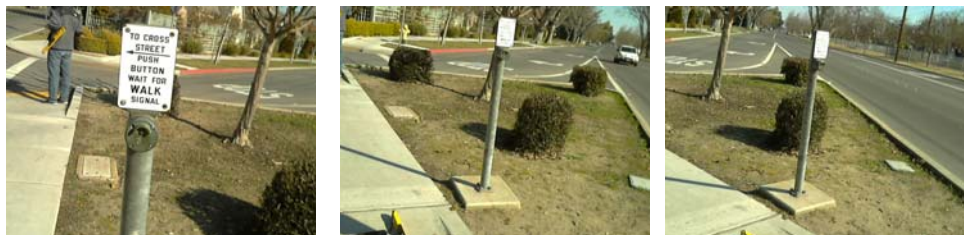
PCODE	PA19B
ADAPROW	R404.2
ADA-1991	4.3.7
CSAS	1118B.4.1
Unit Cost	\$2650.00
Priority	2
Severity	3

Accessible Path	(y/n)	YES
Clear Floor Space	(y/n)	NO
Clear Floor Slope	(%)	1.2
Clear Floor X Slope	(%)	3.5
Button Ht.	(in)	44.5
Button Reach	(in)	20
Button Diameter	(in)	0.5
Button Pressure	(lbs)	2
Closed Fist Operation	(y/n)	NO
Visual Contrast	(y/n)	NO
Contrasting Color Bands	(y/n)	NO
Audible Walk Indicator	(y/n)	NO
Button Locator Tone	(y/n)	NO
Directional Info	(y/n)	YES

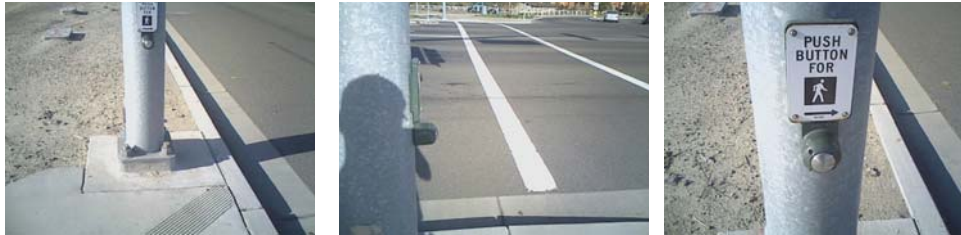
SE Push Button Operation

PCODE PA19B
 ADAPROW **R404.2**
 ADA-1991 **4.3.7**
 CSAS **1118B.4.1**
 Unit Cost **\$1950.00**
 Priority **4** Severity **4**

Accessible Path	(y/n)	YES
Clear Floor Space	(y/n)	NO
Clear Floor Slope	(%)	0.4
Clear Floor X Slope	(%)	2.8
Button Ht.	(in)	39.5
Button Reach	(in)	0
Button Diameter	(in)	2
Button Pressure	(lbs)	4
Closed Fist Operation	(y/n)	YES
Visual Contrast	(y/n)	YES
Contrasting Color Bands	(y/n)	NO
Audible Walk Indicator	(y/n)	YES
Button Locator Tone	(y/n)	NO
Directional Info	(y/n)	YES

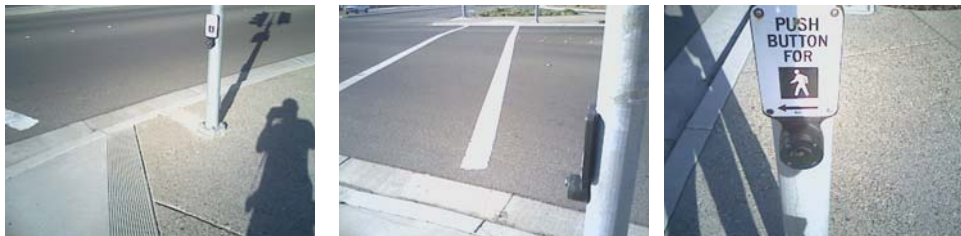
PCODE PA39A
 ADAPROW **R403.4**
 ADA-1991 **4.27.4**
 ADA-2010 **309.4**
 CSAS **1117B.6.4**
 Unit Cost **\$1350.00**
 Priority **4** Severity **4**

Accessible Path	(y/n)	YES
Clear Floor Space	(y/n)	YES
Clear Floor Slope	(%)	0.7
Clear Floor X Slope	(%)	1.6
Button Ht.	(in)	38.5
Button Reach	(in)	0
Button Diameter	(in)	0.5
Button Pressure	(lbs)	8
Closed Fist Operation	(y/n)	NO
Visual Contrast	(y/n)	YES
Contrasting Color Bands	(y/n)	NO
Audible Walk Indicator	(y/n)	YES
Button Locator Tone	(y/n)	NO
Directional Info	(y/n)	YES

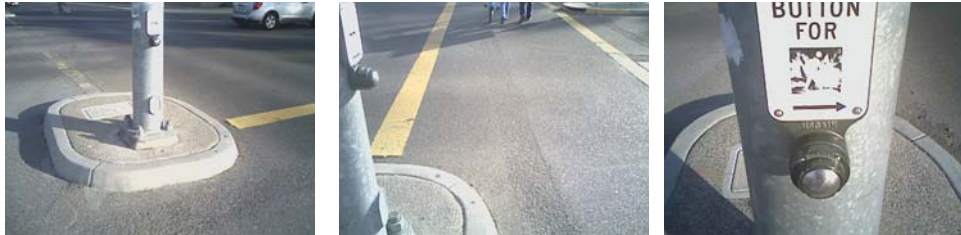
WSW Color Coding

PCODE	PA19A
ADAPROW	R404.2
ADA-1991	4.3.7
CSAS	1118B.4.1
Unit Cost	\$1950.00
Priority	4
Severity	4

Accessible Path	(y/n)	YES
Clear Floor Space	(y/n)	YES
Clear Floor Slope	(%)	2.6
Clear Floor X Slope	(%)	0.1
Button Ht.	(in)	45
Button Reach	(in)	15
Button Diameter	(in)	2
Button Pressure	(lbs)	4
Closed Fist Operation	(y/n)	YES
Visual Contrast	(y/n)	YES
Contrasting Color Bands	(y/n)	NO
Audible Walk Indicator	(y/n)	YES
Button Locator Tone	(y/n)	NO
Directional Info	(y/n)	YES

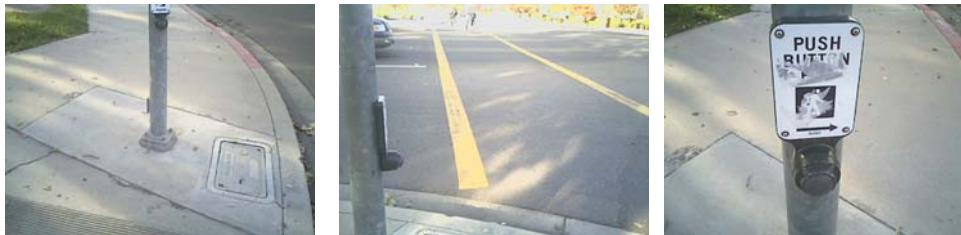
PCODE	PA52A
CSAS	1117B.5.9
Unit Cost	\$1350.00
Priority	4
Severity	4

Accessible Path	(y/n)	YES
Clear Floor Space	(y/n)	YES
Clear Floor Slope	(%)	0.7
Clear Floor X Slope	(%)	1.9
Button Ht.	(in)	39
Button Reach	(in)	0
Button Diameter	(in)	2
Button Pressure	(lbs)	2
Closed Fist Operation	(y/n)	YES
Visual Contrast	(y/n)	NO
Contrasting Color Bands	(y/n)	NO
Audible Walk Indicator	(y/n)	YES
Button Locator Tone	(y/n)	NO
Directional Info	(y/n)	YES

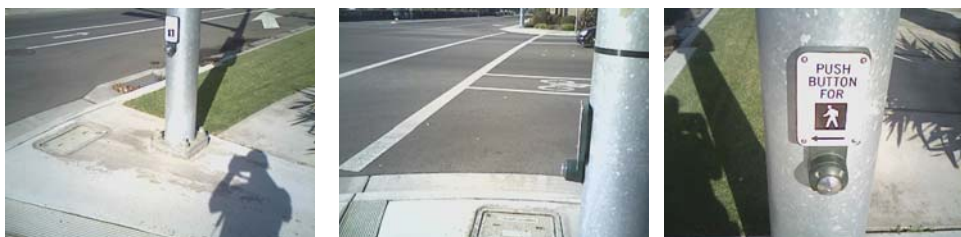
PCODE	PA43
ADAPROW	R209.1
Unit Cost	\$1350.00
Priority	5
Severity	4

Accessible Path	(y/n)	YES
Clear Floor Space	(y/n)	YES
Clear Floor Slope	(%)	1.7
Clear Floor X Slope	(%)	0.5
Button Ht.	(in)	40
Button Reach	(in)	0
Button Diameter	(in)	2
Button Pressure	(lbs)	4
Closed Fist Operation	(y/n)	YES
Visual Contrast	(y/n)	YES
Contrasting Color Bands	(y/n)	NO
Audible Walk Indicator	(y/n)	YES
Button Locator Tone	(y/n)	NO
Directional Info	(y/n)	YES

Provide 2" wide color coding with 1" wide dark borders located directly above control button.

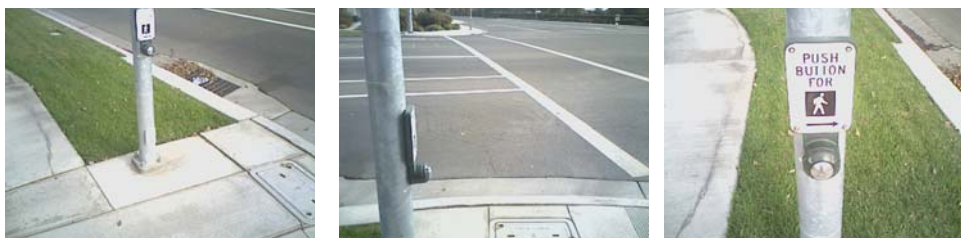
PCODE	PA19B
ADAPROW	R404.2
ADA-1991	4.3.7
CSAS	1118B.4.1
Unit Cost	\$1950.00
Priority	4
Severity	4

Provide 2" wide color coding with 1" wide dark borders located directly above control button. Provide a button locator tone.

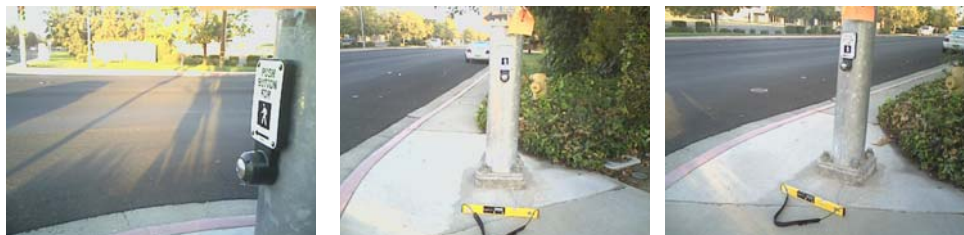
NNW Clear Floor Space

PCODE	PA19A
ADAPROW	R404.2
ADA-1991	4.3.7
CSAS	1118B.4.1
Unit Cost	\$1950.00
Priority	5
Severity	4

Accessible Path	(y/n)	YES
Clear Floor Space	(y/n)	YES
Clear Floor Slope	(%)	4.0
Clear Floor X Slope	(%)	0.3
Button Ht.	(in)	39.75
Button Reach	(in)	0
Button Diameter	(in)	2
Button Pressure	(lbs)	2
Closed Fist Operation	(y/n)	YES
Visual Contrast	(y/n)	YES
Contrasting Color Bands	(y/n)	NO
Audible Walk Indicator	(y/n)	YES
Button Locator Tone	(y/n)	NO
Directional Info	(y/n)	YES

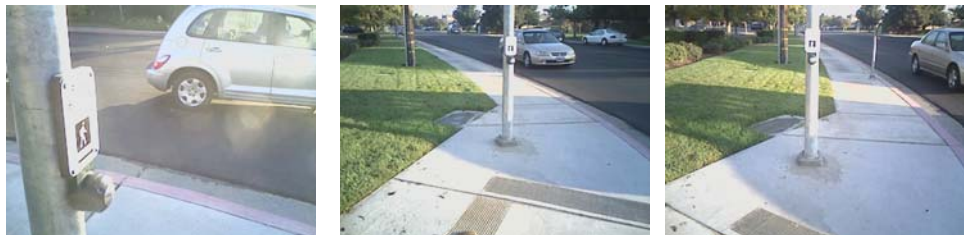
PCODE	PA19A
ADAPROW	R404.2
ADA-1991	4.3.7
CSAS	1118B.4.1
Unit Cost	\$1950.00
Priority	5
Severity	4

Accessible Path	(y/n)	YES
Clear Floor Space	(y/n)	YES
Clear Floor Slope	(%)	3.5
Clear Floor X Slope	(%)	0.5
Button Ht.	(in)	40
Button Reach	(in)	0
Button Diameter	(in)	2
Button Pressure	(lbs)	2
Closed Fist Operation	(y/n)	YES
Visual Contrast	(y/n)	YES
Contrasting Color Bands	(y/n)	NO
Audible Walk Indicator	(y/n)	YES
Button Locator Tone	(y/n)	NO
Directional Info	(y/n)	YES

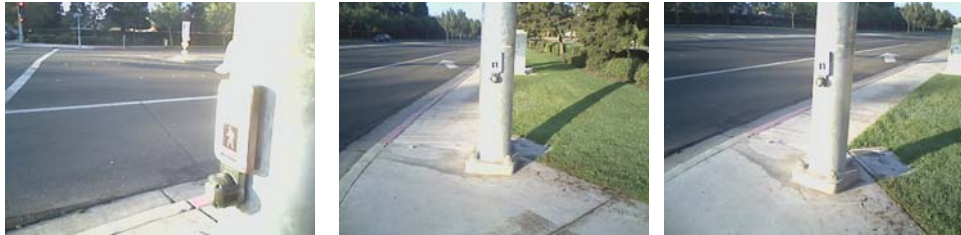
WSW Pedestrian Signal

PCODE PA19B
 ADAPROW **R404.2**
 ADA-1991 **4.3.7**
 CSAS **1118B.4.1**
 Unit Cost **\$1950.00**
 Priority **5** Severity **4**

Accessible Path	(y/n)	YES
Clear Floor Space	(y/n)	YES
Clear Floor Slope	(%)	1.1
Clear Floor X Slope	(%)	2.7
Button Ht.	(in)	39.5
Button Reach	(in)	0
Button Diameter	(in)	2
Button Pressure	(lbs)	2
Closed Fist Operation	(y/n)	YES
Visual Contrast	(y/n)	YES
Contrasting Color Bands	(y/n)	NO
Audible Walk Indicator	(y/n)	YES
Button Locator Tone	(y/n)	NO
Directional Info	(y/n)	YES

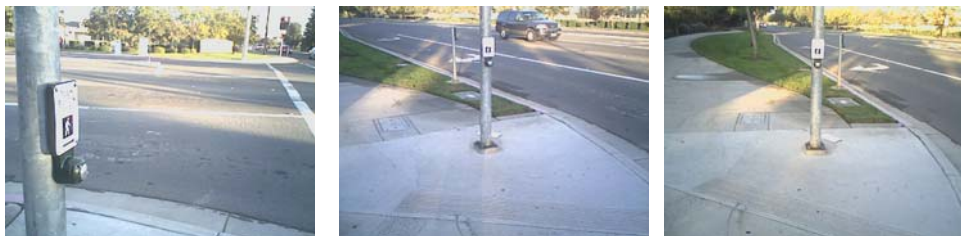
PCODE PA43
 ADAPROW **R209.1**
 Unit Cost **\$1950.00**
 Priority **4** Severity **4**

Accessible Path	(y/n)	YES
Clear Floor Space	(y/n)	YES
Clear Floor Slope	(%)	0.6
Clear Floor X Slope	(%)	2.0
Button Ht.	(in)	40
Button Reach	(in)	0
Button Diameter	(in)	2
Button Pressure	(lbs)	2
Closed Fist Operation	(y/n)	YES
Visual Contrast	(y/n)	YES
Contrasting Color Bands	(y/n)	NO
Audible Walk Indicator	(y/n)	YES
Button Locator Tone	(y/n)	NO
Directional Info	(y/n)	YES

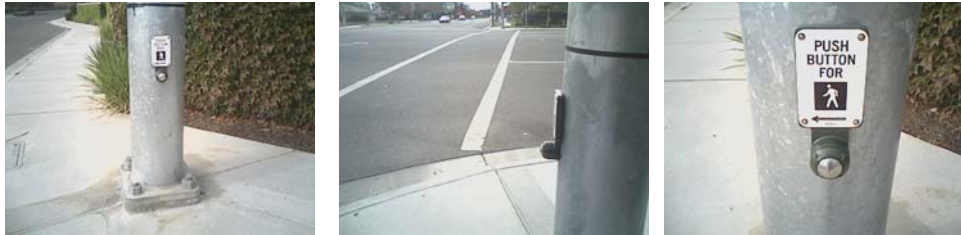
WSW Clear Floor Space

PCODE	PA19A
ADAPROW	R404.2
ADA-1991	4.3.7
CSAS	1118B.4.1
Unit Cost	\$1950.00
Priority	4
Severity	4

Accessible Path	(y/n)	YES
Clear Floor Space	(y/n)	YES
Clear Floor Slope	(%)	5.3
Clear Floor X Slope	(%)	1.8
Button Ht.	(in)	40
Button Reach	(in)	0
Button Diameter	(in)	2
Button Pressure	(lbs)	2
Closed Fist Operation	(y/n)	YES
Visual Contrast	(y/n)	YES
Contrasting Color Bands	(y/n)	NO
Audible Walk Indicator	(y/n)	YES
Button Locator Tone	(y/n)	NO
Directional Info	(y/n)	YES

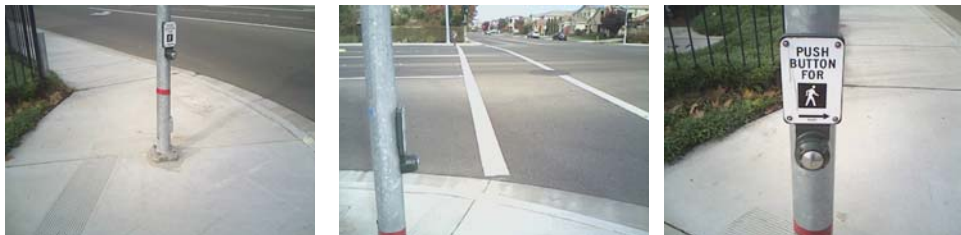
PCODE	PA19A
ADAPROW	R404.2
ADA-1991	4.3.7
CSAS	1118B.4.1
Unit Cost	\$1950.00
Priority	4
Severity	4

Accessible Path	(y/n)	YES
Clear Floor Space	(y/n)	YES
Clear Floor Slope	(%)	5.4
Clear Floor X Slope	(%)	3.3
Button Ht.	(in)	40
Button Reach	(in)	0
Button Diameter	(in)	2
Button Pressure	(lbs)	2
Closed Fist Operation	(y/n)	YES
Visual Contrast	(y/n)	YES
Contrasting Color Bands	(y/n)	NO
Audible Walk Indicator	(y/n)	YES
Button Locator Tone	(y/n)	NO
Directional Info	(y/n)	YES

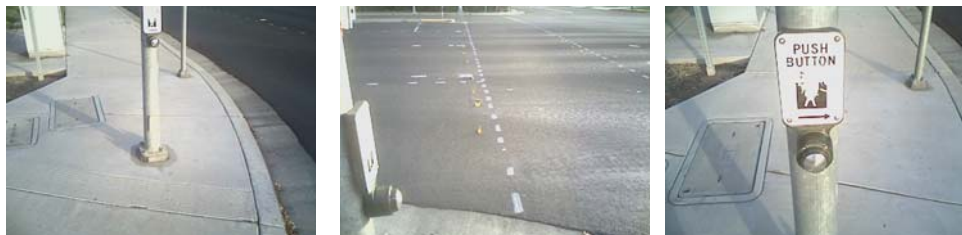
ENE Clear Floor Space

188 • *As-Built Description:*

The running slope of the floor or ground surface at the pedestrian signal device exceed 1:50 (2%) or is not consistent with the grade of the adjacent pedestrian access route.

• *As-is Measurement:* 2.8%

PCODE	PA19A
ADAPROW	R404.2
ADA-1991	4.3.7
CSAS	1118B.4.1
Unit Cost	\$2650.00
Priority	4
Severity	4

Accessible Path	(y/n)	YES
Clear Floor Space	(y/n)	NO
Clear Floor Slope	(%)	2.8
Clear Floor X Slope	(%)	0.9
Button Ht.	(in)	39
Button Reach	(in)	0
Button Diameter	(in)	2
Button Pressure	(lbs)	4
Closed Fist Operation	(y/n)	YES
Visual Contrast	(y/n)	YES
Contrasting Color Bands	(y/n)	NO
Audible Walk Indicator	(y/n)	NO
Button Locator Tone	(y/n)	NO
Directional Info	(y/n)	YES

Modify or repave the ground surface as necessary to provide slope(s) not exceeding 1:50 (2%) maximum in any direction.

Provide 2" wide color coding with 1" wide dark borders located directly above control button. Provide voice or tone audible indication of the WALK interval at the pedestrian signal device. Provide a button locator tone.

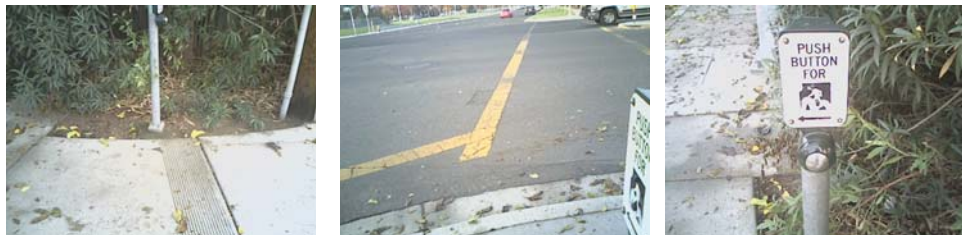
ESE Clear Floor Space

PCODE	PA19A
ADAPROW	R404.2
ADA-1991	4.3.7
CSAS	1118B.4.1
Unit Cost	\$2650.00
Priority	4
Severity	4

Accessible Path	(y/n)	YES
Clear Floor Space	(y/n)	YES
Clear Floor Slope	(%)	2.5
Clear Floor X Slope	(%)	0.6
Button Ht.	(in)	39
Button Reach	(in)	5
Button Diameter	(in)	2
Button Pressure	(lbs)	3
Closed Fist Operation	(y/n)	YES
Visual Contrast	(y/n)	YES
Contrasting Color Bands	(y/n)	NO
Audible Walk Indicator	(y/n)	NO
Button Locator Tone	(y/n)	NO
Directional Info	(y/n)	YES

Provide 2" wide color coding with 1" wide dark borders located directly above control button. Provide voice or tone audible indication of the WALK interval at the pedestrian signal device. Provide a button locator tone.

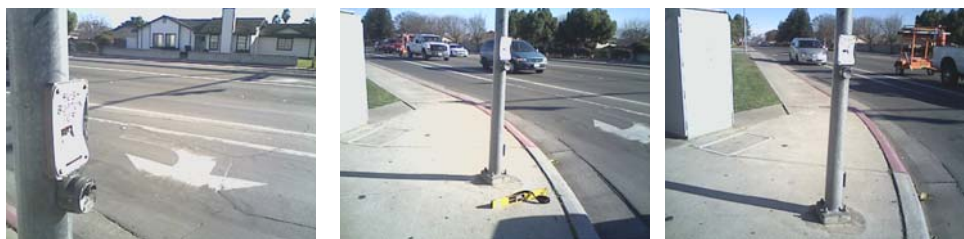
ESE Clear Floor Space

Accessible Path	(y/n)	YES
Clear Floor Space	(y/n)	YES
Clear Floor Slope	(%)	2.8
Clear Floor X Slope	(%)	0.4
Button Ht.	(in)	46.5
Button Reach	(in)	0
Button Diameter	(in)	0.5
Button Pressure	(lbs)	2
Closed Fist Operation	(y/n)	NO
Visual Contrast	(y/n)	NO
Contrasting Color Bands	(y/n)	NO
Audible Walk Indicator	(y/n)	NO
Button Locator Tone	(y/n)	NO
Directional Info	(y/n)	YES

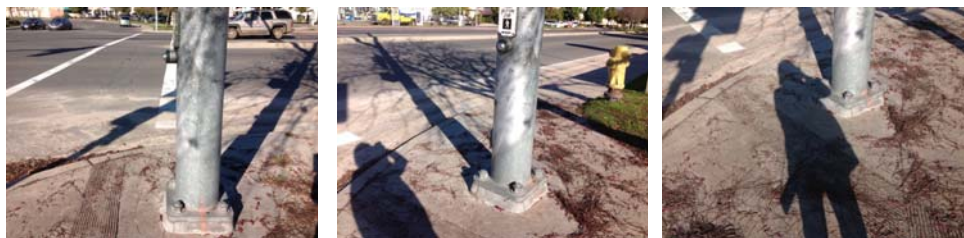
PCODE	PA19A
ADAPROW	R404.2
ADA-1991	4.3.7
CSAS	1118B.4.1
Unit Cost	\$2650.00
Priority	4
Severity	4

Accessible Path	(y/n)	YES
Clear Floor Space	(y/n)	YES
Clear Floor Slope	(%)	3.6
Clear Floor X Slope	(%)	0.8
Button Ht.	(in)	46
Button Reach	(in)	0
Button Diameter	(in)	2
Button Pressure	(lbs)	5
Closed Fist Operation	(y/n)	YES
Visual Contrast	(y/n)	YES
Contrasting Color Bands	(y/n)	NO
Audible Walk Indicator	(y/n)	NO
Button Locator Tone	(y/n)	NO
Directional Info	(y/n)	YES

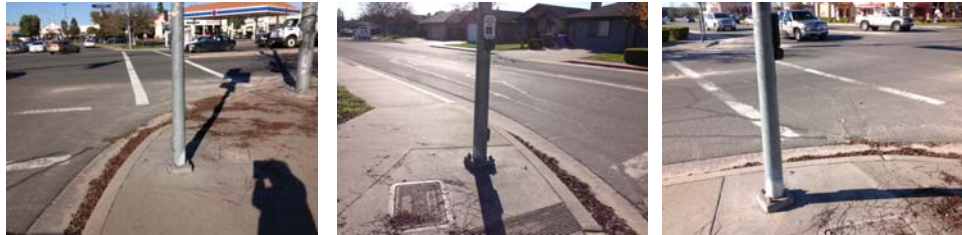
PCODE PA20
 ADAPROW **R404.3**
 ADA-1991 **4.2.4.1**
 CSAS **1118B.4.1**
 Unit Cost **\$2650.00**
 Priority **3** Severity **3**

Accessible Path	(y/n)	YES
Clear Floor Space	(y/n)	NO
Clear Floor Slope	(%)	1.2
Clear Floor X Slope	(%)	1.6
Button Ht.	(in)	46
Button Reach	(in)	0
Button Diameter	(in)	0.5
Button Pressure	(lbs)	10
Closed Fist Operation	(y/n)	NO
Visual Contrast	(y/n)	YES
Contrasting Color Bands	(y/n)	NO
Audible Walk Indicator	(y/n)	NO
Button Locator Tone	(y/n)	NO
Directional Info	(y/n)	YES

Adjust button pressure to be less than 5lbs. Provide 2" wide color coding with 1" wide dark borders located directly above control button. Provide voice or tone audible indication of the WALK interval at the pedestrian signal device. Provide 2" diameter push button. Provide a button locator tone. Provide new push button and housing to allow for closed fist operation.

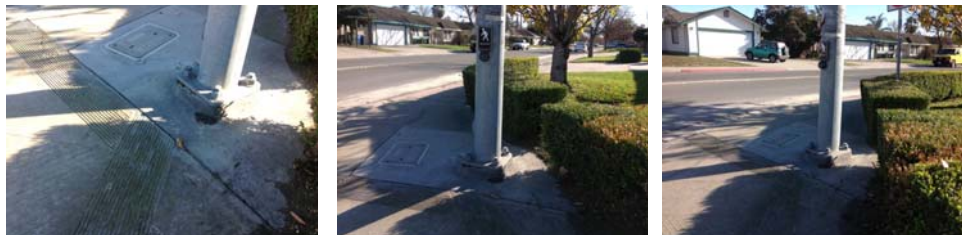
PCODE PA19A
 ADAPROW **R404.2**
 ADA-1991 **4.3.7**
 CSAS **1118B.4.1**
 Unit Cost **\$2650.00**
 Priority **4** Severity **4**

Accessible Path	(y/n)	YES
Clear Floor Space	(y/n)	YES
Clear Floor Slope	(%)	3.7
Clear Floor X Slope	(%)	1.1
Button Ht.	(in)	46
Button Reach	(in)	0
Button Diameter	(in)	0.5
Button Pressure	(lbs)	6
Closed Fist Operation	(y/n)	NO
Visual Contrast	(y/n)	NO
Contrasting Color Bands	(y/n)	NO
Audible Walk Indicator	(y/n)	NO
Button Locator Tone	(y/n)	NO
Directional Info	(y/n)	YES

Adjust button pressure to be less than 5lbs. Provide 2" wide color coding with 1" wide dark borders located directly above control button. Provide push button which contrasts with surrounding housing. Provide voice or tone audible indication of the WALK interval at the pedestrian signal device. Provide 2" diameter push button. Provide a button locator tone. Provide new push button and housing to allow for closed fist operation.

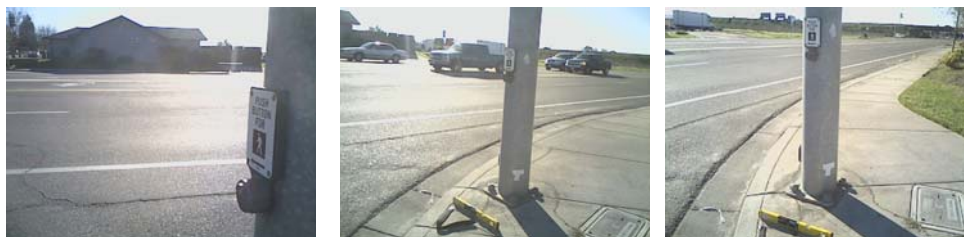
PCODE	PA19A
ADAPROW	R404.2
ADA-1991	4.3.7
CSAS	1118B.4.1
Unit Cost	\$2650.00
Priority	4
Severity	4

Provide 2" wide color coding with 1" wide dark borders located directly above control button. Provide voice or tone audible indication of the WALK interval at the pedestrian signal device. Provide 2" diameter push button. Provide a button locator tone. Provide new push button and housing to allow for closed fist operation.

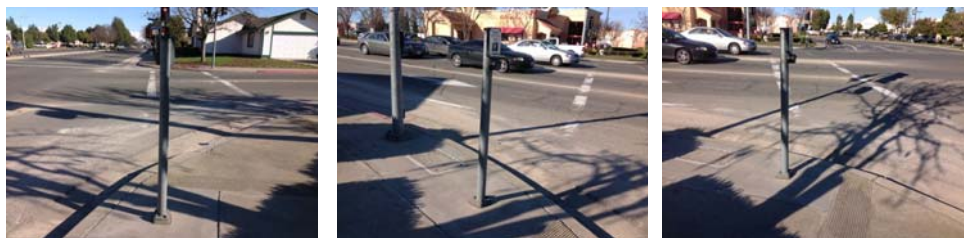
PCODE	PA20
ADAPROW	R404.3
ADA-1991	4.2.4.1
CSAS	1118B.4.1
Unit Cost	\$2650.00
Priority	3
Severity	3

Adjust button pressure to be less than 5lbs. Provide 2" wide color coding with 1" wide dark borders located directly above control button. Provide push button which contrasts with surrounding housing. Provide voice or tone audible indication of the WALK interval at the pedestrian signal device. Provide 2" diameter push button. Provide a button locator tone. Provide new push button and housing to allow for closed fist operation.

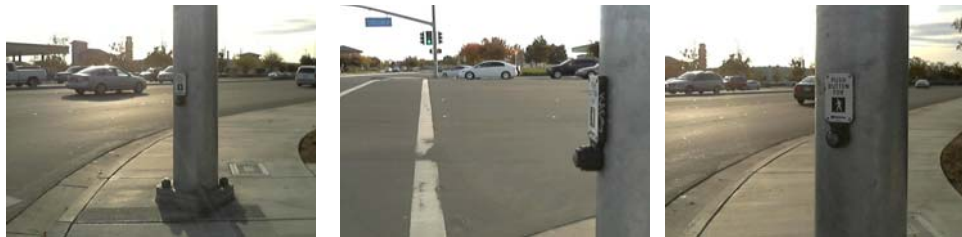
WSW Clear Floor Space

Accessible Path	(y/n)	YES
Clear Floor Space	(y/n)	NO
Clear Floor Slope	(%)	0.5
Clear Floor X Slope	(%)	9.3
Button Ht.	(in)	39
Button Reach	(in)	0
Button Diameter	(in)	2
Button Pressure	(lbs)	3
Closed Fist Operation	(y/n)	YES
Visual Contrast	(y/n)	NO
Contrasting Color Bands	(y/n)	NO
Audible Walk Indicator	(y/n)	NO
Button Locator Tone	(y/n)	NO
Directional Info	(y/n)	YES

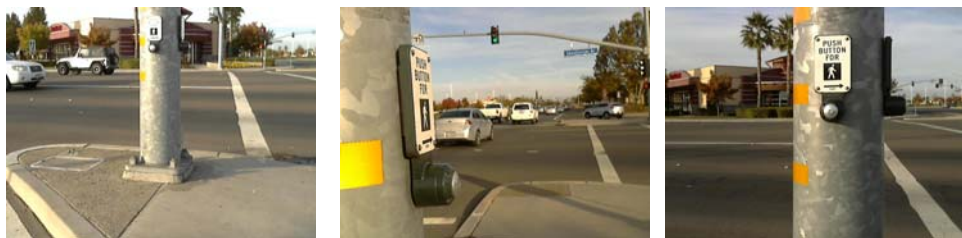
PCODE PA19B
 ADAPROW **R404.2**
 ADA-1991 **4.3.7**
 CSAS **1118B.4.1**
 Unit Cost **\$2650.00**
 Priority **4** Severity **4**

Accessible Path	(y/n)	YES
Clear Floor Space	(y/n)	YES
Clear Floor Slope	(%)	2.8
Clear Floor X Slope	(%)	2.8
Button Ht.	(in)	45
Button Reach	(in)	0
Button Diameter	(in)	2
Button Pressure	(lbs)	5
Closed Fist Operation	(y/n)	YES
Visual Contrast	(y/n)	NO
Contrasting Color Bands	(y/n)	NO
Audible Walk Indicator	(y/n)	NO
Button Locator Tone	(y/n)	NO
Directional Info	(y/n)	YES

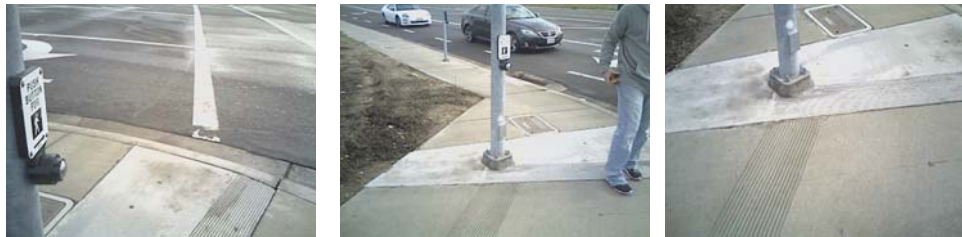
PCODE PA19B
 ADAPROW **R404.2**
 ADA-1991 **4.3.7**
 CSAS **1118B.4.1**
 Unit Cost **\$1950.00**
 Priority **4** Severity **4**

Provide 2" wide color coding with 1" wide dark borders located directly above control button. Provide a button locator tone.

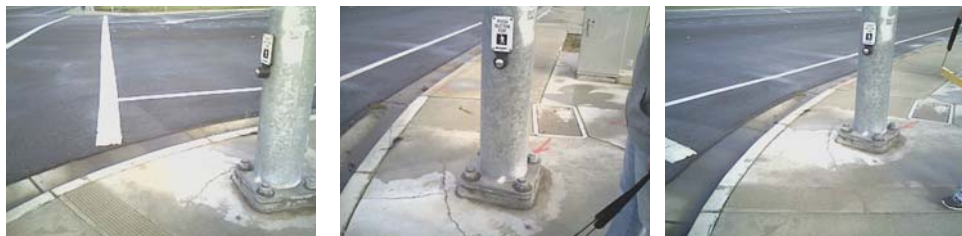
PCODE PA43
 ADAPROW **R209.1**
 Unit Cost **\$1350.00**
 Priority **4** Severity **4**

Accessible Path	(y/n)	YES
Clear Floor Space	(y/n)	YES
Clear Floor Slope	(%)	0.5
Clear Floor X Slope	(%)	0.9
Button Ht.	(in)	39
Button Reach	(in)	0
Button Diameter	(in)	2
Button Pressure	(lbs)	4
Closed Fist Operation	(y/n)	YES
Visual Contrast	(y/n)	YES
Contrasting Color Bands	(y/n)	NO
Audible Walk Indicator	(y/n)	YES
Button Locator Tone	(y/n)	NO
Directional Info	(y/n)	YES

Provide 2" wide color coding with 1" wide dark borders located directly above control button.

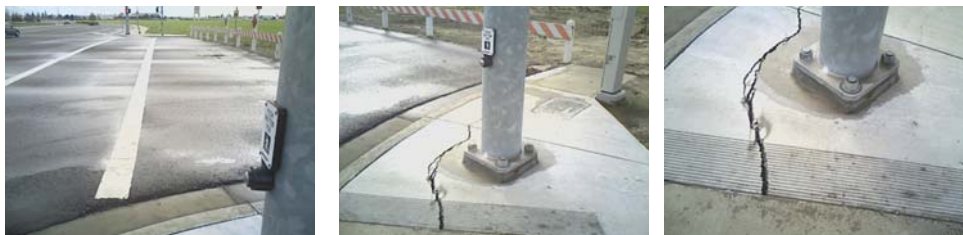
PCODE	PA19B
ADAPROW	R404.2
ADA-1991	4.3.7
CSAS	1118B.4.1
Unit Cost	\$1950.00
Priority	4
Severity	4

Accessible Path	(y/n)	YES
Clear Floor Space	(y/n)	YES
Clear Floor Slope	(%)	0.4
Clear Floor X Slope	(%)	3.5
Button Ht.	(in)	39
Button Reach	(in)	0
Button Diameter	(in)	2
Button Pressure	(lbs)	3
Closed Fist Operation	(y/n)	YES
Visual Contrast	(y/n)	YES
Contrasting Color Bands	(y/n)	NO
Audible Walk Indicator	(y/n)	YES
Button Locator Tone	(y/n)	NO
Directional Info	(y/n)	YES

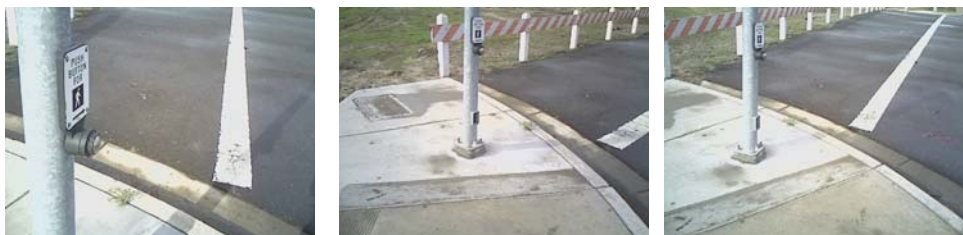
PCODE	PA19B
ADAPROW	R404.2
ADA-1991	4.3.7
CSAS	1118B.4.1
Unit Cost	\$1950.00
Priority	4
Severity	4

Accessible Path	(y/n)	YES
Clear Floor Space	(y/n)	YES
Clear Floor Slope	(%)	1.6
Clear Floor X Slope	(%)	2.6
Button Ht.	(in)	39
Button Reach	(in)	0
Button Diameter	(in)	2
Button Pressure	(lbs)	3
Closed Fist Operation	(y/n)	YES
Visual Contrast	(y/n)	YES
Contrasting Color Bands	(y/n)	NO
Audible Walk Indicator	(y/n)	YES
Button Locator Tone	(y/n)	NO
Directional Info	(y/n)	YES

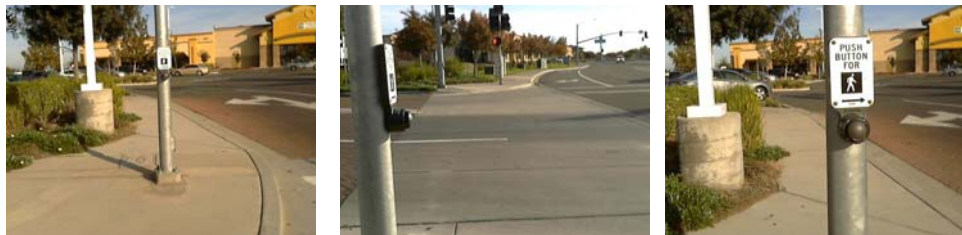
PCODE	PA19B
ADAPROW	R404.2
ADA-1991	4.3.7
CSAS	1118B.4.1
Unit Cost	\$2650.00
Priority	3
Severity	3

Accessible Path	(y/n)	YES
Clear Floor Space	(y/n)	NO
Clear Floor Slope	(%)	2.5
Clear Floor X Slope	(%)	7.8
Button Ht.	(in)	40
Button Reach	(in)	0
Button Diameter	(in)	2
Button Pressure	(lbs)	3
Closed Fist Operation	(y/n)	YES
Visual Contrast	(y/n)	NO
Contrasting Color Bands	(y/n)	NO
Audible Walk Indicator	(y/n)	NO
Button Locator Tone	(y/n)	NO
Directional Info	(y/n)	YES

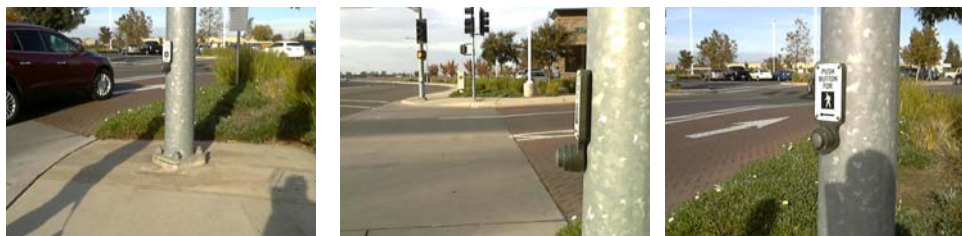
PCODE	PA19B
ADAPROW	R404.2
ADA-1991	4.3.7
CSAS	1118B.4.1
Unit Cost	\$2650.00
Priority	4
Severity	4

Accessible Path	(y/n)	YES
Clear Floor Space	(y/n)	YES
Clear Floor Slope	(%)	1.3
Clear Floor X Slope	(%)	7.8
Button Ht.	(in)	39
Button Reach	(in)	0
Button Diameter	(in)	2
Button Pressure	(lbs)	3
Closed Fist Operation	(y/n)	YES
Visual Contrast	(y/n)	NO
Contrasting Color Bands	(y/n)	NO
Audible Walk Indicator	(y/n)	NO
Button Locator Tone	(y/n)	NO
Directional Info	(y/n)	YES

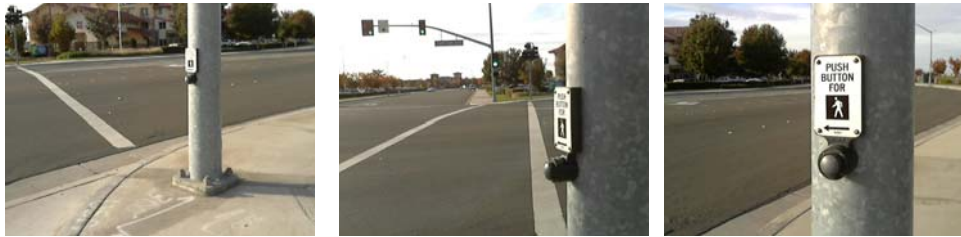
PCODE PA19B
 ADAPROW **R404.2**
 ADA-1991 **4.3.7**
 CSAS **1118B.4.1**
 Unit Cost **\$2650.00**
 Priority **3** Severity **3**

Accessible Path	(y/n)	YES
Clear Floor Space	(y/n)	NO
Clear Floor Slope	(%)	1.3
Clear Floor X Slope	(%)	4.7
Button Ht.	(in)	39
Button Reach	(in)	0
Button Diameter	(in)	2
Button Pressure	(lbs)	3
Closed Fist Operation	(y/n)	YES
Visual Contrast	(y/n)	NO
Contrasting Color Bands	(y/n)	NO
Audible Walk Indicator	(y/n)	NO
Button Locator Tone	(y/n)	NO
Directional Info	(y/n)	YES

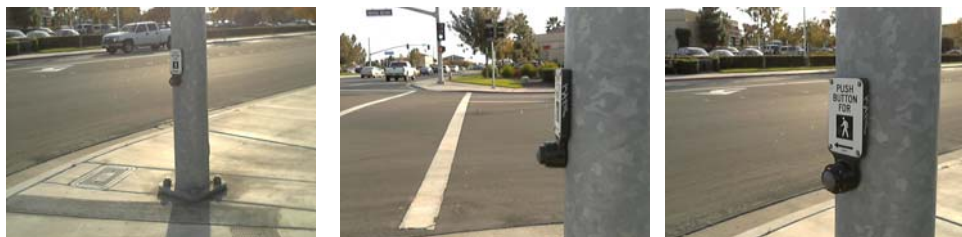
WSW Clear Floor Space

Accessible Path	(y/n)	YES
Clear Floor Space	(y/n)	NO
Clear Floor Slope	(%)	3.9
Clear Floor X Slope	(%)	1.5
Button Ht.	(in)	39
Button Reach	(in)	0
Button Diameter	(in)	2
Button Pressure	(lbs)	3
Closed Fist Operation	(y/n)	YES
Visual Contrast	(y/n)	NO
Contrasting Color Bands	(y/n)	NO
Audible Walk Indicator	(y/n)	NO
Button Locator Tone	(y/n)	NO
Directional Info	(y/n)	YES

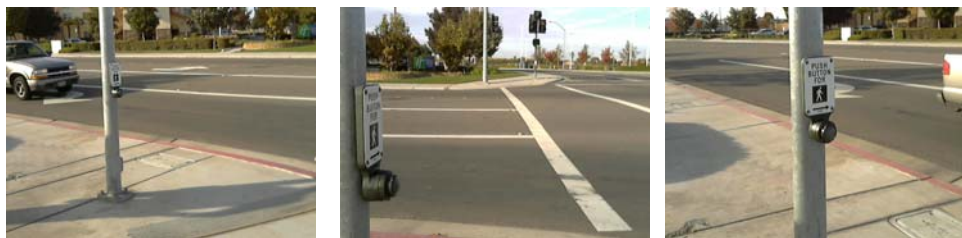
PCODE	PA19A
ADAPROW	R404.2
ADA-1991	4.3.7
CSAS	1118B.4.1
Unit Cost	\$2650.00
Priority	4
Severity	4

Accessible Path	(y/n)	YES
Clear Floor Space	(y/n)	YES
Clear Floor Slope	(%)	4.4
Clear Floor X Slope	(%)	2.6
Button Ht.	(in)	37
Button Reach	(in)	0
Button Diameter	(in)	2
Button Pressure	(lbs)	3
Closed Fist Operation	(y/n)	YES
Visual Contrast	(y/n)	NO
Contrasting Color Bands	(y/n)	NO
Audible Walk Indicator	(y/n)	NO
Button Locator Tone	(y/n)	NO
Directional Info	(y/n)	YES

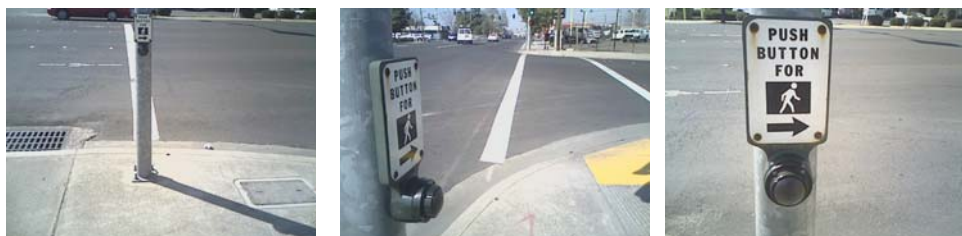
PCODE PA43
 ADAPROW R209.1
 Unit Cost \$2100.00
 Priority 4 Severity 4

Accessible Path	(y/n)	YES
Clear Floor Space	(y/n)	YES
Clear Floor Slope	(%)	0.2
Clear Floor X Slope	(%)	0.6
Button Ht.	(in)	46
Button Reach	(in)	0
Button Diameter	(in)	2
Button Pressure	(lbs)	3
Closed Fist Operation	(y/n)	YES
Visual Contrast	(y/n)	NO
Contrasting Color Bands	(y/n)	NO
Audible Walk Indicator	(y/n)	NO
Button Locator Tone	(y/n)	NO
Directional Info	(y/n)	YES

Provide voice or tone audible indication of the WALK interval at the pedestrian signal device. Provide push button which contrasts with surrounding housing. Provide 2" wide color coding with 1" wide dark borders located directly above control button.

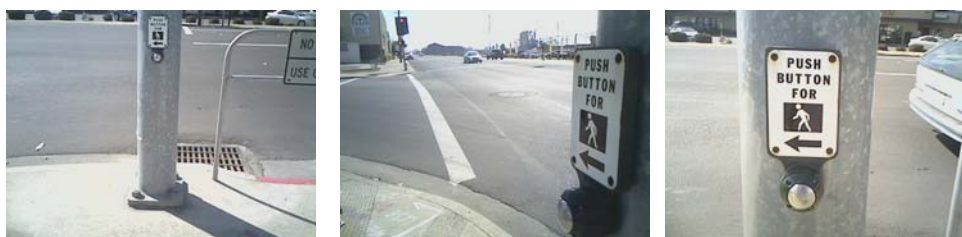
PCODE PA43
 ADAPROW R209.1
 Unit Cost \$2100.00
 Priority 4 Severity 4

Provide voice or tone audible indication of the WALK interval at the pedestrian signal device. Provide push button which contrasts with surrounding housing. Provide 2" wide color coding with 1" wide dark borders located directly above control button.

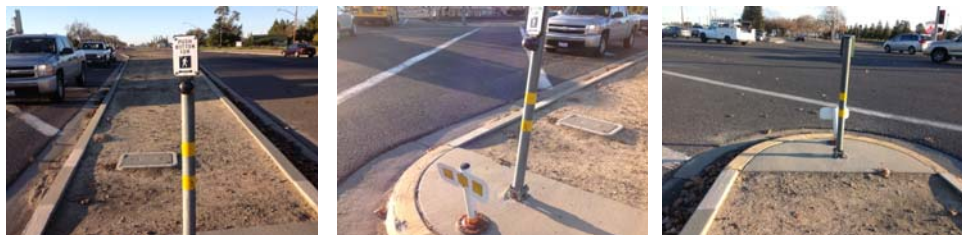
PCODE	PR02A
ADAPROW	R301.2
ADA-1991	4.1.2 (1) & (2)
Unit Cost	\$2650.00
Priority	2
Severity	2

Accessible Path	(y/n)	NO
Clear Floor Space	(y/n)	NO
Clear Floor Slope	(%)	N/A
Clear Floor X Slope	(%)	N/A
Button Ht.	(in)	49
Button Reach	(in)	30
Button Diameter	(in)	2
Button Pressure	(lbs)	5
Closed Fist Operation	(y/n)	NO
Visual Contrast	(y/n)	NO
Contrasting Color Bands	(y/n)	NO
Audible Walk Indicator	(y/n)	NO
Button Locator Tone	(y/n)	NO
Directional Info	(y/n)	YES

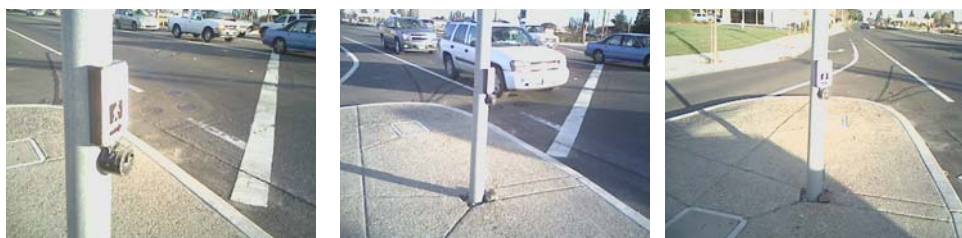
PCODE	PA39A
ADAPROW	R403.4
ADA-1991	4.27.4
ADA-2010	309.4
CSAS	1117B.6.4
Unit Cost	\$2050.00
Priority	4
Severity	4

Accessible Path	(y/n)	YES
Clear Floor Space	(y/n)	YES
Clear Floor Slope	(%)	0.8
Clear Floor X Slope	(%)	0.6
Button Ht.	(in)	36.5
Button Reach	(in)	0
Button Diameter	(in)	0.5
Button Pressure	(lbs)	2
Closed Fist Operation	(y/n)	NO
Visual Contrast	(y/n)	YES
Contrasting Color Bands	(y/n)	NO
Audible Walk Indicator	(y/n)	NO
Button Locator Tone	(y/n)	NO
Directional Info	(y/n)	YES

Modify or replace the operable part(s) to not require tight grasping, pinching, or twisting of the wrist with one hand.

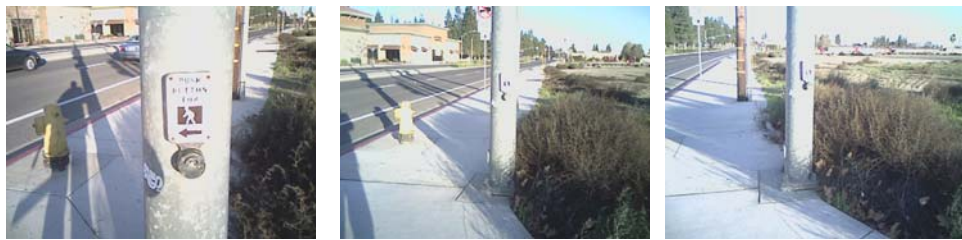
PCODE	PA39A
ADAPROW	R403.4
ADA-1991	4.27.4
ADA-2010	309.4
CSAS	1117B.6.4
Unit Cost	\$2050.00
Priority	4
Severity	4

Provide a button locator tone. Provide 2" diameter push button. Provide voice or tone audible indication of the WALK interval at the pedestrian signal device. Provide 2" wide color coding with 1" wide dark borders located directly above control button.

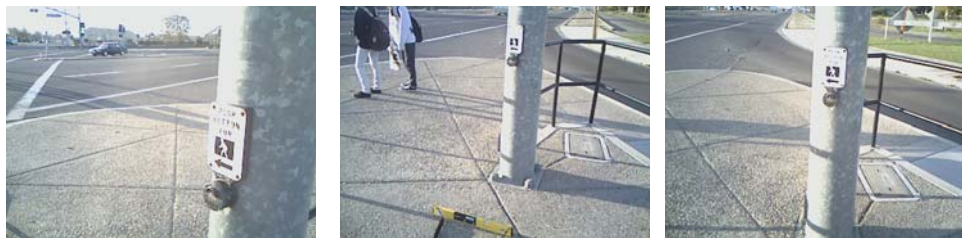
PCODE	PA19B
ADAPROW	R404.2
ADA-1991	4.3.7
CSAS	1118B.4.1
Unit Cost	\$2650.00
Priority	4
Severity	4

Provide voice or tone audible indication of the WALK interval at the pedestrian signal device. Provide 2" diameter push button. Provide a button locator tone. Provide new push button and housing to allow for closed fist operation.

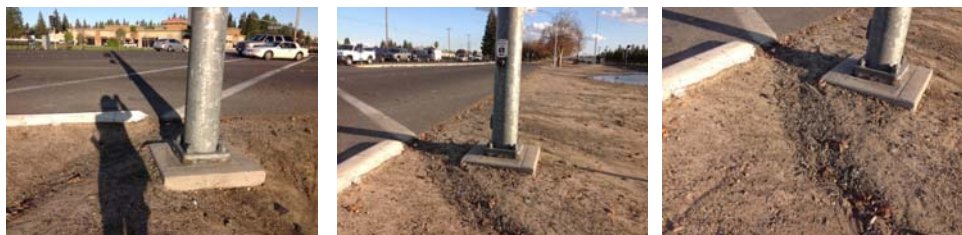
PCODE	PR02A
ADAPROW	R301.2
ADA-1991	4.1.2 (1) & (2)
Unit Cost	\$2650.00
Priority	2
Severity	2

Accessible Path	(y/n)	NO
Clear Floor Space	(y/n)	NO
Clear Floor Slope	(%)	N/A
Clear Floor X Slope	(%)	N/A
Button Ht.	(in)	46
Button Reach	(in)	70
Button Diameter	(in)	0.5
Button Pressure	(lbs)	2
Closed Fist Operation	(y/n)	NO
Visual Contrast	(y/n)	NO
Contrasting Color Bands	(y/n)	NO
Audible Walk Indicator	(y/n)	NO
Button Locator Tone	(y/n)	NO
Directional Info	(y/n)	YES

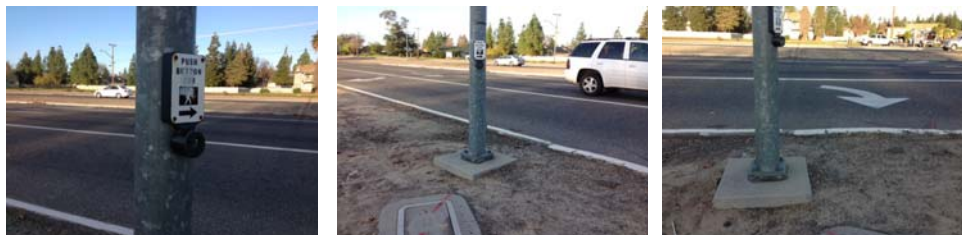
PCODE	PR02A
ADAPROW	R301.2
ADA-1991	4.1.2 (1) & (2)
Unit Cost	\$2650.00
Priority	2
Severity	2

Accessible Path	(y/n)	NO
Clear Floor Space	(y/n)	NO
Clear Floor Slope	(%)	N/A
Clear Floor X Slope	(%)	N/A
Button Ht.	(in)	45
Button Reach	(in)	99
Button Diameter	(in)	0.5
Button Pressure	(lbs)	10
Closed Fist Operation	(y/n)	NO
Visual Contrast	(y/n)	NO
Contrasting Color Bands	(y/n)	NO
Audible Walk Indicator	(y/n)	NO
Button Locator Tone	(y/n)	NO
Directional Info	(y/n)	YES

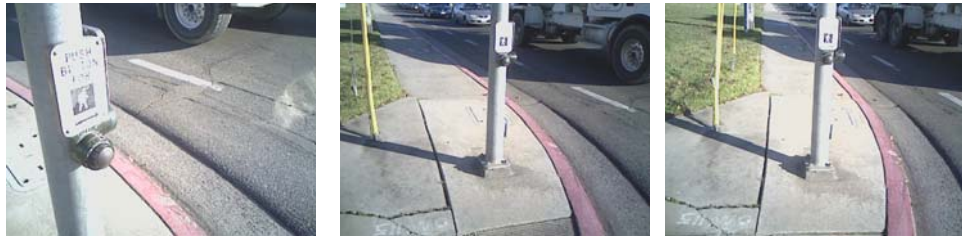
ENE - N Clear Floor Space

Accessible Path	(y/n)	YES
Clear Floor Space	(y/n)	YES
Clear Floor Slope	(%)	3.5
Clear Floor X Slope	(%)	2.2
Button Ht.	(in)	36
Button Reach	(in)	0
Button Diameter	(in)	2
Button Pressure	(lbs)	2
Closed Fist Operation	(y/n)	YES
Visual Contrast	(y/n)	NO
Contrasting Color Bands	(y/n)	NO
Audible Walk Indicator	(y/n)	NO
Button Locator Tone	(y/n)	NO
Directional Info	(y/n)	YES

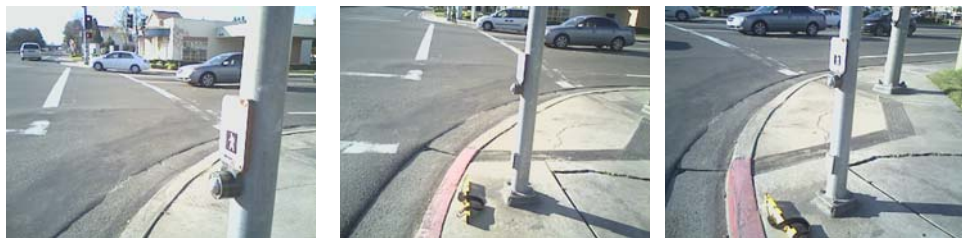
PCODE PA19A
 ADAPROW **R404.2**
 ADA-1991 **4.3.7**
 CSAS **1118B.4.1**
 Unit Cost **\$2650.00**
 Priority **5** Severity **4**

Accessible Path	(y/n)	YES
Clear Floor Space	(y/n)	YES
Clear Floor Slope	(%)	2.8
Clear Floor X Slope	(%)	1.2
Button Ht.	(in)	36
Button Reach	(in)	0
Button Diameter	(in)	2
Button Pressure	(lbs)	5
Closed Fist Operation	(y/n)	YES
Visual Contrast	(y/n)	YES
Contrasting Color Bands	(y/n)	NO
Audible Walk Indicator	(y/n)	NO
Button Locator Tone	(y/n)	NO
Directional Info	(y/n)	YES

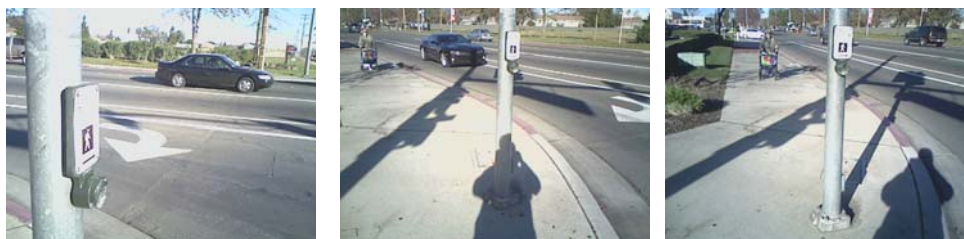
SSE Clear Floor Space

Accessible Path	(y/n)	YES
Clear Floor Space	(y/n)	YES
Clear Floor Slope	(%)	2.7
Clear Floor X Slope	(%)	2.1
Button Ht.	(in)	46.25
Button Reach	(in)	0
Button Diameter	(in)	0.5
Button Pressure	(lbs)	2
Closed Fist Operation	(y/n)	NO
Visual Contrast	(y/n)	NO
Contrasting Color Bands	(y/n)	NO
Audible Walk Indicator	(y/n)	NO
Button Locator Tone	(y/n)	NO
Directional Info	(y/n)	YES

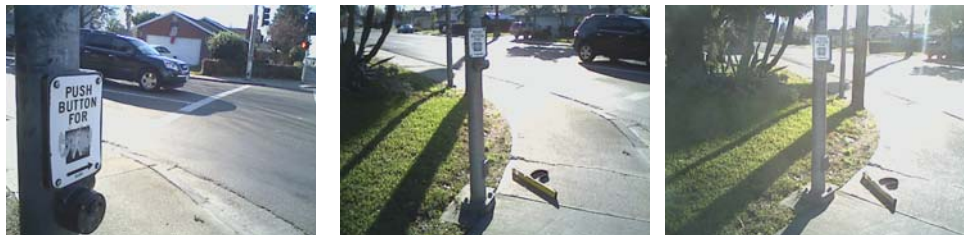
PCODE	PA19A
ADAPROW	R404.2
ADA-1991	4.3.7
CSAS	1118B.4.1
Unit Cost	\$2650.00
Priority	4
Severity	4

Accessible Path	(y/n)	YES
Clear Floor Space	(y/n)	YES
Clear Floor Slope	(%)	3.9
Clear Floor X Slope	(%)	2.5
Button Ht.	(in)	46.25
Button Reach	(in)	0
Button Diameter	(in)	0.5
Button Pressure	(lbs)	2
Closed Fist Operation	(y/n)	YES
Visual Contrast	(y/n)	NO
Contrasting Color Bands	(y/n)	NO
Audible Walk Indicator	(y/n)	NO
Button Locator Tone	(y/n)	NO
Directional Info	(y/n)	YES

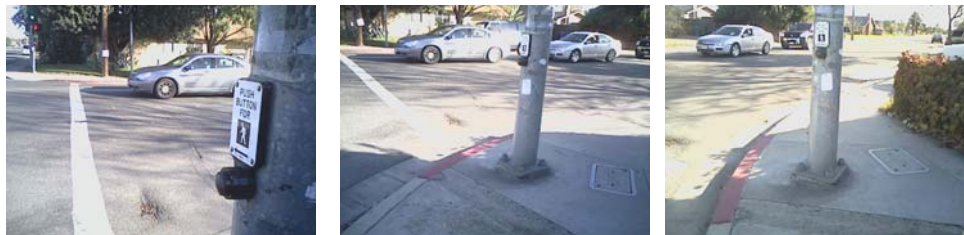
WNW Clear Floor Space

PCODE	PA19A
ADAPROW	R404.2
ADA-1991	4.3.7
CSAS	1118B.4.1
Unit Cost	\$2650.00
Priority	3
Severity	3

Accessible Path	(y/n)	YES
Clear Floor Space	(y/n)	NO
Clear Floor Slope	(%)	8.7
Clear Floor X Slope	(%)	0.1
Button Ht.	(in)	46
Button Reach	(in)	0
Button Diameter	(in)	2
Button Pressure	(lbs)	2
Closed Fist Operation	(y/n)	YES
Visual Contrast	(y/n)	NO
Contrasting Color Bands	(y/n)	NO
Audible Walk Indicator	(y/n)	NO
Button Locator Tone	(y/n)	NO
Directional Info	(y/n)	YES

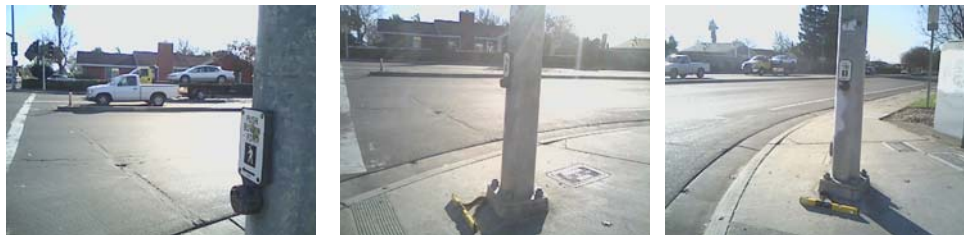
WSW Clear Floor Space

PCODE	PA19A
ADAPROW	R404.2
ADA-1991	4.3.7
CSAS	1118B.4.1
Unit Cost	\$2650.00
Priority	4
Severity	4

Accessible Path	(y/n)	YES
Clear Floor Space	(y/n)	YES
Clear Floor Slope	(%)	3.8
Clear Floor X Slope	(%)	1.6
Button Ht.	(in)	46
Button Reach	(in)	0
Button Diameter	(in)	0.5
Button Pressure	(lbs)	2
Closed Fist Operation	(y/n)	NO
Visual Contrast	(y/n)	NO
Contrasting Color Bands	(y/n)	NO
Audible Walk Indicator	(y/n)	NO
Button Locator Tone	(y/n)	NO
Directional Info	(y/n)	YES

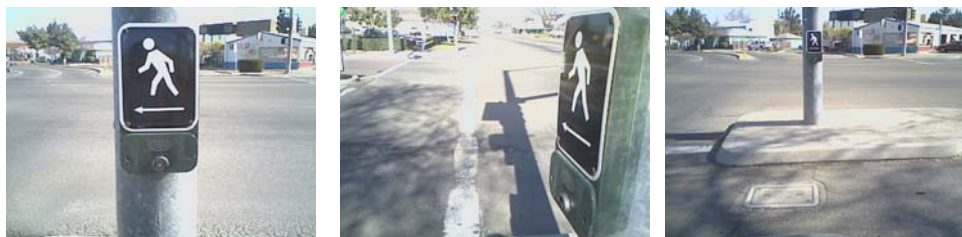
WNW Push Button Operation

Accessible Path	(y/n)	YES
Clear Floor Space	(y/n)	YES
Clear Floor Slope	(%)	3.1
Clear Floor X Slope	(%)	1.2
Button Ht.	(in)	45
Button Reach	(in)	38
Button Diameter	(in)	0.5
Button Pressure	(lbs)	8
Closed Fist Operation	(y/n)	NO
Visual Contrast	(y/n)	YES
Contrasting Color Bands	(y/n)	NO
Audible Walk Indicator	(y/n)	NO
Button Locator Tone	(y/n)	NO
Directional Info	(y/n)	YES

Modify or replace the operable part(s) to not require tight grasping, pinching, or twisting of the wrist with one hand.

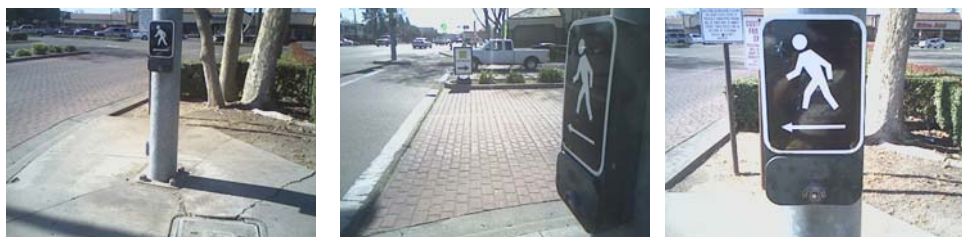
PCODE	PA39A
ADAPROW	R403.4
ADA-1991	4.27.4
ADA-2010	309.4
CSAS	1117B.6.4
Unit Cost	\$2150.00
Priority	4
Severity	4

Accessible Path	(y/n)	YES
Clear Floor Space	(y/n)	YES
Clear Floor Slope	(%)	0.4
Clear Floor X Slope	(%)	0.8
Button Ht.	(in)	44
Button Reach	(in)	0
Button Diameter	(in)	0.5
Button Pressure	(lbs)	10
Closed Fist Operation	(y/n)	NO
Visual Contrast	(y/n)	NO
Contrasting Color Bands	(y/n)	NO
Audible Walk Indicator	(y/n)	NO
Button Locator Tone	(y/n)	NO
Directional Info	(y/n)	YES

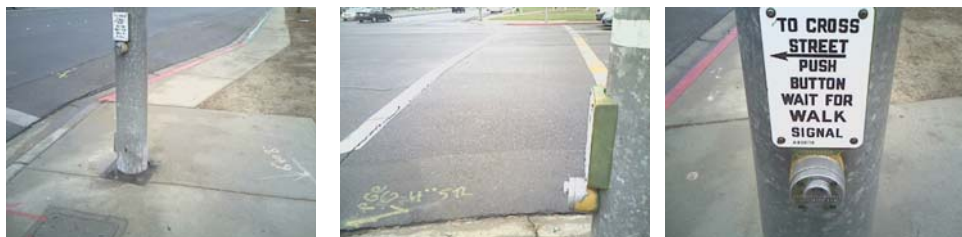
NNW Clear Floor Space

Accessible Path	(y/n)	YES
Clear Floor Space	(y/n)	YES
Clear Floor Slope	(%)	3.3
Clear Floor X Slope	(%)	1.6
Button Ht.	(in)	45
Button Reach	(in)	0
Button Diameter	(in)	2
Button Pressure	(lbs)	12
Closed Fist Operation	(y/n)	YES
Visual Contrast	(y/n)	NO
Contrasting Color Bands	(y/n)	NO
Audible Walk Indicator	(y/n)	NO
Button Locator Tone	(y/n)	NO
Directional Info	(y/n)	YES

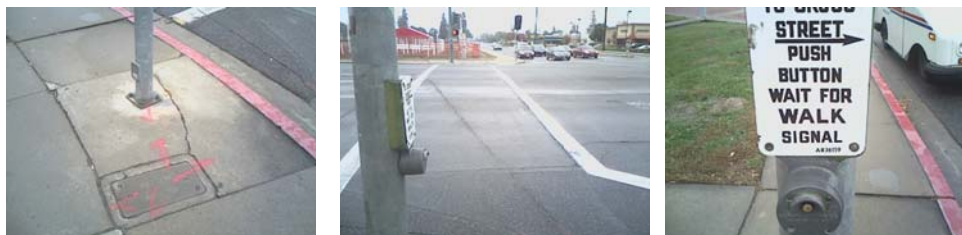
PCODE	PA19B
ADAPROW	R404.2
ADA-1991	4.3.7
CSAS	1118B.4.1
Unit Cost	\$2650.00
Priority	3
Severity	3

Accessible Path	(y/n)	YES
Clear Floor Space	(y/n)	YES
Clear Floor Slope	(%)	2.4
Clear Floor X Slope	(%)	3.0
Button Ht.	(in)	50
Button Reach	(in)	0
Button Diameter	(in)	0.5
Button Pressure	(lbs)	13
Closed Fist Operation	(y/n)	NO
Visual Contrast	(y/n)	YES
Contrasting Color Bands	(y/n)	NO
Audible Walk Indicator	(y/n)	NO
Button Locator Tone	(y/n)	NO
Directional Info	(y/n)	YES
