City of Turlock

PRoW - Pedestrian Signals

Access Compliance Survey Report

July 2014

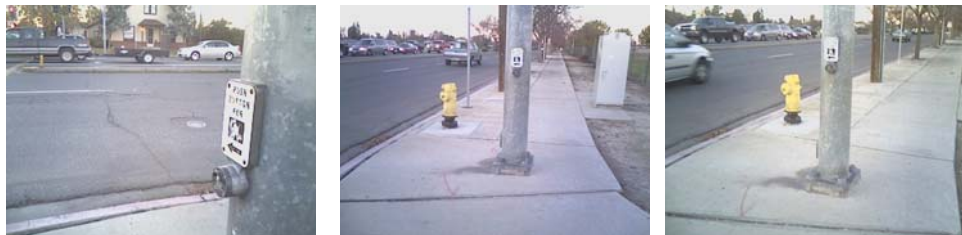
NNW Clear Floor Space

PCODE PA19B
 ADAPROW **R404.2**
 ADA-1991 **4.3.7**
 CSAS **1118B.4.1**
 Unit Cost **\$2650.00**
 Priority **3** Severity **4**

Accessible Path	(y/n)	YES
Clear Floor Space	(y/n)	YES
Clear Floor Slope	(%)	0.5
Clear Floor X Slope	(%)	3.4
Button Ht.	(in)	46.5
Button Reach	(in)	0
Button Diameter	(in)	0.5
Button Pressure	(lbs)	2
Closed Fist Operation	(y/n)	NO
Visual Contrast	(y/n)	YES
Contrasting Color Bands	(y/n)	NO
Audible Walk Indicator	(y/n)	NO
Button Locator Tone	(y/n)	NO
Directional Info	(y/n)	YES

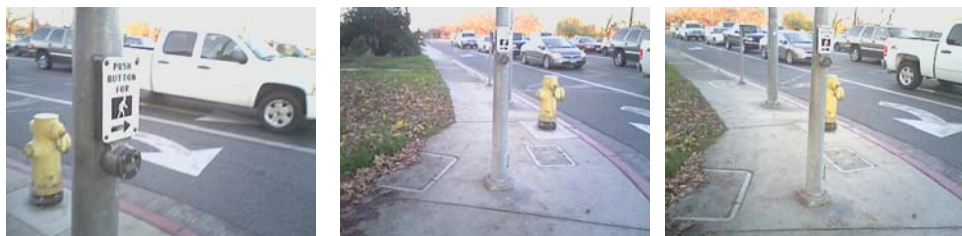
SSE Clear Floor Space

PCODE PA19A
 ADAPROW **R404.2**
 ADA-1991 **4.3.7**
 CSAS **1118B.4.1**
 Unit Cost **\$2650.00**
 Priority **3** Severity **4**

Accessible Path	(y/n)	YES
Clear Floor Space	(y/n)	YES
Clear Floor Slope	(%)	4.2
Clear Floor X Slope	(%)	1.2
Button Ht.	(in)	47
Button Reach	(in)	0
Button Diameter	(in)	0.5
Button Pressure	(lbs)	2
Closed Fist Operation	(y/n)	NO
Visual Contrast	(y/n)	YES
Contrasting Color Bands	(y/n)	NO
Audible Walk Indicator	(y/n)	NO
Button Locator Tone	(y/n)	NO
Directional Info	(y/n)	YES

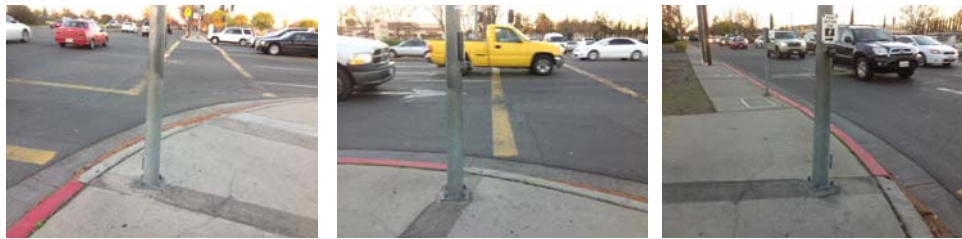
PCODE	PA19A
ADAPROW	R404.2
ADA-1991	4.3.7
CSAS	1118B.4.1
Unit Cost	\$2650.00
Priority	3
Severity	4

Provide 2" wide color coding with 1" wide dark borders located directly above control button. Provide push button which contrasts with surrounding housing. Provide voice or tone audible indication of the WALK interval at the pedestrian signal device. Provide a button locator tone.

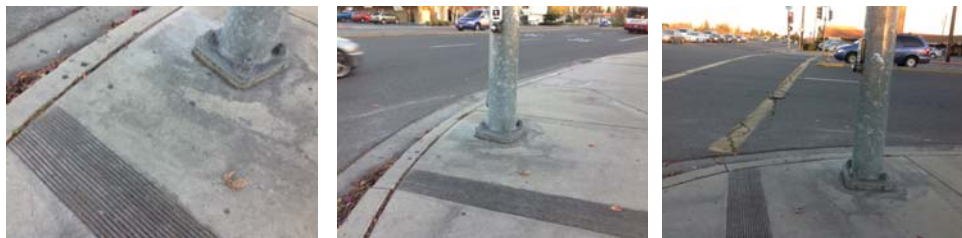
PCODE	PA19B
ADAPROW	R404.2
ADA-1991	4.3.7
CSAS	1118B.4.1
Unit Cost	\$2650.00
Priority	3
Severity	4

Accessible Path	(y/n)	YES
Clear Floor Space	(y/n)	NO
Clear Floor Slope	(%)	0.5
Clear Floor X Slope	(%)	2.2
Button Ht.	(in)	46
Button Reach	(in)	0
Button Diameter	(in)	2
Button Pressure	(lbs)	5
Closed Fist Operation	(y/n)	YES
Visual Contrast	(y/n)	YES
Contrasting Color Bands	(y/n)	NO
Audible Walk Indicator	(y/n)	NO
Button Locator Tone	(y/n)	NO
Directional Info	(y/n)	YES

Provide 2" wide color coding with 1" wide dark borders located directly above control button. Provide voice or tone audible indication of the WALK interval at the pedestrian signal device. Provide a button locator tone.

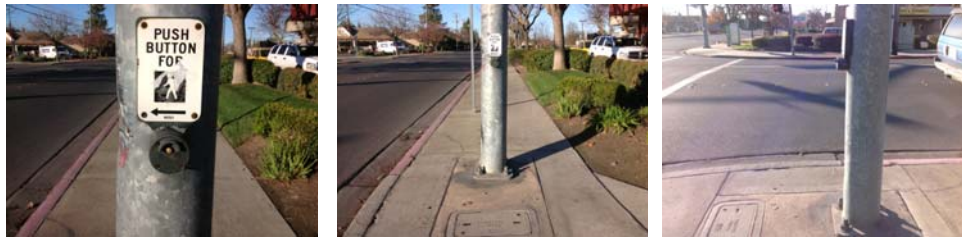
WSW Clear Floor Space

PCODE PA39A
 ADAPROW **R403.4**
 ADA-1991 **4.27.4**
 ADA-2010 **309.4**
 CSAS **1117B.6.4**
 Unit Cost **\$2150.00**
 Priority **3** Severity **4**

Accessible Path	(y/n)	YES
Clear Floor Space	(y/n)	YES
Clear Floor Slope	(%)	0.3
Clear Floor X Slope	(%)	2.0
Button Ht.	(in)	46.5
Button Reach	(in)	0
Button Diameter	(in)	0.5
Button Pressure	(lbs)	6
Closed Fist Operation	(y/n)	NO
Visual Contrast	(y/n)	NO
Contrasting Color Bands	(y/n)	NO
Audible Walk Indicator	(y/n)	NO
Button Locator Tone	(y/n)	NO
Directional Info	(y/n)	YES

Modify or replace the operable part(s) to not require tight grasping, pinching, or twisting of the wrist with one hand.

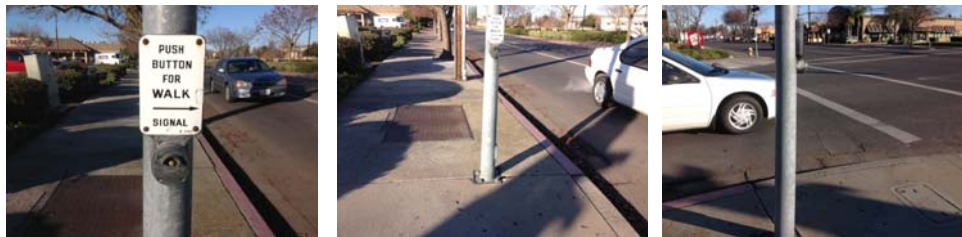
PCODE PA19B
 ADAPROW **R404.2**
 ADA-1991 **4.3.7**
 CSAS **1118B.4.1**
 Unit Cost **\$2650.00**
 Priority **3** Severity **4**

Accessible Path	(y/n)	YES
Clear Floor Space	(y/n)	YES
Clear Floor Slope	(%)	1.7
Clear Floor X Slope	(%)	2.5
Button Ht.	(in)	46
Button Reach	(in)	0
Button Diameter	(in)	0.5
Button Pressure	(lbs)	7
Closed Fist Operation	(y/n)	NO
Visual Contrast	(y/n)	NO
Contrasting Color Bands	(y/n)	NO
Audible Walk Indicator	(y/n)	NO
Button Locator Tone	(y/n)	NO
Directional Info	(y/n)	YES

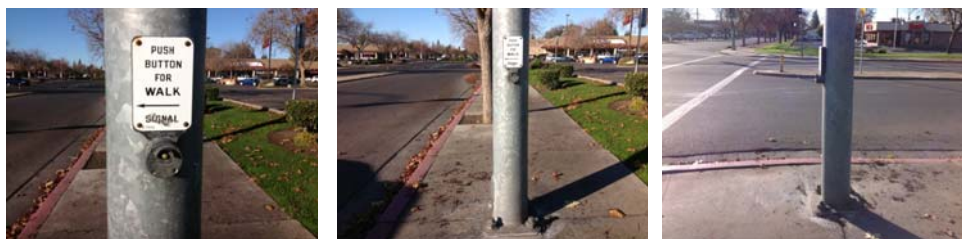
WSW Push Button Operation

PCODE PA19B
 ADAPROW **R404.2**
 ADA-1991 **4.3.7**
 CSAS **1118B.4.1**
 Unit Cost **\$2650.00**
 Priority **3** Severity **4**

Accessible Path	(y/n)	YES
Clear Floor Space	(y/n)	YES
Clear Floor Slope	(%)	0.5
Clear Floor X Slope	(%)	2.9
Button Ht.	(in)	45.5
Button Reach	(in)	0
Button Diameter	(in)	0.5
Button Pressure	(lbs)	10
Closed Fist Operation	(y/n)	NO
Visual Contrast	(y/n)	NO
Contrasting Color Bands	(y/n)	NO
Audible Walk Indicator	(y/n)	NO
Button Locator Tone	(y/n)	NO
Directional Info	(y/n)	YES

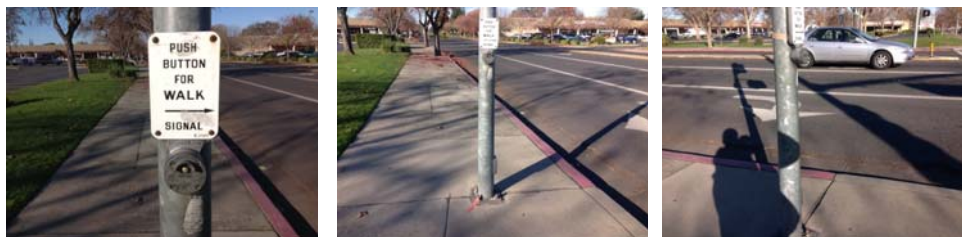
PCODE PA39A
 ADAPROW **R403.4**
 ADA-1991 **4.27.4**
 ADA-2010 **309.4**
 CSAS **1117B.6.4**
 Unit Cost **\$2150.00**
 Priority **3** Severity **4**

Accessible Path	(y/n)	YES
Clear Floor Space	(y/n)	YES
Clear Floor Slope	(%)	2.0
Clear Floor X Slope	(%)	0.1
Button Ht.	(in)	46
Button Reach	(in)	0
Button Diameter	(in)	0.5
Button Pressure	(lbs)	10
Closed Fist Operation	(y/n)	NO
Visual Contrast	(y/n)	NO
Contrasting Color Bands	(y/n)	NO
Audible Walk Indicator	(y/n)	NO
Button Locator Tone	(y/n)	NO
Directional Info	(y/n)	YES

Modify or replace the operable part(s) to not require tight grasping, pinching, or twisting of the wrist with one hand.

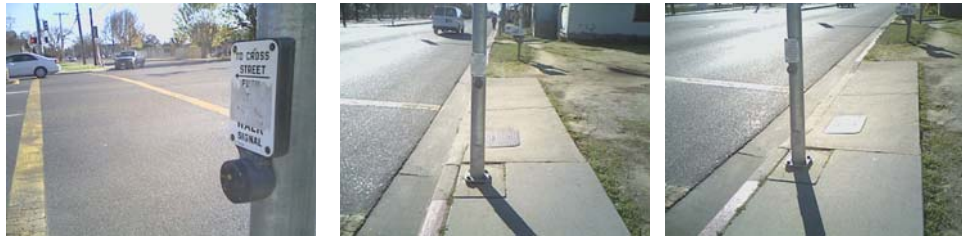
PCODE PA19B
 ADAPROW **R404.2**
 ADA-1991 **4.3.7**
 CSAS **1118B.4.1**
 Unit Cost **\$2650.00**
 Priority **3** Severity **4**

Accessible Path	(y/n)	YES
Clear Floor Space	(y/n)	YES
Clear Floor Slope	(%)	0.1
Clear Floor X Slope	(%)	2.5
Button Ht.	(in)	37.25
Button Reach	(in)	0
Button Diameter	(in)	0.5
Button Pressure	(lbs)	2
Closed Fist Operation	(y/n)	NO
Visual Contrast	(y/n)	YES
Contrasting Color Bands	(y/n)	NO
Audible Walk Indicator	(y/n)	NO
Button Locator Tone	(y/n)	NO
Directional Info	(y/n)	YES

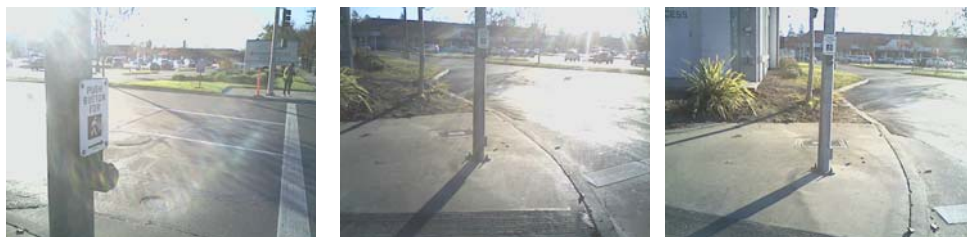
ESE Pedestrian Signal

PCODE	PA19A
ADAPROW	R404.2
ADA-1991	4.3.7
CSAS	1118B.4.1
Unit Cost	\$2650.00
Priority	4
Severity	4

Accessible Path	(y/n)	YES
Clear Floor Space	(y/n)	YES
Clear Floor Slope	(%)	6.5
Clear Floor X Slope	(%)	0.2
Button Ht.	(in)	46.5
Button Reach	(in)	0
Button Diameter	(in)	2
Button Pressure	(lbs)	2
Closed Fist Operation	(y/n)	YES
Visual Contrast	(y/n)	NO
Contrasting Color Bands	(y/n)	NO
Audible Walk Indicator	(y/n)	NO
Button Locator Tone	(y/n)	NO
Directional Info	(y/n)	YES

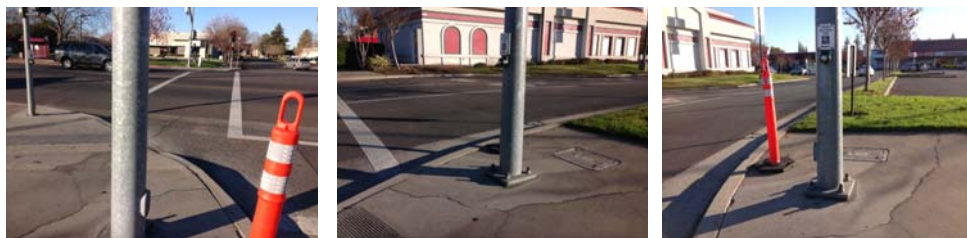
NNE Clear Floor Space

PCODE	PA43
ADAPROW	R209.1
Unit Cost	\$2050.00
Priority	4
Severity	4

Accessible Path	(y/n)	YES
Clear Floor Space	(y/n)	YES
Clear Floor Slope	(%)	2.0
Clear Floor X Slope	(%)	1.1
Button Ht.	(in)	47
Button Reach	(in)	0
Button Diameter	(in)	2
Button Pressure	(lbs)	5
Closed Fist Operation	(y/n)	YES
Visual Contrast	(y/n)	YES
Contrasting Color Bands	(y/n)	NO
Audible Walk Indicator	(y/n)	NO
Button Locator Tone	(y/n)	NO
Directional Info	(y/n)	YES

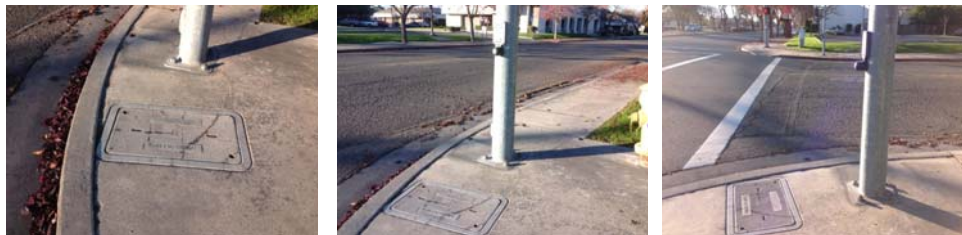
WSW Clear Floor Space

PCODE	PA19B
ADAPROW	R404.2
ADA-1991	4.3.7
CSAS	1118B.4.1
Unit Cost	\$2650.00
Priority	4
Severity	4

Accessible Path	(y/n)	YES
Clear Floor Space	(y/n)	YES
Clear Floor Slope	(%)	0.2
Clear Floor X Slope	(%)	3.4
Button Ht.	(in)	45
Button Reach	(in)	0
Button Diameter	(in)	2
Button Pressure	(lbs)	1
Closed Fist Operation	(y/n)	YES
Visual Contrast	(y/n)	NO
Contrasting Color Bands	(y/n)	NO
Audible Walk Indicator	(y/n)	NO
Button Locator Tone	(y/n)	NO
Directional Info	(y/n)	YES

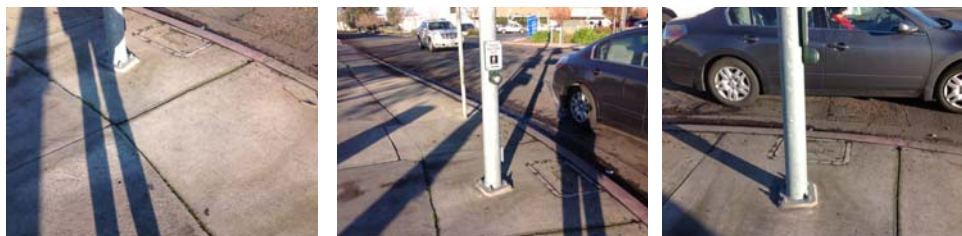
PCODE	PA19B
ADAPROW	R404.2
ADA-1991	4.3.7
CSAS	1118B.4.1
Unit Cost	\$2650.00
Priority	4
Severity	4

Accessible Path	(y/n)	YES
Clear Floor Space	(y/n)	YES
Clear Floor Slope	(%)	0.8
Clear Floor X Slope	(%)	2.5
Button Ht.	(in)	37
Button Reach	(in)	0
Button Diameter	(in)	2
Button Pressure	(lbs)	7
Closed Fist Operation	(y/n)	YES
Visual Contrast	(y/n)	YES
Contrasting Color Bands	(y/n)	NO
Audible Walk Indicator	(y/n)	NO
Button Locator Tone	(y/n)	NO
Directional Info	(y/n)	YES

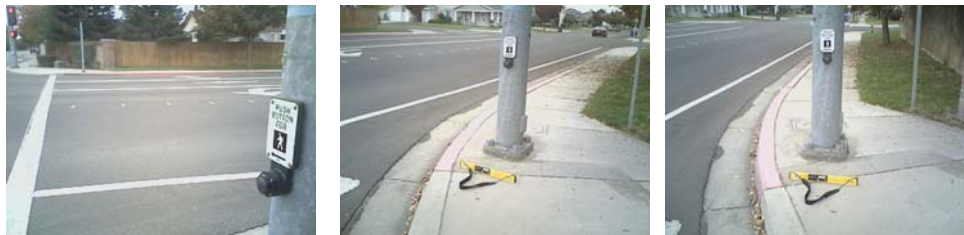
WSW Pedestrian Signal

PCODE	PA19A
ADAPROW	R404.2
ADA-1991	4.3.7
CSAS	1118B.4.1
Unit Cost	\$2650.00
Priority	5
Severity	4

Accessible Path	(y/n)	YES
Clear Floor Space	(y/n)	YES
Clear Floor Slope	(%)	3.5
Clear Floor X Slope	(%)	1.3
Button Ht.	(in)	38.5
Button Reach	(in)	0
Button Diameter	(in)	2
Button Pressure	(lbs)	2
Closed Fist Operation	(y/n)	YES
Visual Contrast	(y/n)	NO
Contrasting Color Bands	(y/n)	NO
Audible Walk Indicator	(y/n)	NO
Button Locator Tone	(y/n)	NO
Directional Info	(y/n)	YES

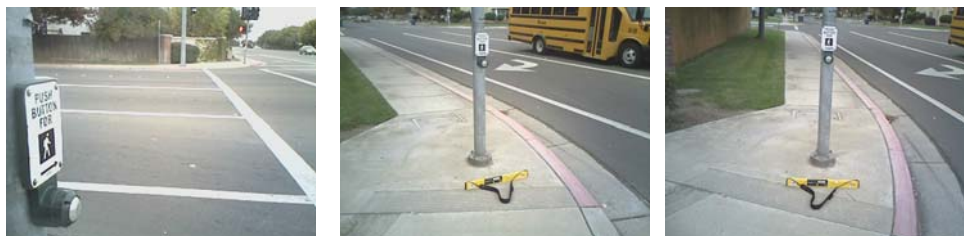
PCODE	PA43
ADAPROW	R209.1
Unit Cost	\$2050.00
Priority	5
Severity	4

Accessible Path	(y/n)	YES
Clear Floor Space	(y/n)	YES
Clear Floor Slope	(%)	1.5
Clear Floor X Slope	(%)	1.5
Button Ht.	(in)	39
Button Reach	(in)	0
Button Diameter	(in)	2
Button Pressure	(lbs)	2
Closed Fist Operation	(y/n)	YES
Visual Contrast	(y/n)	YES
Contrasting Color Bands	(y/n)	NO
Audible Walk Indicator	(y/n)	NO
Button Locator Tone	(y/n)	NO
Directional Info	(y/n)	YES

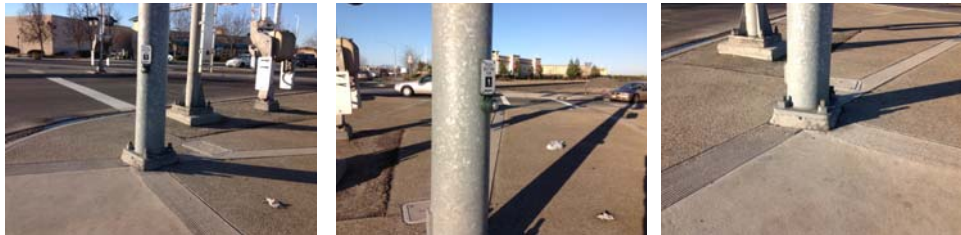
WSW Clear Floor Space

PCODE	PA19A
ADAPROW	R404.2
ADA-1991	4.3.7
CSAS	1118B.4.1
Unit Cost	\$2650.00
Priority	4
Severity	4

Accessible Path	(y/n)	YES
Clear Floor Space	(y/n)	YES
Clear Floor Slope	(%)	5.1
Clear Floor X Slope	(%)	2.4
Button Ht.	(in)	45.5
Button Reach	(in)	0
Button Diameter	(in)	2
Button Pressure	(lbs)	2
Closed Fist Operation	(y/n)	YES
Visual Contrast	(y/n)	YES
Contrasting Color Bands	(y/n)	NO
Audible Walk Indicator	(y/n)	NO
Button Locator Tone	(y/n)	NO
Directional Info	(y/n)	YES

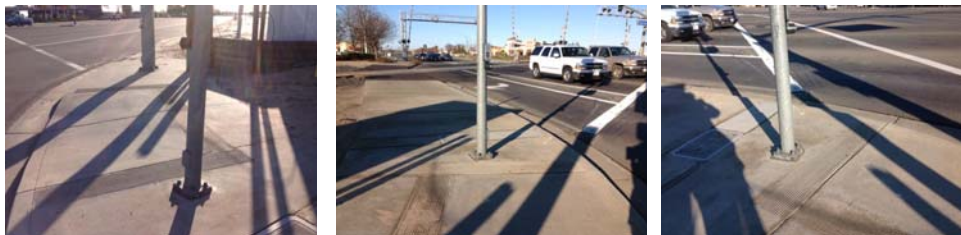
PCODE	PA19A
ADAPROW	R404.2
ADA-1991	4.3.7
CSAS	1118B.4.1
Unit Cost	\$2650.00
Priority	4
Severity	4

Accessible Path	(y/n)	YES
Clear Floor Space	(y/n)	YES
Clear Floor Slope	(%)	4.4
Clear Floor X Slope	(%)	1.7
Button Ht.	(in)	46
Button Reach	(in)	0
Button Diameter	(in)	2
Button Pressure	(lbs)	5
Closed Fist Operation	(y/n)	YES
Visual Contrast	(y/n)	YES
Contrasting Color Bands	(y/n)	NO
Audible Walk Indicator	(y/n)	NO
Button Locator Tone	(y/n)	NO
Directional Info	(y/n)	YES

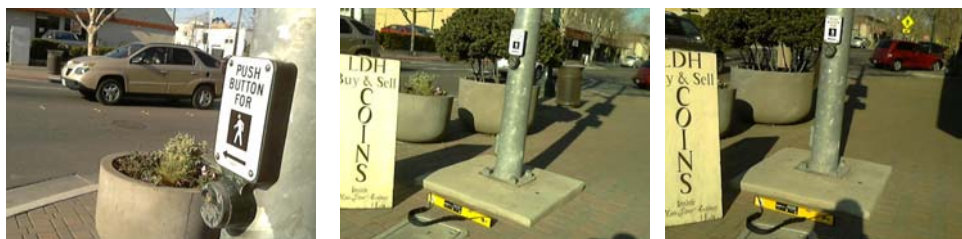
E - S Clear Floor Space

PCODE	PA19A
ADAPROW	R404.2
ADA-1991	4.3.7
CSAS	1118B.4.1
Unit Cost	\$2650.00
Priority	3
Severity	4

Accessible Path	(y/n)	YES
Clear Floor Space	(y/n)	YES
Clear Floor Slope	(%)	3.4
Clear Floor X Slope	(%)	0.3
Button Ht.	(in)	43.25
Button Reach	(in)	18
Button Diameter	(in)	0.5
Button Pressure	(lbs)	2
Closed Fist Operation	(y/n)	NO
Visual Contrast	(y/n)	NO
Contrasting Color Bands	(y/n)	NO
Audible Walk Indicator	(y/n)	NO
Button Locator Tone	(y/n)	NO
Directional Info	(y/n)	YES

365 • *As-Built Description:*

The cross slope of the floor or ground surface at the pedestrian signal device exceed 1:48 (2%).

• *As-is Measurement:* 2.4%

• *Proposed Solution:*

Modify or repave the ground surface as necessary to provide slope(s) not exceeding the required 1:48 (2%) maximum in any direction.

• *Additional Items:*

Provide 2" wide color coding with 1" wide dark borders located directly above control button. Provide voice or tone audible indication of the WALK interval at the pedestrian signal device. Provide a button locator tone.

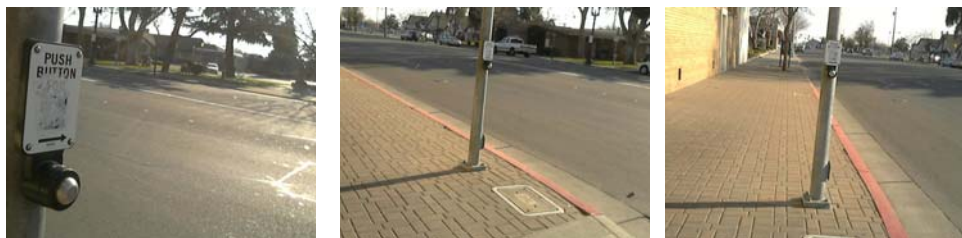
N - E Clear Floor Space

PCODE	PA19B
ADAPROW	R404.2
ADA-1991	4.3.7
CSAS	1118B.4.1
Unit Cost	\$2650.00
Priority	4
Severity	4

Accessible Path	(y/n)	YES
Clear Floor Space	(y/n)	YES
Clear Floor Slope	(%)	1.9
Clear Floor X Slope	(%)	2.4
Button Ht.	(in)	46
Button Reach	(in)	0
Button Diameter	(in)	2
Button Pressure	(lbs)	5
Closed Fist Operation	(y/n)	YES
Visual Contrast	(y/n)	YES
Contrasting Color Bands	(y/n)	NO
Audible Walk Indicator	(y/n)	NO
Button Locator Tone	(y/n)	NO
Directional Info	(y/n)	YES

366 • *As-Built Description:*

The running slope of the floor or ground surface at the pedestrian signal device exceed 1:50 (2%) or is not consistent with the grade of the adjacent pedestrian access route.

• *As-is Measurement:* 10.6%

• *Proposed Solution:*

Modify or repave the ground surface as necessary to provide slope(s) not exceeding 1:50 (2%) maximum in any direction.

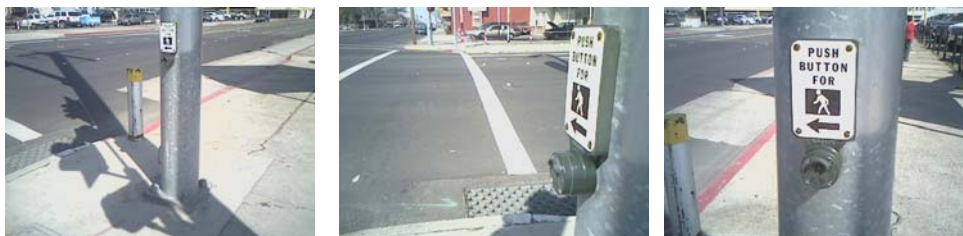
N Clear Floor Space

PCODE PA39A
 ADAPROW **R403.4**
 ADA-1991 **4.27.4**
 ADA-2010 **309.4**
 CSAS **1117B.6.4**
 Unit Cost **\$2150.00**
 Priority **3** Severity **4**

Accessible Path	(y/n)	YES
Clear Floor Space	(y/n)	YES
Clear Floor Slope	(%)	0.7
Clear Floor X Slope	(%)	0.1
Button Ht.	(in)	46.5
Button Reach	(in)	0
Button Diameter	(in)	0.5
Button Pressure	(lbs)	8
Closed Fist Operation	(y/n)	NO
Visual Contrast	(y/n)	NO
Contrasting Color Bands	(y/n)	NO
Audible Walk Indicator	(y/n)	NO
Button Locator Tone	(y/n)	NO
Directional Info	(y/n)	YES

373 • *As-Built Description:*

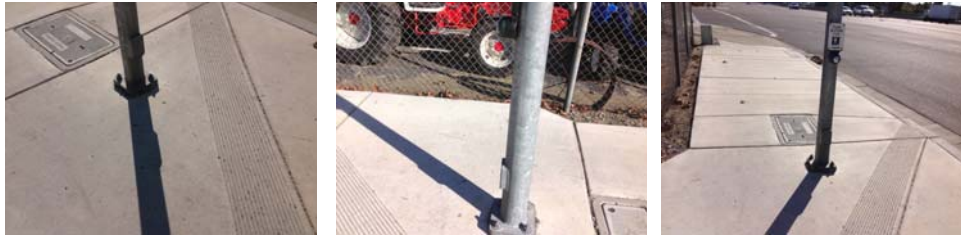
NW Clear Floor Space

PCODE PA19B
 ADAPROW **R404.2**
 ADA-1991 **4.3.7**
 CSAS **1118B.4.1**
 Unit Cost **\$1950.00**
 Priority **4** Severity **4**

Accessible Path	(y/n)	YES
Clear Floor Space	(y/n)	YES
Clear Floor Slope	(%)	0.1
Clear Floor X Slope	(%)	2.9
Button Ht.	(in)	39
Button Reach	(in)	0
Button Diameter	(in)	2
Button Pressure	(lbs)	5
Closed Fist Operation	(y/n)	YES
Visual Contrast	(y/n)	YES
Contrasting Color Bands	(y/n)	NO
Audible Walk Indicator	(y/n)	YES
Button Locator Tone	(y/n)	NO
Directional Info	(y/n)	YES

361 • *As-Built Description:*

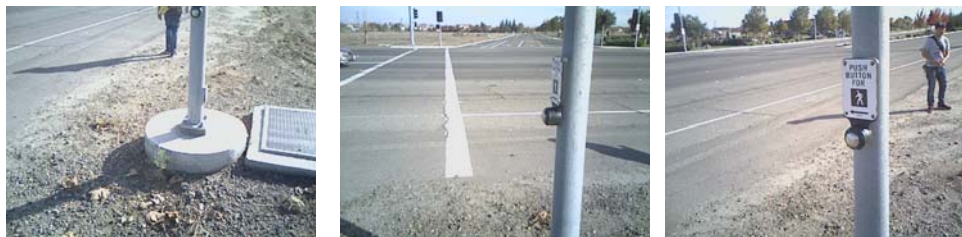
SE Pedestrian Signal

PCODE PR02A
 ADAPROW **R301.2**
 ADA-1991 **4.1.2 (1) & (2)**
 Unit Cost **\$1950.00**
 Priority **3** Severity **2**

Accessible Path	(y/n)	NO
Clear Floor Space	(y/n)	NO
Clear Floor Slope	(%)	N/A
Clear Floor X Slope	(%)	N/A
Button Ht.	(in)	47
Button Reach	(in)	12
Button Diameter	(in)	2
Button Pressure	(lbs)	9
Closed Fist Operation	(y/n)	YES
Visual Contrast	(y/n)	YES
Contrasting Color Bands	(y/n)	NO
Audible Walk Indicator	(y/n)	YES
Button Locator Tone	(y/n)	NO
Directional Info	(y/n)	YES

353 • *As-Built Description:*

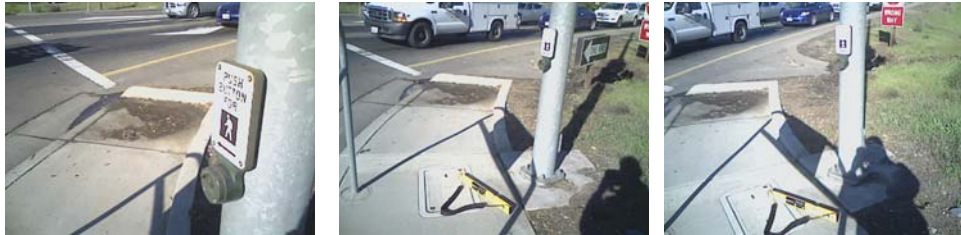
NNW Clear Floor Space

PCODE PA39A
 ADAPROW **R403.4**
 ADA-1991 **4.27.4**
 ADA-2010 **309.4**
 CSAS **1117B.6.4**
 Unit Cost **\$2350.00**
 Priority **4** Severity **4**

Accessible Path	(y/n)	YES
Clear Floor Space	(y/n)	YES
Clear Floor Slope	(%)	1.2
Clear Floor X Slope	(%)	1.8
Button Ht.	(in)	39
Button Reach	(in)	0
Button Diameter	(in)	0.5
Button Pressure	(lbs)	2
Closed Fist Operation	(y/n)	NO
Visual Contrast	(y/n)	NO
Contrasting Color Bands	(y/n)	NO
Audible Walk Indicator	(y/n)	NO
Button Locator Tone	(y/n)	NO
Directional Info	(y/n)	YES

386 • *As-Built Description:*

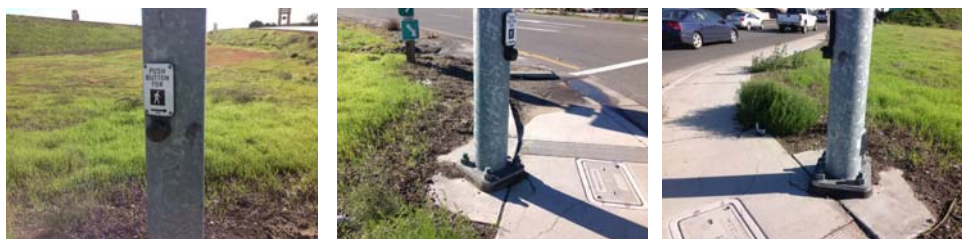
SSW Continuous Access Route

PCODE	PA19A
ADAPROW	R404.2
ADA-1991	4.3.7
CSAS	1118B.4.1
Unit Cost	\$2650.00
Priority	3
Severity	4

Accessible Path	(y/n)	YES
Clear Floor Space	(y/n)	YES
Clear Floor Slope	(%)	2.2
Clear Floor X Slope	(%)	2.1
Button Ht.	(in)	40
Button Reach	(in)	0
Button Diameter	(in)	0.5
Button Pressure	(lbs)	5
Closed Fist Operation	(y/n)	NO
Visual Contrast	(y/n)	NO
Contrasting Color Bands	(y/n)	NO
Audible Walk Indicator	(y/n)	NO
Button Locator Tone	(y/n)	NO
Directional Info	(y/n)	YES

388 • *As-Built Description:*

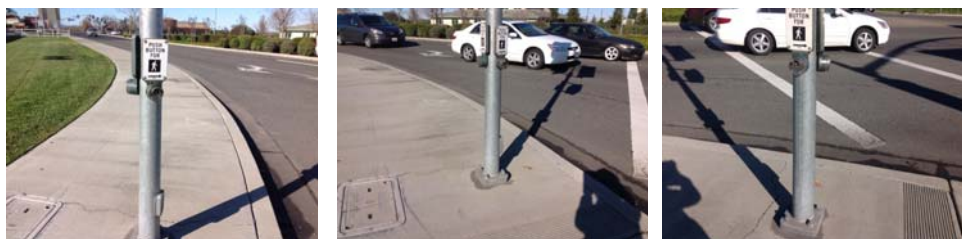
WNW - N Push Button Operation

PCODE	PA19A
ADAPROW	R404.2
ADA-1991	4.3.7
CSAS	1118B.4.1
Unit Cost	\$2650.00
Priority	3
Severity	4

Accessible Path	(y/n)	YES
Clear Floor Space	(y/n)	YES
Clear Floor Slope	(%)	2.8
Clear Floor X Slope	(%)	2.3
Button Ht.	(in)	40
Button Reach	(in)	0
Button Diameter	(in)	0.5
Button Pressure	(lbs)	7
Closed Fist Operation	(y/n)	NO
Visual Contrast	(y/n)	NO
Contrasting Color Bands	(y/n)	NO
Audible Walk Indicator	(y/n)	NO
Button Locator Tone	(y/n)	NO
Directional Info	(y/n)	YES

390 • *As-Built Description:*

Modify or replace the operable part(s) to not require tight grasping, pinching, or twisting of the wrist with one hand.

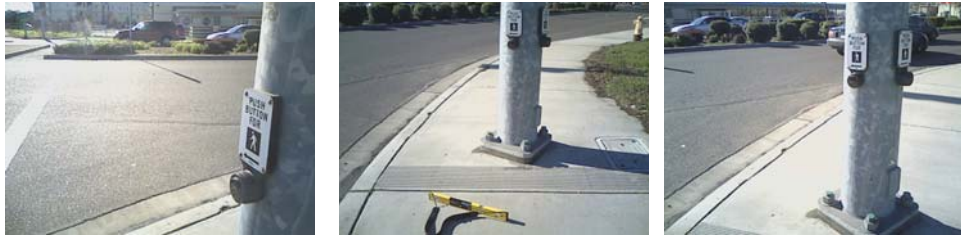
WSW Push Button Operation

PCODE	PA19A
ADAPROW	R404.2
ADA-1991	4.3.7
CSAS	1118B.4.1
Unit Cost	\$2650.00
Priority	3
Severity	3

Accessible Path	(y/n)	YES
Clear Floor Space	(y/n)	NO
Clear Floor Slope	(%)	7.6
Clear Floor X Slope	(%)	1.3
Button Ht.	(in)	39.5
Button Reach	(in)	0
Button Diameter	(in)	0.5
Button Pressure	(lbs)	2
Closed Fist Operation	(y/n)	NO
Visual Contrast	(y/n)	NO
Contrasting Color Bands	(y/n)	NO
Audible Walk Indicator	(y/n)	NO
Button Locator Tone	(y/n)	NO
Directional Info	(y/n)	YES

392 • *As-Built Description:*

Modify or replace the operable part(s) to not require tight grasping, pinching, or twisting of the wrist with one hand.

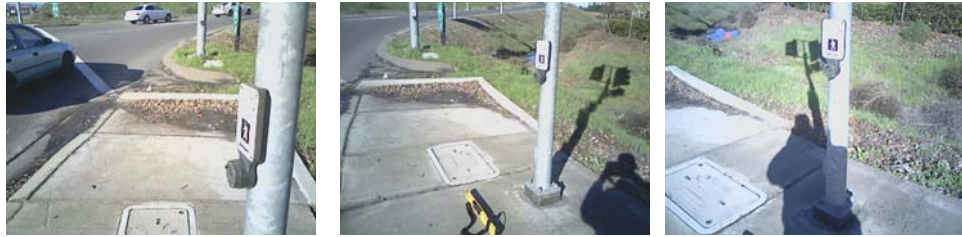
ESE Clear Floor Space

PCODE PA19B
 ADAPROW **R404.2**
 ADA-1991 **4.3.7**
 CSAS **1118B.4.1**
 Unit Cost **\$2650.00**
 Priority **3** Severity **4**

Accessible Path	(y/n)	YES
Clear Floor Space	(y/n)	YES
Clear Floor Slope	(%)	3.2
Clear Floor X Slope	(%)	5.3
Button Ht.	(in)	39.75
Button Reach	(in)	0
Button Diameter	(in)	0.5
Button Pressure	(lbs)	2
Closed Fist Operation	(y/n)	NO
Visual Contrast	(y/n)	NO
Contrasting Color Bands	(y/n)	NO
Audible Walk Indicator	(y/n)	NO
Button Locator Tone	(y/n)	NO
Directional Info	(y/n)	YES

400 • *As-Built Description:*

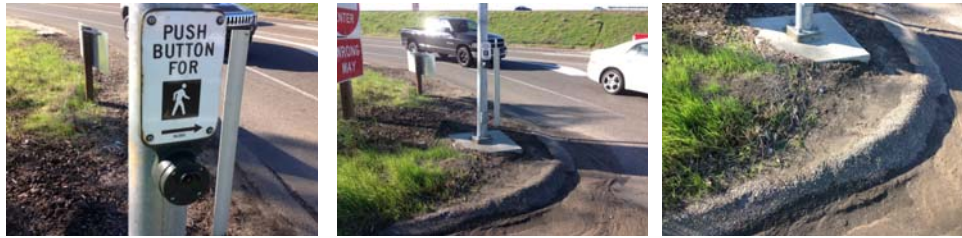
SSE Clear Floor Space

PCODE PR02A
 ADAPROW **R301.2**
 ADA-1991 **4.1.2 (1) & (2)**
 Unit Cost **\$2650.00**
 Priority **2** Severity **2**

Accessible Path	(y/n)	NO
Clear Floor Space	(y/n)	NO
Clear Floor Slope	(%)	N/A
Clear Floor X Slope	(%)	N/A
Button Ht.	(in)	39
Button Reach	(in)	99
Button Diameter	(in)	0.5
Button Pressure	(lbs)	7
Closed Fist Operation	(y/n)	NO
Visual Contrast	(y/n)	NO
Contrasting Color Bands	(y/n)	NO
Audible Walk Indicator	(y/n)	NO
Button Locator Tone	(y/n)	NO
Directional Info	(y/n)	YES

404 • *As-Built Description:*

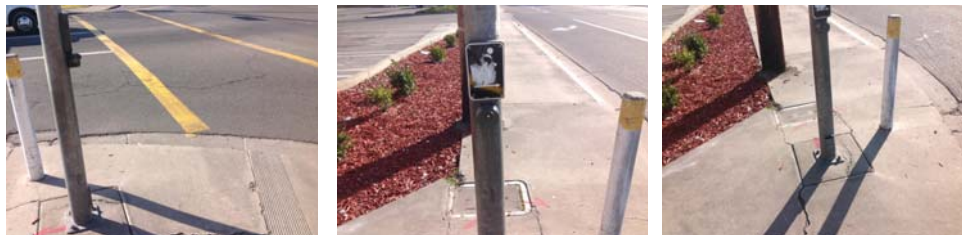
PCODE PA19A
 ADAPROW **R404.2**
 ADA-1991 **4.3.7**
 CSAS **1118B.4.1**
 Unit Cost **\$2650.00**
 Priority **3** Severity **4**

Accessible Path	(y/n)	YES
Clear Floor Space	(y/n)	YES
Clear Floor Slope	(%)	9.6
Clear Floor X Slope	(%)	1.2
Button Ht.	(in)	46.5
Button Reach	(in)	0
Button Diameter	(in)	0.5
Button Pressure	(lbs)	4
Closed Fist Operation	(y/n)	NO
Visual Contrast	(y/n)	YES
Contrasting Color Bands	(y/n)	NO
Audible Walk Indicator	(y/n)	NO
Button Locator Tone	(y/n)	NO
Directional Info	(y/n)	YES

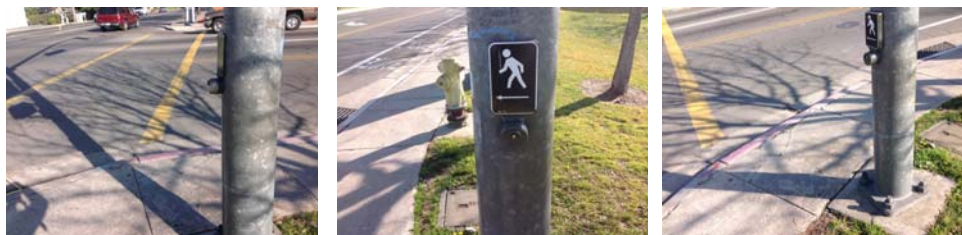
ESE Clear Floor Space

The running slope of the floor or ground surface at the pedestrian signal device exceed 1:50 (2%) or is not consistent with the grade of the adjacent pedestrian access route.

• *As-is Measurement:* 4.0%

PCODE PA19A
 ADAPROW **R404.2**
 ADA-1991 **4.3.7**
 CSAS **1118B.4.1**
 Unit Cost **\$2650.00**
 Priority **3** Severity **3**

Accessible Path	(y/n)	YES
Clear Floor Space	(y/n)	YES
Clear Floor Slope	(%)	4.0
Clear Floor X Slope	(%)	0.2
Button Ht.	(in)	47
Button Reach	(in)	13
Button Diameter	(in)	0.5
Button Pressure	(lbs)	8
Closed Fist Operation	(y/n)	NO
Visual Contrast	(y/n)	YES
Contrasting Color Bands	(y/n)	NO
Audible Walk Indicator	(y/n)	NO
Button Locator Tone	(y/n)	NO
Directional Info	(y/n)	YES

Modify or repave the ground surface as necessary to provide slope(s) not exceeding 1:50 (2%) maximum in any direction.

Adjust button pressure to be less than 5lbs. Provide 2" wide color coding with 1" wide dark borders located directly above control button. Provide voice or tone audible indication of the WALK interval at the pedestrian signal device. Provide 2" diameter push button. Provide a button locator tone. Provide new push button and housing to allow for closed fist operation.

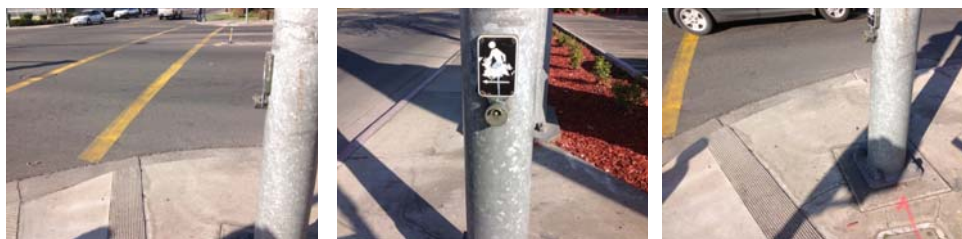
NNE Clear Floor Space

The running slope of the floor or ground surface at the pedestrian signal device exceed 1:50 (2%) or is not consistent with the grade of the adjacent pedestrian access route.

• *As-is Measurement:* 4.3%

PCODE	PA19A
ADAPROW	R404.2
ADA-1991	4.3.7
CSAS	1118B.4.1
Unit Cost	\$2650.00
Priority	3
Severity	4

Accessible Path	(y/n)	YES
Clear Floor Space	(y/n)	YES
Clear Floor Slope	(%)	4.3
Clear Floor X Slope	(%)	0.9
Button Ht.	(in)	46
Button Reach	(in)	0
Button Diameter	(in)	0.5
Button Pressure	(lbs)	8
Closed Fist Operation	(y/n)	NO
Visual Contrast	(y/n)	YES
Contrasting Color Bands	(y/n)	NO
Audible Walk Indicator	(y/n)	NO
Button Locator Tone	(y/n)	NO
Directional Info	(y/n)	YES

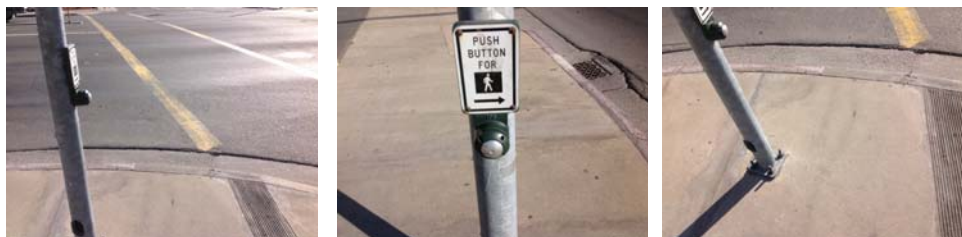
PCODE	PA19B
ADAPROW	R404.2
ADA-1991	4.3.7
CSAS	1118B.4.1
Unit Cost	\$2650.00
Priority	4
Severity	4

Accessible Path	(y/n)	YES
Clear Floor Space	(y/n)	YES
Clear Floor Slope	(%)	0.1
Clear Floor X Slope	(%)	3.6
Button Ht.	(in)	43.5
Button Reach	(in)	0
Button Diameter	(in)	2
Button Pressure	(lbs)	7
Closed Fist Operation	(y/n)	YES
Visual Contrast	(y/n)	YES
Contrasting Color Bands	(y/n)	NO
Audible Walk Indicator	(y/n)	NO
Button Locator Tone	(y/n)	NO
Directional Info	(y/n)	YES

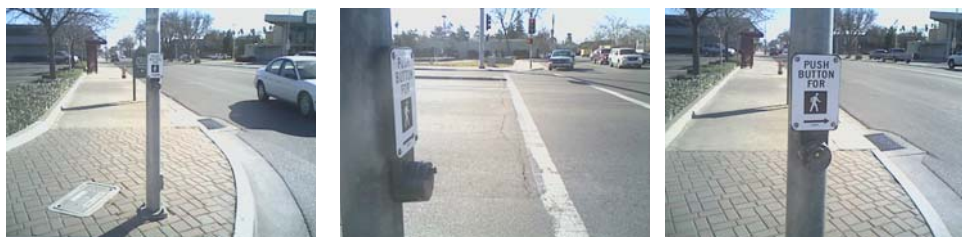
PCODE	PA19A
ADAPROW	R404.2
ADA-1991	4.3.7
CSAS	1118B.4.1
Unit Cost	\$2650.00
Priority	3
Severity	3

Accessible Path	(y/n)	YES
Clear Floor Space	(y/n)	NO
Clear Floor Slope	(%)	5.3
Clear Floor X Slope	(%)	1.2
Button Ht.	(in)	45.5
Button Reach	(in)	0
Button Diameter	(in)	0.5
Button Pressure	(lbs)	8
Closed Fist Operation	(y/n)	NO
Visual Contrast	(y/n)	NO
Contrasting Color Bands	(y/n)	NO
Audible Walk Indicator	(y/n)	NO
Button Locator Tone	(y/n)	NO
Directional Info	(y/n)	YES

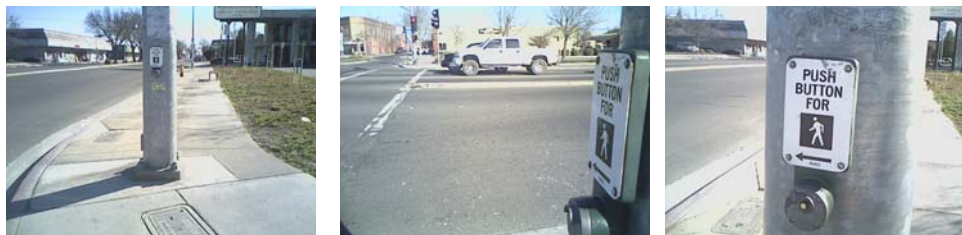
PCODE	PA19B
ADAPROW	R404.2
ADA-1991	4.3.7
CSAS	1118B.4.1
Unit Cost	\$2650.00
Priority	3
Severity	4

Accessible Path	(y/n)	YES
Clear Floor Space	(y/n)	YES
Clear Floor Slope	(%)	3.4
Clear Floor X Slope	(%)	3.6
Button Ht.	(in)	45.5
Button Reach	(in)	0
Button Diameter	(in)	0.5
Button Pressure	(lbs)	8
Closed Fist Operation	(y/n)	NO
Visual Contrast	(y/n)	NO
Contrasting Color Bands	(y/n)	NO
Audible Walk Indicator	(y/n)	NO
Button Locator Tone	(y/n)	NO
Directional Info	(y/n)	YES

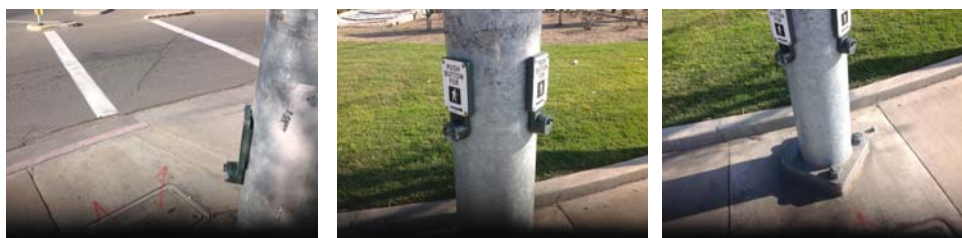
PCODE PA39A
 ADAPROW **R403.4**
 ADA-1991 **4.27.4**
 ADA-2010 **309.4**
 CSAS **1117B.6.4**
 Unit Cost **\$2150.00**
 Priority **4** Severity **4**

Accessible Path	(y/n)	YES
Clear Floor Space	(y/n)	YES
Clear Floor Slope	(%)	1.4
Clear Floor X Slope	(%)	1.3
Button Ht.	(in)	40
Button Reach	(in)	0
Button Diameter	(in)	0.5
Button Pressure	(lbs)	7
Closed Fist Operation	(y/n)	NO
Visual Contrast	(y/n)	NO
Contrasting Color Bands	(y/n)	NO
Audible Walk Indicator	(y/n)	NO
Button Locator Tone	(y/n)	NO
Directional Info	(y/n)	YES

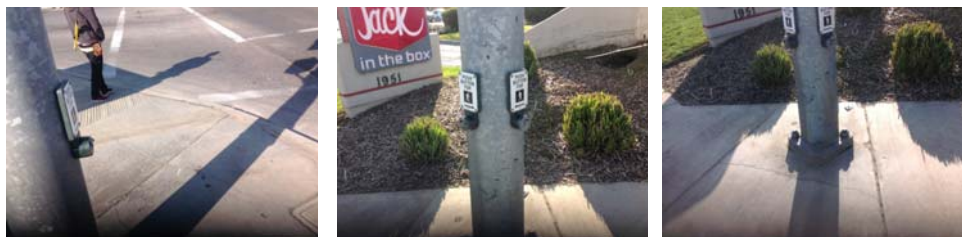
PCODE PA19A
 ADAPROW **R404.2**
 ADA-1991 **4.3.7**
 CSAS **1118B.4.1**
 Unit Cost **\$2650.00**
 Priority **4** Severity **4**

Accessible Path	(y/n)	YES
Clear Floor Space	(y/n)	YES
Clear Floor Slope	(%)	3.7
Clear Floor X Slope	(%)	2.2
Button Ht.	(in)	40
Button Reach	(in)	0
Button Diameter	(in)	0.5
Button Pressure	(lbs)	6
Closed Fist Operation	(y/n)	NO
Visual Contrast	(y/n)	NO
Contrasting Color Bands	(y/n)	NO
Audible Walk Indicator	(y/n)	NO
Button Locator Tone	(y/n)	NO
Directional Info	(y/n)	YES

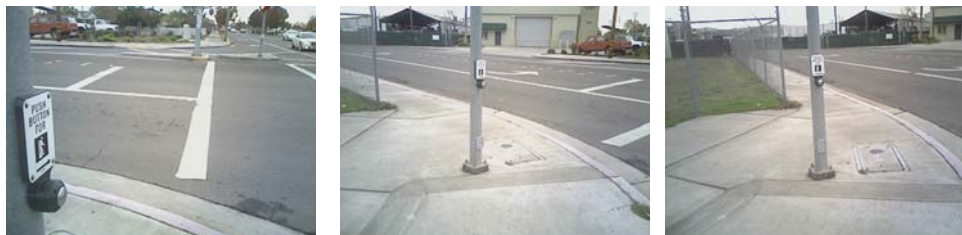
PCODE	PA19A
ADAPROW	R404.2
ADA-1991	4.3.7
CSAS	1118B.4.1
Unit Cost	\$1950.00
Priority	4
Severity	4

Accessible Path	(y/n)	YES
Clear Floor Space	(y/n)	NO
Clear Floor Slope	(%)	5.9
Clear Floor X Slope	(%)	1.1
Button Ht.	(in)	38.75
Button Reach	(in)	0
Button Diameter	(in)	2
Button Pressure	(lbs)	2
Closed Fist Operation	(y/n)	YES
Visual Contrast	(y/n)	YES
Contrasting Color Bands	(y/n)	NO
Audible Walk Indicator	(y/n)	YES
Button Locator Tone	(y/n)	NO
Directional Info	(y/n)	YES

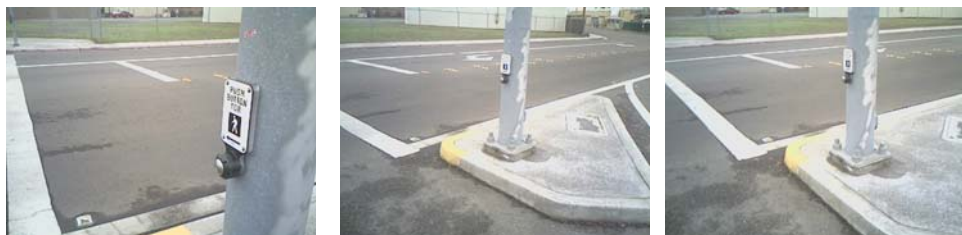
PCODE	PA19B
ADAPROW	R404.2
ADA-1991	4.3.7
CSAS	1118B.4.1
Unit Cost	\$1950.00
Priority	4
Severity	4

Accessible Path	(y/n)	YES
Clear Floor Space	(y/n)	YES
Clear Floor Slope	(%)	0.8
Clear Floor X Slope	(%)	2.9
Button Ht.	(in)	39
Button Reach	(in)	13
Button Diameter	(in)	2
Button Pressure	(lbs)	4
Closed Fist Operation	(y/n)	YES
Visual Contrast	(y/n)	YES
Contrasting Color Bands	(y/n)	NO
Audible Walk Indicator	(y/n)	YES
Button Locator Tone	(y/n)	NO
Directional Info	(y/n)	YES

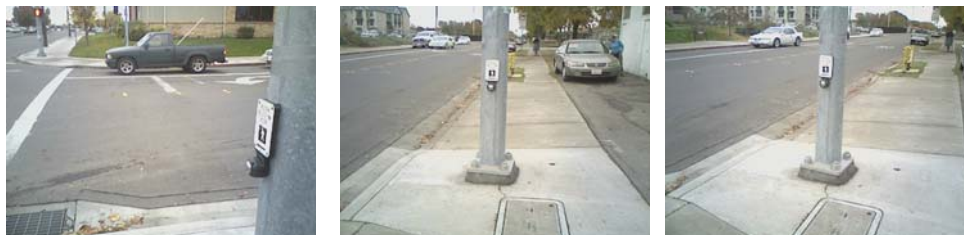
PCODE	PA19B
ADAPROW	R404.2
ADA-1991	4.3.7
CSAS	1118B.4.1
Unit Cost	\$1950.00
Priority	4
Severity	4

Accessible Path	(y/n)	YES
Clear Floor Space	(y/n)	YES
Clear Floor Slope	(%)	0.2
Clear Floor X Slope	(%)	2.3
Button Ht.	(in)	38
Button Reach	(in)	0
Button Diameter	(in)	2
Button Pressure	(lbs)	2
Closed Fist Operation	(y/n)	YES
Visual Contrast	(y/n)	YES
Contrasting Color Bands	(y/n)	NO
Audible Walk Indicator	(y/n)	YES
Button Locator Tone	(y/n)	NO
Directional Info	(y/n)	YES

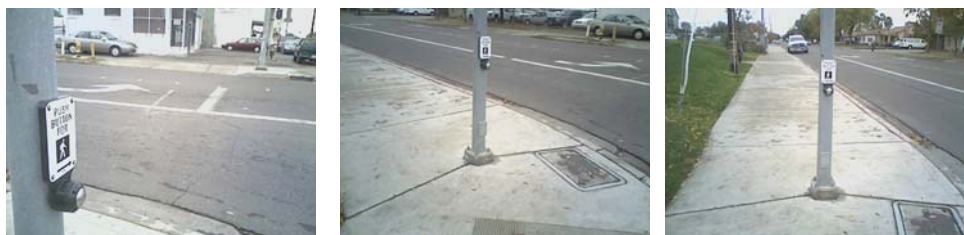
PCODE	PA43
ADAPROW	R209.1
Unit Cost	\$1350.00
Priority	4
Severity	4

Accessible Path	(y/n)	YES
Clear Floor Space	(y/n)	YES
Clear Floor Slope	(%)	0.4
Clear Floor X Slope	(%)	2.0
Button Ht.	(in)	39
Button Reach	(in)	0
Button Diameter	(in)	2
Button Pressure	(lbs)	2
Closed Fist Operation	(y/n)	YES
Visual Contrast	(y/n)	YES
Contrasting Color Bands	(y/n)	NO
Audible Walk Indicator	(y/n)	YES
Button Locator Tone	(y/n)	NO
Directional Info	(y/n)	YES

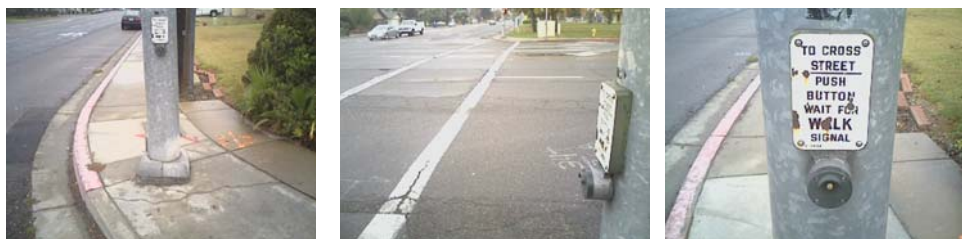
PCODE	PA19A
ADAPROW	R404.2
ADA-1991	4.3.7
CSAS	1118B.4.1
Unit Cost	\$2650.00
Priority	4
Severity	4

Accessible Path	(y/n)	YES
Clear Floor Space	(y/n)	YES
Clear Floor Slope	(%)	2.6
Clear Floor X Slope	(%)	1.6
Button Ht.	(in)	47.5
Button Reach	(in)	0
Button Diameter	(in)	0.5
Button Pressure	(lbs)	12
Closed Fist Operation	(y/n)	NO
Visual Contrast	(y/n)	YES
Contrasting Color Bands	(y/n)	NO
Audible Walk Indicator	(y/n)	NO
Button Locator Tone	(y/n)	NO
Directional Info	(y/n)	NO

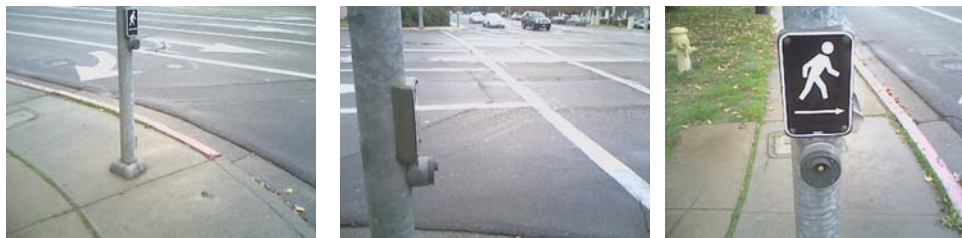
PCODE	PA19B
ADAPROW	R404.2
ADA-1991	4.3.7
CSAS	1118B.4.1
Unit Cost	\$2650.00
Priority	4
Severity	4

Accessible Path	(y/n)	YES
Clear Floor Space	(y/n)	YES
Clear Floor Slope	(%)	0.3
Clear Floor X Slope	(%)	3.2
Button Ht.	(in)	46
Button Reach	(in)	0
Button Diameter	(in)	0.5
Button Pressure	(lbs)	12
Closed Fist Operation	(y/n)	NO
Visual Contrast	(y/n)	YES
Contrasting Color Bands	(y/n)	NO
Audible Walk Indicator	(y/n)	NO
Button Locator Tone	(y/n)	NO
Directional Info	(y/n)	YES

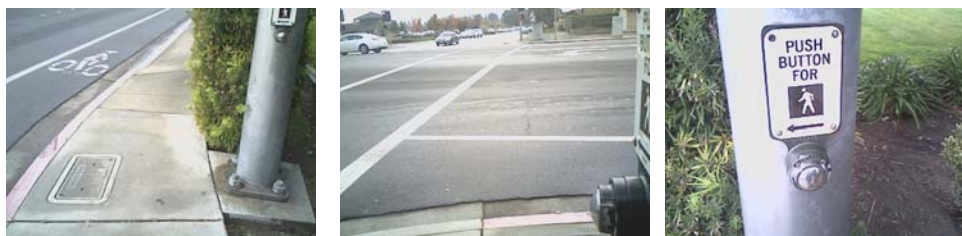
PCODE	PA43
ADAPROW	R209.1
Unit Cost	\$2100.00
Priority	4
Severity	4

Accessible Path	(y/n)	YES
Clear Floor Space	(y/n)	YES
Clear Floor Slope	(%)	0.4
Clear Floor X Slope	(%)	1.2
Button Ht.	(in)	45.5
Button Reach	(in)	11
Button Diameter	(in)	2
Button Pressure	(lbs)	3
Closed Fist Operation	(y/n)	YES
Visual Contrast	(y/n)	NO
Contrasting Color Bands	(y/n)	NO
Audible Walk Indicator	(y/n)	NO
Button Locator Tone	(y/n)	NO
Directional Info	(y/n)	YES

Provide voice or tone audible indication of the WALK interval at the pedestrian signal device. Provide push button which contrasts with surrounding housing. Provide 2" wide color coding with 1" wide dark borders located directly above control button.

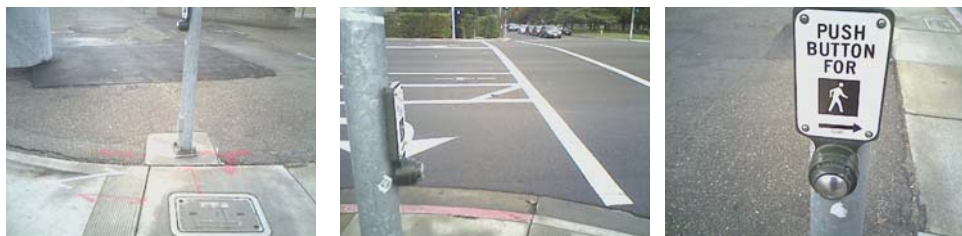
PCODE	PA19A
ADAPROW	R404.2
ADA-1991	4.3.7
CSAS	1118B.4.1
Unit Cost	\$2650.00
Priority	4
Severity	4

Accessible Path	(y/n)	YES
Clear Floor Space	(y/n)	YES
Clear Floor Slope	(%)	2.5
Clear Floor X Slope	(%)	1.7
Button Ht.	(in)	46
Button Reach	(in)	10
Button Diameter	(in)	2
Button Pressure	(lbs)	2
Closed Fist Operation	(y/n)	YES
Visual Contrast	(y/n)	YES
Contrasting Color Bands	(y/n)	NO
Audible Walk Indicator	(y/n)	NO
Button Locator Tone	(y/n)	NO
Directional Info	(y/n)	YES

Provide 2" wide color coding with 1" wide dark borders located directly above control button. Provide voice or tone audible indication of the WALK interval at the pedestrian signal device. Provide a button locator tone.

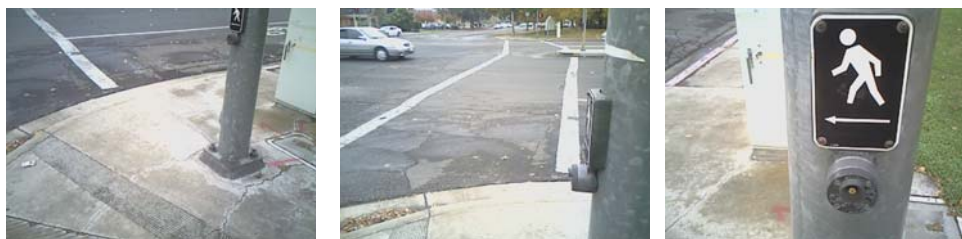
PCODE	PA19A
ADAPROW	R404.2
ADA-1991	4.3.7
CSAS	1118B.4.1
Unit Cost	\$2650.00
Priority	4
Severity	4

Accessible Path	(y/n)	YES
Clear Floor Space	(y/n)	YES
Clear Floor Slope	(%)	3.4
Clear Floor X Slope	(%)	1.9
Button Ht.	(in)	46.5
Button Reach	(in)	0
Button Diameter	(in)	0.5
Button Pressure	(lbs)	7
Closed Fist Operation	(y/n)	NO
Visual Contrast	(y/n)	NO
Contrasting Color Bands	(y/n)	NO
Audible Walk Indicator	(y/n)	NO
Button Locator Tone	(y/n)	NO
Directional Info	(y/n)	YES

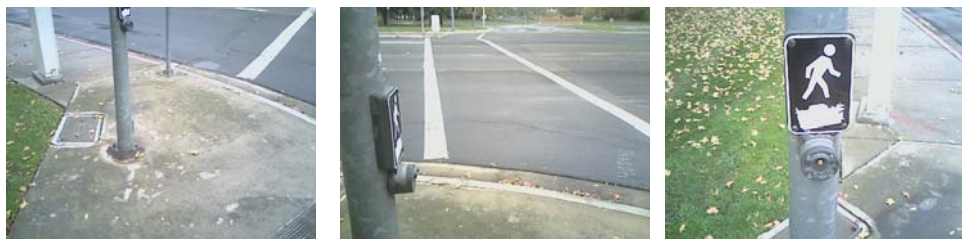
PCODE	PA39A
ADAPROW	R403.4
ADA-1991	4.27.4
ADA-2010	309.4
CSAS	1117B.6.4
Unit Cost	\$2050.00
Priority	4
Severity	4

Accessible Path	(y/n)	YES
Clear Floor Space	(y/n)	YES
Clear Floor Slope	(%)	0.5
Clear Floor X Slope	(%)	1.8
Button Ht.	(in)	46
Button Reach	(in)	0
Button Diameter	(in)	0.5
Button Pressure	(lbs)	12
Closed Fist Operation	(y/n)	NO
Visual Contrast	(y/n)	NO
Contrasting Color Bands	(y/n)	NO
Audible Walk Indicator	(y/n)	NO
Button Locator Tone	(y/n)	NO
Directional Info	(y/n)	NO

Modify or replace the operable part(s) to not require tight grasping, pinching, or twisting of the wrist with one hand.

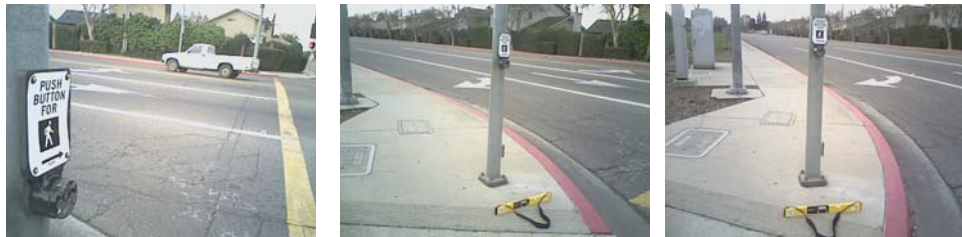
PCODE PA19A
 ADAPROW **R404.2**
 ADA-1991 **4.3.7**
 CSAS **1118B.4.1**
 Unit Cost **\$2650.00**
 Priority **3** Severity **4**

Accessible Path	(y/n)	YES
Clear Floor Space	(y/n)	YES
Clear Floor Slope	(%)	2.9
Clear Floor X Slope	(%)	1.4
Button Ht.	(in)	46.5
Button Reach	(in)	0
Button Diameter	(in)	0.5
Button Pressure	(lbs)	2
Closed Fist Operation	(y/n)	NO
Visual Contrast	(y/n)	NO
Contrasting Color Bands	(y/n)	NO
Audible Walk Indicator	(y/n)	NO
Button Locator Tone	(y/n)	NO
Directional Info	(y/n)	YES

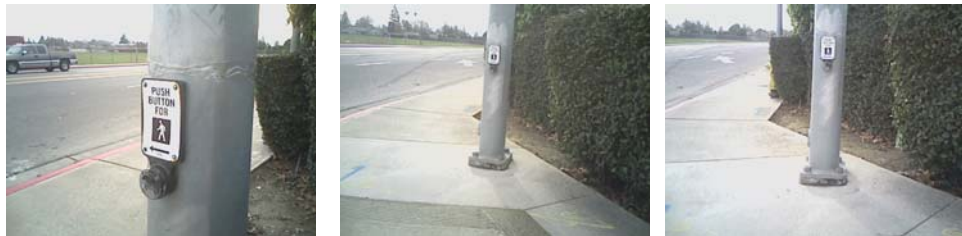
PCODE PA19A
 ADAPROW **R404.2**
 ADA-1991 **4.3.7**
 CSAS **1118B.4.1**
 Unit Cost **\$2650.00**
 Priority **3** Severity **4**

Accessible Path	(y/n)	YES
Clear Floor Space	(y/n)	YES
Clear Floor Slope	(%)	2.8
Clear Floor X Slope	(%)	1.4
Button Ht.	(in)	46
Button Reach	(in)	0
Button Diameter	(in)	0.5
Button Pressure	(lbs)	2
Closed Fist Operation	(y/n)	NO
Visual Contrast	(y/n)	NO
Contrasting Color Bands	(y/n)	NO
Audible Walk Indicator	(y/n)	NO
Button Locator Tone	(y/n)	NO
Directional Info	(y/n)	YES

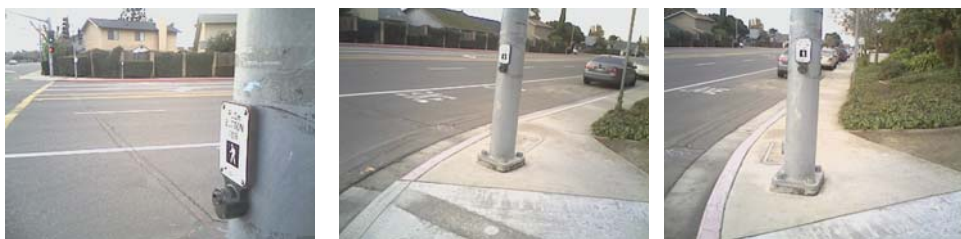
PCODE	PA19A
ADAPROW	R404.2
ADA-1991	4.3.7
CSAS	1118B.4.1
Unit Cost	\$2650.00
Priority	3
Severity	4

Accessible Path	(y/n)	YES
Clear Floor Space	(y/n)	YES
Clear Floor Slope	(%)	3.6
Clear Floor X Slope	(%)	2.0
Button Ht.	(in)	46.25
Button Reach	(in)	0
Button Diameter	(in)	0.5
Button Pressure	(lbs)	2
Closed Fist Operation	(y/n)	NO
Visual Contrast	(y/n)	NO
Contrasting Color Bands	(y/n)	NO
Audible Walk Indicator	(y/n)	NO
Button Locator Tone	(y/n)	NO
Directional Info	(y/n)	YES

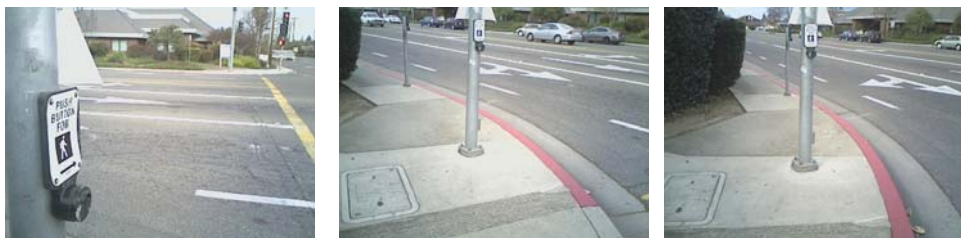
PCODE	PA39A
ADAPROW	R403.4
ADA-1991	4.27.4
ADA-2010	309.4
CSAS	1117B.6.4
Unit Cost	\$2100.00
Priority	3
Severity	4

Accessible Path	(y/n)	YES
Clear Floor Space	(y/n)	YES
Clear Floor Slope	(%)	0.4
Clear Floor X Slope	(%)	0.5
Button Ht.	(in)	46.5
Button Reach	(in)	0
Button Diameter	(in)	0.5
Button Pressure	(lbs)	2
Closed Fist Operation	(y/n)	NO
Visual Contrast	(y/n)	NO
Contrasting Color Bands	(y/n)	NO
Audible Walk Indicator	(y/n)	NO
Button Locator Tone	(y/n)	NO
Directional Info	(y/n)	YES

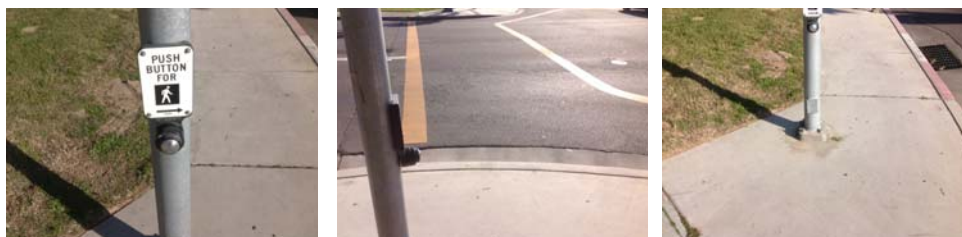
PCODE	PA43
ADAPROW	R209.1
Unit Cost	\$1350.00
Priority	4
Severity	4

Accessible Path	(y/n)	YES
Clear Floor Space	(y/n)	YES
Clear Floor Slope	(%)	0.9
Clear Floor X Slope	(%)	0.6
Button Ht.	(in)	39
Button Reach	(in)	0
Button Diameter	(in)	2
Button Pressure	(lbs)	2
Closed Fist Operation	(y/n)	YES
Visual Contrast	(y/n)	YES
Contrasting Color Bands	(y/n)	NO
Audible Walk Indicator	(y/n)	YES
Button Locator Tone	(y/n)	NO
Directional Info	(y/n)	YES

Provide 2" wide color coding with 1" wide dark borders located directly above control button.

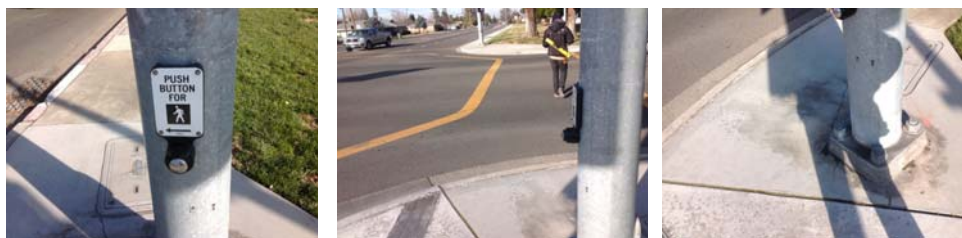
PCODE	PA19A
ADAPROW	R404.2
ADA-1991	4.3.7
CSAS	1118B.4.1
Unit Cost	\$1950.00
Priority	3
Severity	4

Accessible Path	(y/n)	YES
Clear Floor Space	(y/n)	YES
Clear Floor Slope	(%)	2.7
Clear Floor X Slope	(%)	1.1
Button Ht.	(in)	39
Button Reach	(in)	0
Button Diameter	(in)	2
Button Pressure	(lbs)	2
Closed Fist Operation	(y/n)	YES
Visual Contrast	(y/n)	YES
Contrasting Color Bands	(y/n)	NO
Audible Walk Indicator	(y/n)	YES
Button Locator Tone	(y/n)	NO
Directional Info	(y/n)	YES

Provide 2" wide color coding with 1" wide dark borders located directly above control button. Provide a button locator tone.

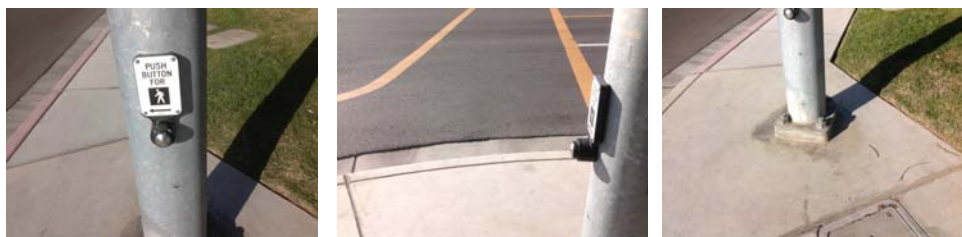
PCODE PA43
 ADAPROW **R209.1**
 Unit Cost **\$1350.00**
 Priority **4** Severity **4**

Accessible Path	(y/n)	YES
Clear Floor Space	(y/n)	YES
Clear Floor Slope	(%)	1.8
Clear Floor X Slope	(%)	0.5
Button Ht.	(in)	39
Button Reach	(in)	0
Button Diameter	(in)	2
Button Pressure	(lbs)	2
Closed Fist Operation	(y/n)	YES
Visual Contrast	(y/n)	YES
Contrasting Color Bands	(y/n)	NO
Audible Walk Indicator	(y/n)	YES
Button Locator Tone	(y/n)	NO
Directional Info	(y/n)	YES

Provide 2" wide color coding with 1" wide dark borders located directly above control button.

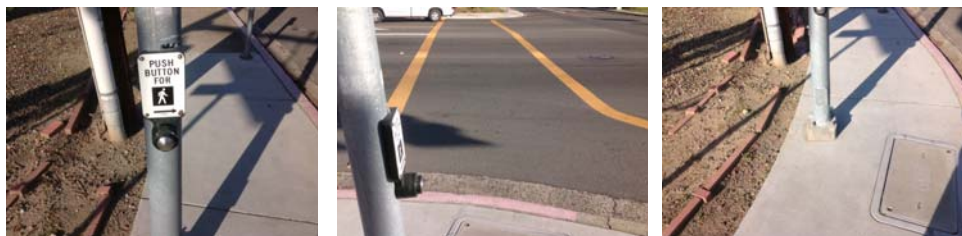
PCODE PA43
 ADAPROW **R209.1**
 Unit Cost **\$1350.00**
 Priority **4** Severity **4**

Accessible Path	(y/n)	YES
Clear Floor Space	(y/n)	YES
Clear Floor Slope	(%)	0.1
Clear Floor X Slope	(%)	1.3
Button Ht.	(in)	40
Button Reach	(in)	0
Button Diameter	(in)	2
Button Pressure	(lbs)	2
Closed Fist Operation	(y/n)	YES
Visual Contrast	(y/n)	YES
Contrasting Color Bands	(y/n)	NO
Audible Walk Indicator	(y/n)	YES
Button Locator Tone	(y/n)	NO
Directional Info	(y/n)	YES

Provide 2" wide color coding with 1" wide dark borders located directly above control button.

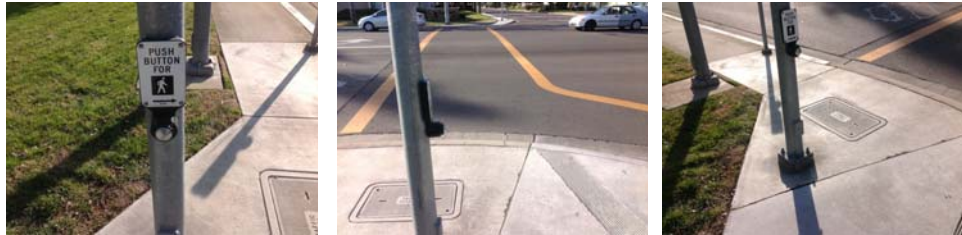
PCODE	PA43
ADAPROW	R209.1
Unit Cost	\$1350.00
Priority	3
Severity	4

Accessible Path	(y/n)	YES
Clear Floor Space	(y/n)	YES
Clear Floor Slope	(%)	0.4
Clear Floor X Slope	(%)	0.1
Button Ht.	(in)	39
Button Reach	(in)	0
Button Diameter	(in)	2
Button Pressure	(lbs)	2
Closed Fist Operation	(y/n)	YES
Visual Contrast	(y/n)	YES
Contrasting Color Bands	(y/n)	NO
Audible Walk Indicator	(y/n)	YES
Button Locator Tone	(y/n)	NO
Directional Info	(y/n)	YES

Provide 2" wide color coding with 1" wide dark borders located directly above control button.

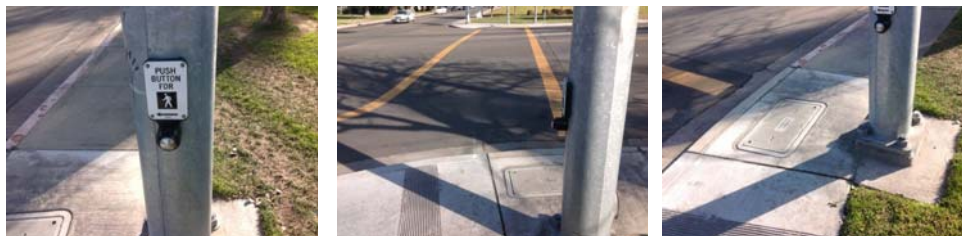
PCODE	PA19B
ADAPROW	R404.2
ADA-1991	4.3.7
CSAS	1118B.4.1
Unit Cost	\$1950.00
Priority	3
Severity	4

Accessible Path	(y/n)	YES
Clear Floor Space	(y/n)	YES
Clear Floor Slope	(%)	1.7
Clear Floor X Slope	(%)	3.7
Button Ht.	(in)	39
Button Reach	(in)	7
Button Diameter	(in)	2
Button Pressure	(lbs)	2
Closed Fist Operation	(y/n)	YES
Visual Contrast	(y/n)	YES
Contrasting Color Bands	(y/n)	NO
Audible Walk Indicator	(y/n)	YES
Button Locator Tone	(y/n)	NO
Directional Info	(y/n)	YES

Provide 2" wide color coding with 1" wide dark borders located directly above control button. Provide a button locator tone.

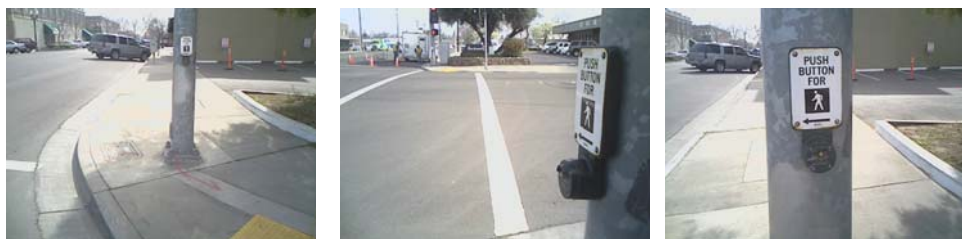
PCODE PA19A
 ADAPROW **R404.2**
 ADA-1991 **4.3.7**
 CSAS **1118B.4.1**
 Unit Cost **\$2650.00**
 Priority **3** Severity **3**

Accessible Path	(y/n)	YES
Clear Floor Space	(y/n)	NO
Clear Floor Slope	(%)	6.1
Clear Floor X Slope	(%)	2.0
Button Ht.	(in)	45.5
Button Reach	(in)	0
Button Diameter	(in)	0.5
Button Pressure	(lbs)	8
Closed Fist Operation	(y/n)	NO
Visual Contrast	(y/n)	NO
Contrasting Color Bands	(y/n)	NO
Audible Walk Indicator	(y/n)	NO
Button Locator Tone	(y/n)	NO
Directional Info	(y/n)	YES

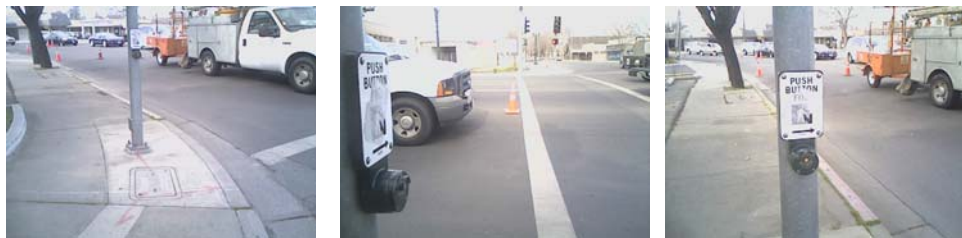
PCODE PA19B
 ADAPROW **R404.2**
 ADA-1991 **4.3.7**
 CSAS **1118B.4.1**
 Unit Cost **\$2650.00**
 Priority **3** Severity **4**

Accessible Path	(y/n)	YES
Clear Floor Space	(y/n)	YES
Clear Floor Slope	(%)	0.4
Clear Floor X Slope	(%)	4.4
Button Ht.	(in)	45.5
Button Reach	(in)	0
Button Diameter	(in)	0.5
Button Pressure	(lbs)	8
Closed Fist Operation	(y/n)	NO
Visual Contrast	(y/n)	NO
Contrasting Color Bands	(y/n)	NO
Audible Walk Indicator	(y/n)	NO
Button Locator Tone	(y/n)	NO
Directional Info	(y/n)	YES
