City of Turlock

PRoW - Pedestrian Signals

Access Compliance Survey Report

July 2014

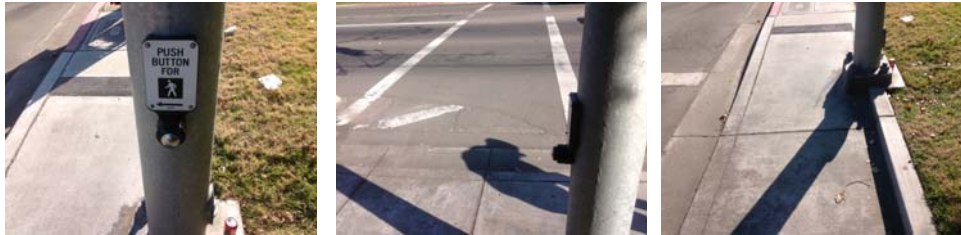
PCODE	PA19A
ADAPROW	R404.2
ADA-1991	4.3.7
CSAS	1118B.4.1
Unit Cost	\$1950.00
Priority	3
Severity	4

Accessible Path	(y/n)	YES
Clear Floor Space	(y/n)	NO
Clear Floor Slope	(%)	3.9
Clear Floor X Slope	(%)	1.3
Button Ht.	(in)	41
Button Reach	(in)	0
Button Diameter	(in)	2
Button Pressure	(lbs)	2
Closed Fist Operation	(y/n)	YES
Visual Contrast	(y/n)	YES
Contrasting Color Bands	(y/n)	NO
Audible Walk Indicator	(y/n)	YES
Button Locator Tone	(y/n)	NO
Directional Info	(y/n)	YES

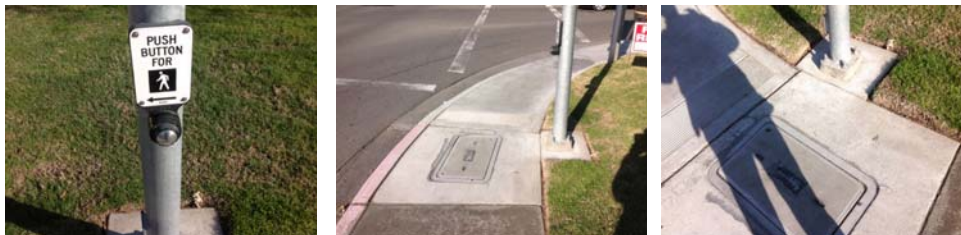
PCODE	PA19A
ADAPROW	R404.2
ADA-1991	4.3.7
CSAS	1118B.4.1
Unit Cost	\$1950.00
Priority	3
Severity	4

Accessible Path	(y/n)	YES
Clear Floor Space	(y/n)	YES
Clear Floor Slope	(%)	4.5
Clear Floor X Slope	(%)	1.4
Button Ht.	(in)	39
Button Reach	(in)	0
Button Diameter	(in)	2
Button Pressure	(lbs)	3
Closed Fist Operation	(y/n)	YES
Visual Contrast	(y/n)	YES
Contrasting Color Bands	(y/n)	NO
Audible Walk Indicator	(y/n)	YES
Button Locator Tone	(y/n)	NO
Directional Info	(y/n)	YES

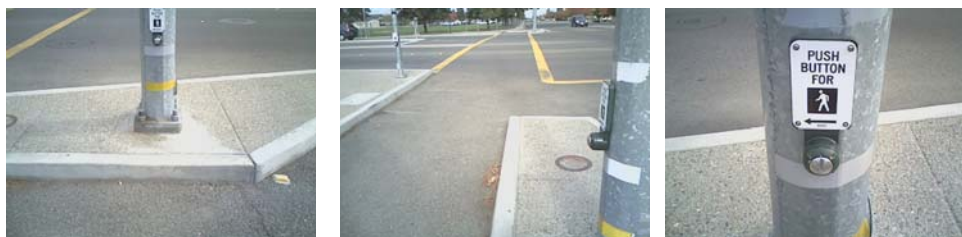
PCODE PA43
 ADAPROW **R209.1**
 Unit Cost **\$1950.00**
 Priority **4** Severity **4**

Accessible Path	(y/n)	YES
Clear Floor Space	(y/n)	YES
Clear Floor Slope	(%)	2.6
Clear Floor X Slope	(%)	1.4
Button Ht.	(in)	40
Button Reach	(in)	20
Button Diameter	(in)	2
Button Pressure	(lbs)	3
Closed Fist Operation	(y/n)	YES
Visual Contrast	(y/n)	YES
Contrasting Color Bands	(y/n)	NO
Audible Walk Indicator	(y/n)	YES
Button Locator Tone	(y/n)	NO
Directional Info	(y/n)	YES

Provide 2" wide color coding with 1" wide dark borders located directly above control button.

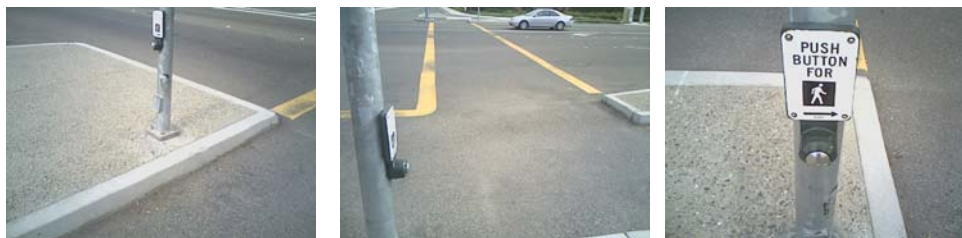
PCODE PA43
 ADAPROW **R209.1**
 Unit Cost **\$1350.00**
 Priority **4** Severity **4**

Accessible Path	(y/n)	YES
Clear Floor Space	(y/n)	YES
Clear Floor Slope	(%)	0.2
Clear Floor X Slope	(%)	1.9
Button Ht.	(in)	40
Button Reach	(in)	17
Button Diameter	(in)	2
Button Pressure	(lbs)	2
Closed Fist Operation	(y/n)	YES
Visual Contrast	(y/n)	YES
Contrasting Color Bands	(y/n)	NO
Audible Walk Indicator	(y/n)	YES
Button Locator Tone	(y/n)	NO
Directional Info	(y/n)	YES

Provide 2" wide color coding with 1" wide dark borders located directly above control button.

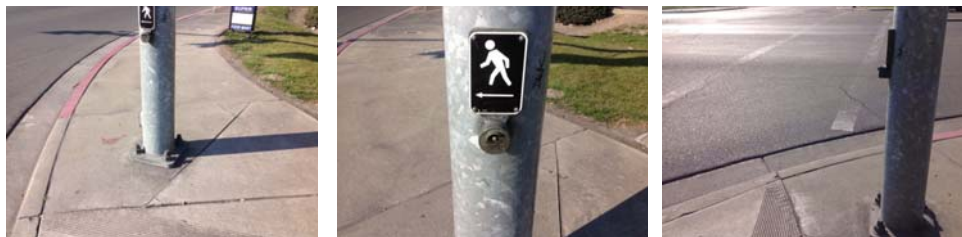
PCODE	PA19A
ADAPROW	R404.2
ADA-1991	4.3.7
CSAS	1118B.4.1
Unit Cost	\$2650.00
Priority	4
Severity	4

Accessible Path	(y/n)	YES
Clear Floor Space	(y/n)	YES
Clear Floor Slope	(%)	4.2
Clear Floor X Slope	(%)	1.7
Button Ht.	(in)	46
Button Reach	(in)	0
Button Diameter	(in)	0.5
Button Pressure	(lbs)	5
Closed Fist Operation	(y/n)	NO
Visual Contrast	(y/n)	NO
Contrasting Color Bands	(y/n)	NO
Audible Walk Indicator	(y/n)	NO
Button Locator Tone	(y/n)	NO
Directional Info	(y/n)	YES

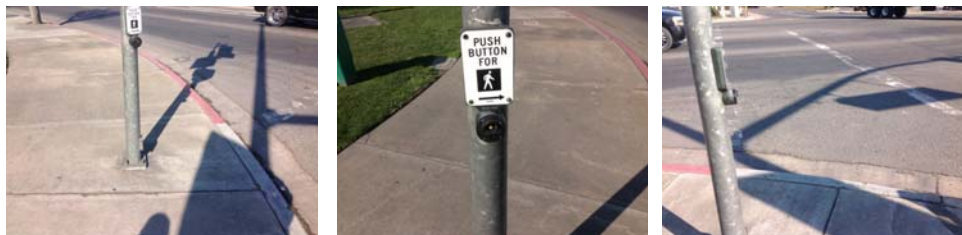
PCODE	PA19A
ADAPROW	R404.2
ADA-1991	4.3.7
CSAS	1118B.4.1
Unit Cost	\$2650.00
Priority	4
Severity	4

Accessible Path	(y/n)	YES
Clear Floor Space	(y/n)	YES
Clear Floor Slope	(%)	2.8
Clear Floor X Slope	(%)	1.0
Button Ht.	(in)	47
Button Reach	(in)	0
Button Diameter	(in)	0.5
Button Pressure	(lbs)	5
Closed Fist Operation	(y/n)	NO
Visual Contrast	(y/n)	NO
Contrasting Color Bands	(y/n)	NO
Audible Walk Indicator	(y/n)	NO
Button Locator Tone	(y/n)	NO
Directional Info	(y/n)	YES

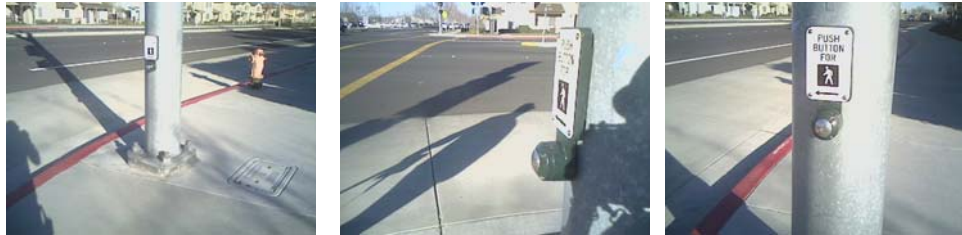
PCODE	PA19A
ADAPROW	R404.2
ADA-1991	4.3.7
CSAS	1118B.4.1
Unit Cost	\$1950.00
Priority	4
Severity	4

Accessible Path	(y/n)	YES
Clear Floor Space	(y/n)	YES
Clear Floor Slope	(%)	3.2
Clear Floor X Slope	(%)	2.1
Button Ht.	(in)	39
Button Reach	(in)	0
Button Diameter	(in)	2
Button Pressure	(lbs)	3
Closed Fist Operation	(y/n)	YES
Visual Contrast	(y/n)	NO
Contrasting Color Bands	(y/n)	NO
Audible Walk Indicator	(y/n)	YES
Button Locator Tone	(y/n)	NO
Directional Info	(y/n)	YES

Provide 2" wide color coding with 1" wide dark borders located directly above control button. Provide push button which contrasts with surrounding housing. Provide a button locator tone.

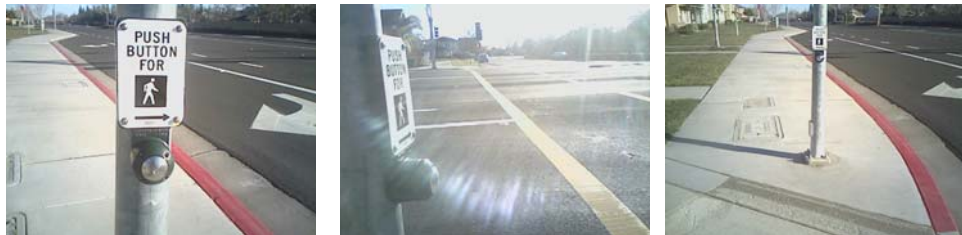
PCODE	PA43
ADAPROW	R209.1
Unit Cost	\$1400.00
Priority	4
Severity	4

Accessible Path	(y/n)	YES
Clear Floor Space	(y/n)	YES
Clear Floor Slope	(%)	0.2
Clear Floor X Slope	(%)	0.6
Button Ht.	(in)	39
Button Reach	(in)	0
Button Diameter	(in)	2
Button Pressure	(lbs)	3
Closed Fist Operation	(y/n)	YES
Visual Contrast	(y/n)	NO
Contrasting Color Bands	(y/n)	NO
Audible Walk Indicator	(y/n)	YES
Button Locator Tone	(y/n)	NO
Directional Info	(y/n)	YES

Provide push button which contrasts with surrounding housing. Provide 2" wide color coding with 1" wide dark borders located directly above control button.

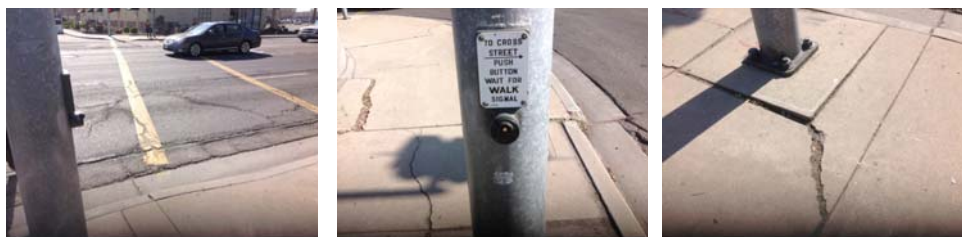
PCODE	PA19A
ADAPROW	R404.2
ADA-1991	4.3.7
CSAS	1118B.4.1
Unit Cost	\$2650.00
Priority	3
Severity	3

Accessible Path	(y/n)	YES
Clear Floor Space	(y/n)	YES
Clear Floor Slope	(%)	7.5
Clear Floor X Slope	(%)	3.1
Button Ht.	(in)	46.5
Button Reach	(in)	0
Button Diameter	(in)	0.5
Button Pressure	(lbs)	8
Closed Fist Operation	(y/n)	NO
Visual Contrast	(y/n)	NO
Contrasting Color Bands	(y/n)	NO
Audible Walk Indicator	(y/n)	NO
Button Locator Tone	(y/n)	NO
Directional Info	(y/n)	YES

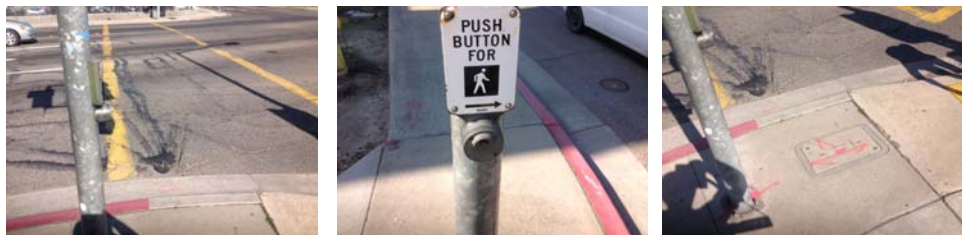
PCODE	PA19B
ADAPROW	R404.2
ADA-1991	4.3.7
CSAS	1118B.4.1
Unit Cost	\$2650.00
Priority	3
Severity	4

Accessible Path	(y/n)	YES
Clear Floor Space	(y/n)	YES
Clear Floor Slope	(%)	3.1
Clear Floor X Slope	(%)	4.8
Button Ht.	(in)	47
Button Reach	(in)	0
Button Diameter	(in)	0.5
Button Pressure	(lbs)	7
Closed Fist Operation	(y/n)	NO
Visual Contrast	(y/n)	NO
Contrasting Color Bands	(y/n)	NO
Audible Walk Indicator	(y/n)	NO
Button Locator Tone	(y/n)	NO
Directional Info	(y/n)	YES

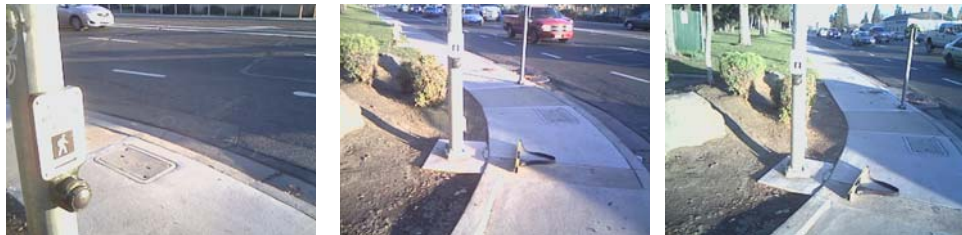
PCODE PA19A
 ADAPROW **R404.2**
 ADA-1991 **4.3.7**
 CSAS **1118B.4.1**
 Unit Cost **\$1950.00**
 Priority **4** Severity **4**

Accessible Path	(y/n)	YES
Clear Floor Space	(y/n)	NO
Clear Floor Slope	(%)	3.5
Clear Floor X Slope	(%)	1.8
Button Ht.	(in)	35.5
Button Reach	(in)	0
Button Diameter	(in)	2
Button Pressure	(lbs)	2
Closed Fist Operation	(y/n)	YES
Visual Contrast	(y/n)	NO
Contrasting Color Bands	(y/n)	NO
Audible Walk Indicator	(y/n)	YES
Button Locator Tone	(y/n)	NO
Directional Info	(y/n)	YES

Provide 2" wide color coding with 1" wide dark borders located directly above control button. Provide push button which contrasts with surrounding housing. Provide a button locator tone.

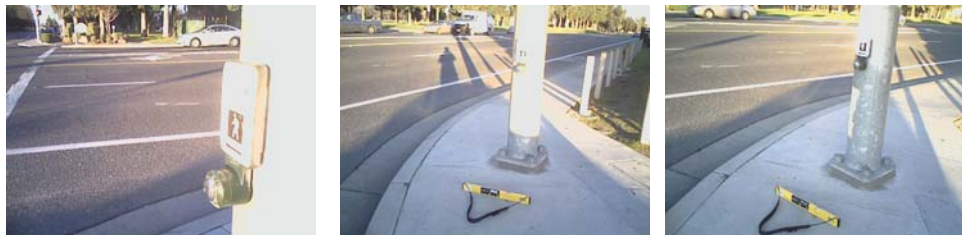
PCODE PA19A
 ADAPROW **R404.2**
 ADA-1991 **4.3.7**
 CSAS **1118B.4.1**
 Unit Cost **\$1950.00**
 Priority **3** Severity **3**

Accessible Path	(y/n)	YES
Clear Floor Space	(y/n)	NO
Clear Floor Slope	(%)	7.5
Clear Floor X Slope	(%)	0.8
Button Ht.	(in)	39
Button Reach	(in)	0
Button Diameter	(in)	2
Button Pressure	(lbs)	5
Closed Fist Operation	(y/n)	YES
Visual Contrast	(y/n)	YES
Contrasting Color Bands	(y/n)	NO
Audible Walk Indicator	(y/n)	YES
Button Locator Tone	(y/n)	NO
Directional Info	(y/n)	YES

Provide 2" wide color coding with 1" wide dark borders located directly above control button. Provide a button locator tone.

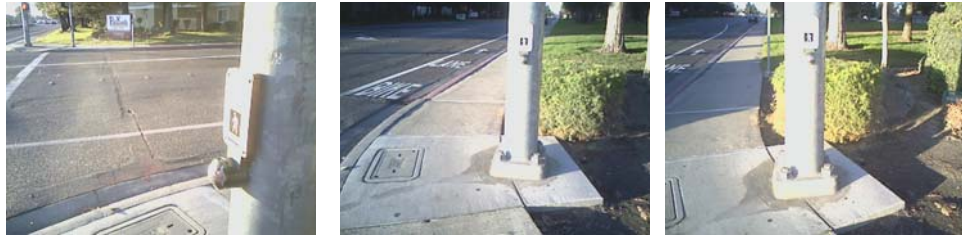
PCODE	PA19B
ADAPROW	R404.2
ADA-1991	4.3.7
CSAS	1118B.4.1
Unit Cost	\$1950.00
Priority	3
Severity	4

Accessible Path	(y/n)	YES
Clear Floor Space	(y/n)	NO
Clear Floor Slope	(%)	2.4
Clear Floor X Slope	(%)	2.6
Button Ht.	(in)	39
Button Reach	(in)	0
Button Diameter	(in)	2
Button Pressure	(lbs)	5
Closed Fist Operation	(y/n)	YES
Visual Contrast	(y/n)	YES
Contrasting Color Bands	(y/n)	NO
Audible Walk Indicator	(y/n)	YES
Button Locator Tone	(y/n)	NO
Directional Info	(y/n)	YES

Provide 2" wide color coding with 1" wide dark borders located directly above control button. Provide a button locator tone.

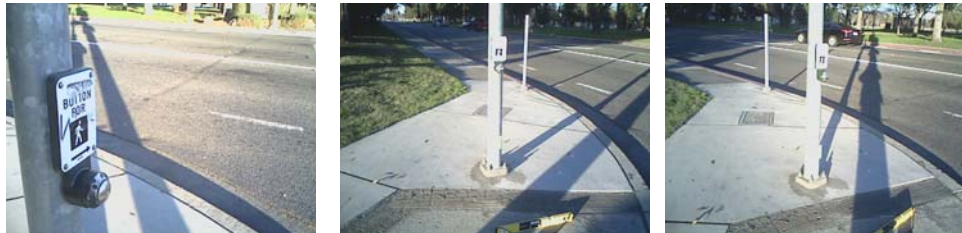
PCODE	PA19A
ADAPROW	R404.2
ADA-1991	4.3.7
CSAS	1118B.4.1
Unit Cost	\$1950.00
Priority	3
Severity	3

Accessible Path	(y/n)	YES
Clear Floor Space	(y/n)	NO
Clear Floor Slope	(%)	9.0
Clear Floor X Slope	(%)	1.0
Button Ht.	(in)	39
Button Reach	(in)	0
Button Diameter	(in)	2
Button Pressure	(lbs)	5
Closed Fist Operation	(y/n)	YES
Visual Contrast	(y/n)	YES
Contrasting Color Bands	(y/n)	NO
Audible Walk Indicator	(y/n)	YES
Button Locator Tone	(y/n)	NO
Directional Info	(y/n)	YES

Provide 2" wide color coding with 1" wide dark borders located directly above control button. Provide a button locator tone.

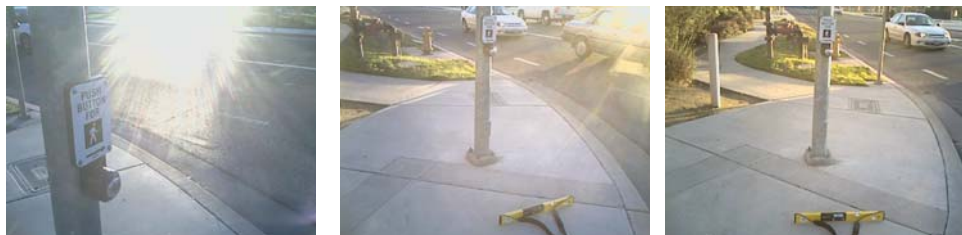
PCODE	PA19A
ADAPROW	R404.2
ADA-1991	4.3.7
CSAS	1118B.4.1
Unit Cost	\$1950.00
Priority	3
Severity	4

Accessible Path	(y/n)	YES
Clear Floor Space	(y/n)	NO
Clear Floor Slope	(%)	3.9
Clear Floor X Slope	(%)	0.1
Button Ht.	(in)	39
Button Reach	(in)	0
Button Diameter	(in)	2
Button Pressure	(lbs)	5
Closed Fist Operation	(y/n)	YES
Visual Contrast	(y/n)	YES
Contrasting Color Bands	(y/n)	NO
Audible Walk Indicator	(y/n)	YES
Button Locator Tone	(y/n)	NO
Directional Info	(y/n)	YES

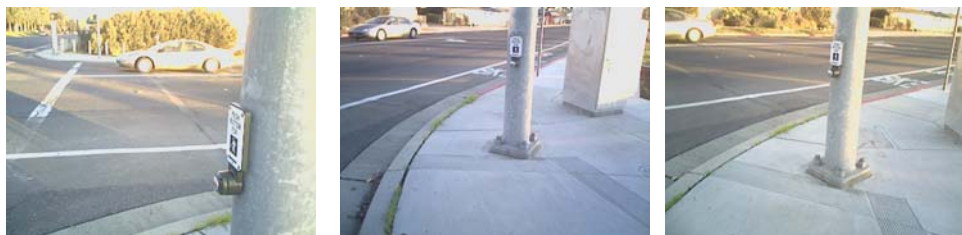
PCODE	PA19A
ADAPROW	R404.2
ADA-1991	4.3.7
CSAS	1118B.4.1
Unit Cost	\$1950.00
Priority	3
Severity	4

Accessible Path	(y/n)	YES
Clear Floor Space	(y/n)	NO
Clear Floor Slope	(%)	4.6
Clear Floor X Slope	(%)	0.4
Button Ht.	(in)	39
Button Reach	(in)	0
Button Diameter	(in)	2
Button Pressure	(lbs)	5
Closed Fist Operation	(y/n)	YES
Visual Contrast	(y/n)	YES
Contrasting Color Bands	(y/n)	NO
Audible Walk Indicator	(y/n)	YES
Button Locator Tone	(y/n)	NO
Directional Info	(y/n)	YES

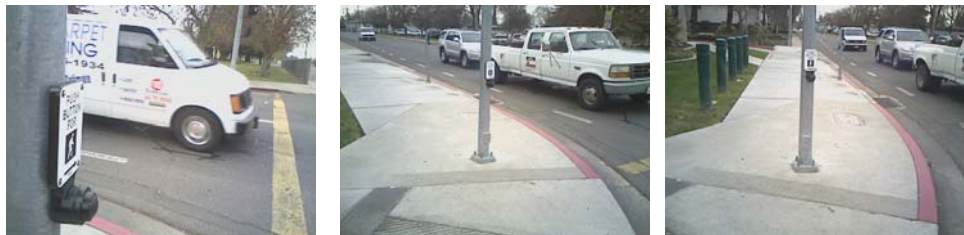
PCODE	PA19A
ADAPROW	R404.2
ADA-1991	4.3.7
CSAS	1118B.4.1
Unit Cost	\$2650.00
Priority	3
Severity	4

Accessible Path	(y/n)	YES
Clear Floor Space	(y/n)	NO
Clear Floor Slope	(%)	6.3
Clear Floor X Slope	(%)	0.7
Button Ht.	(in)	38
Button Reach	(in)	0
Button Diameter	(in)	2
Button Pressure	(lbs)	2
Closed Fist Operation	(y/n)	YES
Visual Contrast	(y/n)	NO
Contrasting Color Bands	(y/n)	NO
Audible Walk Indicator	(y/n)	NO
Button Locator Tone	(y/n)	NO
Directional Info	(y/n)	YES

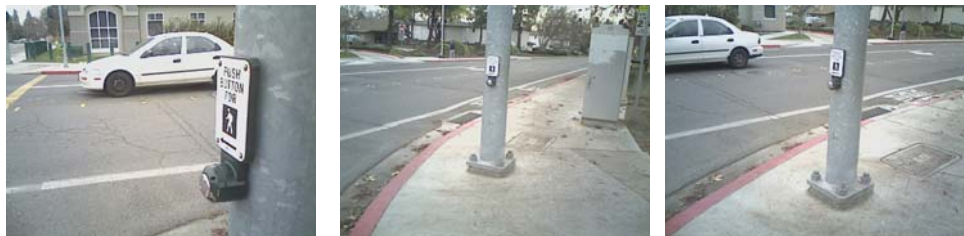
PCODE	PA43
ADAPROW	R209.1
Unit Cost	\$2050.00
Priority	3
Severity	4

Accessible Path	(y/n)	YES
Clear Floor Space	(y/n)	YES
Clear Floor Slope	(%)	1.3
Clear Floor X Slope	(%)	2.0
Button Ht.	(in)	39
Button Reach	(in)	0
Button Diameter	(in)	2
Button Pressure	(lbs)	4
Closed Fist Operation	(y/n)	YES
Visual Contrast	(y/n)	YES
Contrasting Color Bands	(y/n)	NO
Audible Walk Indicator	(y/n)	NO
Button Locator Tone	(y/n)	NO
Directional Info	(y/n)	YES

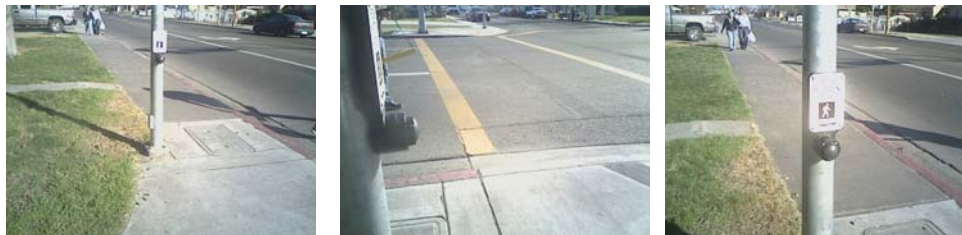
PCODE PA43
 ADAPROW **R209.1**
 Unit Cost **\$1400.00**
 Priority **4** Severity **4**

Accessible Path	(y/n)	YES
Clear Floor Space	(y/n)	YES
Clear Floor Slope	(%)	1.9
Clear Floor X Slope	(%)	1.1
Button Ht.	(in)	39
Button Reach	(in)	0
Button Diameter	(in)	2
Button Pressure	(lbs)	5
Closed Fist Operation	(y/n)	YES
Visual Contrast	(y/n)	NO
Contrasting Color Bands	(y/n)	NO
Audible Walk Indicator	(y/n)	YES
Button Locator Tone	(y/n)	NO
Directional Info	(y/n)	YES

Provide 2" wide color coding with 1" wide dark borders located directly above control button. Provide push button which contrasts with surrounding housing.

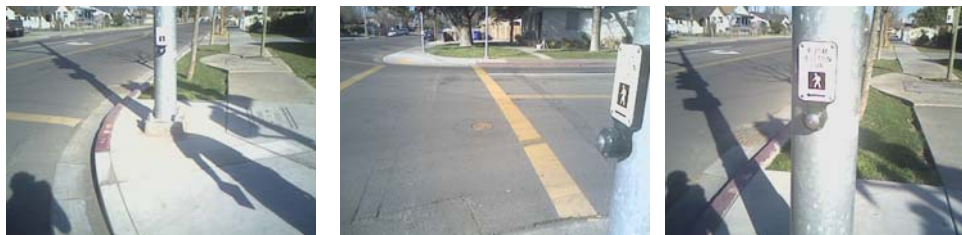
PCODE PA19A
 ADAPROW **R404.2**
 ADA-1991 **4.3.7**
 CSAS **1118B.4.1**
 Unit Cost **\$1950.00**
 Priority **4** Severity **4**

Accessible Path	(y/n)	YES
Clear Floor Space	(y/n)	YES
Clear Floor Slope	(%)	3.7
Clear Floor X Slope	(%)	0.8
Button Ht.	(in)	39
Button Reach	(in)	0
Button Diameter	(in)	2
Button Pressure	(lbs)	5
Closed Fist Operation	(y/n)	YES
Visual Contrast	(y/n)	NO
Contrasting Color Bands	(y/n)	NO
Audible Walk Indicator	(y/n)	YES
Button Locator Tone	(y/n)	NO
Directional Info	(y/n)	YES

Provide 2" wide color coding with 1" wide dark borders located directly above control button. Provide push button which contrasts with surrounding housing. Provide a button locator tone.

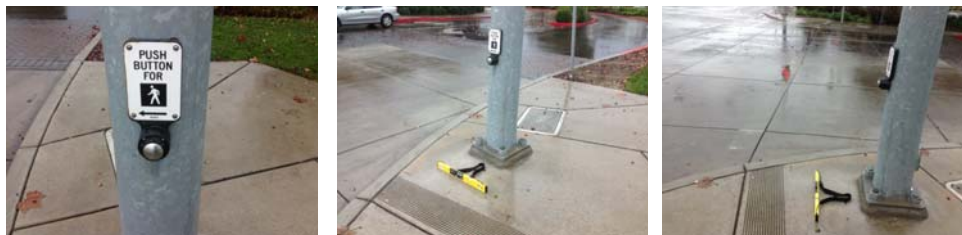
PCODE	PA19A
ADAPROW	R404.2
ADA-1991	4.3.7
CSAS	1118B.4.1
Unit Cost	\$1950.00
Priority	4
Severity	4

Accessible Path	(y/n)	YES
Clear Floor Space	(y/n)	YES
Clear Floor Slope	(%)	3.7
Clear Floor X Slope	(%)	0.8
Button Ht.	(in)	38.5
Button Reach	(in)	0
Button Diameter	(in)	2
Button Pressure	(lbs)	3
Closed Fist Operation	(y/n)	YES
Visual Contrast	(y/n)	YES
Contrasting Color Bands	(y/n)	NO
Audible Walk Indicator	(y/n)	YES
Button Locator Tone	(y/n)	NO
Directional Info	(y/n)	YES

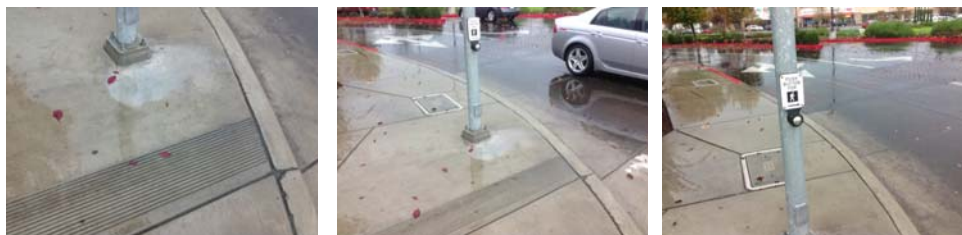
PCODE	PA19A
ADAPROW	R404.2
ADA-1991	4.3.7
CSAS	1118B.4.1
Unit Cost	\$1950.00
Priority	4
Severity	4

Accessible Path	(y/n)	YES
Clear Floor Space	(y/n)	YES
Clear Floor Slope	(%)	3.8
Clear Floor X Slope	(%)	1.0
Button Ht.	(in)	39.5
Button Reach	(in)	0
Button Diameter	(in)	2
Button Pressure	(lbs)	3
Closed Fist Operation	(y/n)	YES
Visual Contrast	(y/n)	YES
Contrasting Color Bands	(y/n)	NO
Audible Walk Indicator	(y/n)	YES
Button Locator Tone	(y/n)	NO
Directional Info	(y/n)	YES

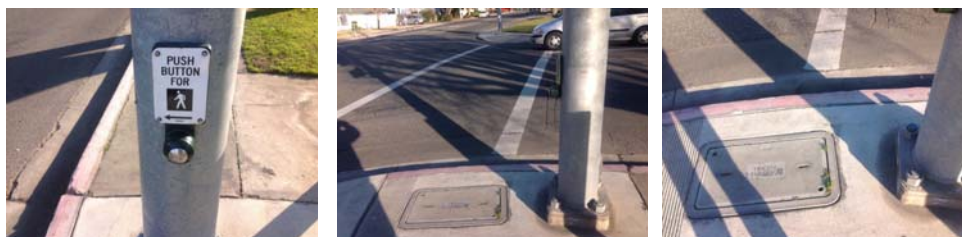
PCODE PA43
 ADAPROW **R209.1**
 Unit Cost **\$1350.00**
 Priority **4** Severity **4**

Accessible Path	(y/n)	YES
Clear Floor Space	(y/n)	YES
Clear Floor Slope	(%)	1.0
Clear Floor X Slope	(%)	1.1
Button Ht.	(in)	40
Button Reach	(in)	0
Button Diameter	(in)	2
Button Pressure	(lbs)	2
Closed Fist Operation	(y/n)	YES
Visual Contrast	(y/n)	YES
Contrasting Color Bands	(y/n)	NO
Audible Walk Indicator	(y/n)	YES
Button Locator Tone	(y/n)	NO
Directional Info	(y/n)	YES

Provide 2" wide color coding with 1" wide dark borders located directly above control button.

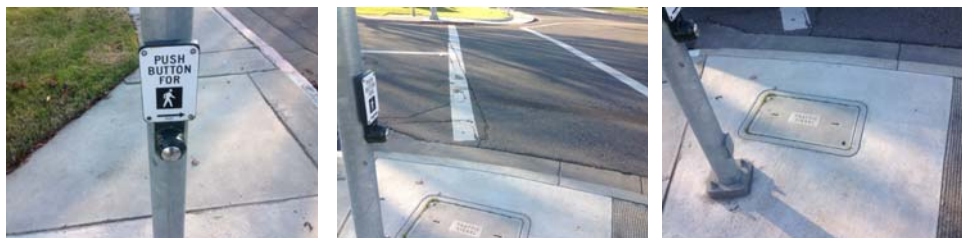
PCODE PA43
 ADAPROW **R209.1**
 Unit Cost **\$1350.00**
 Priority **3** Severity **4**

Accessible Path	(y/n)	YES
Clear Floor Space	(y/n)	YES
Clear Floor Slope	(%)	1.1
Clear Floor X Slope	(%)	1.7
Button Ht.	(in)	40
Button Reach	(in)	0
Button Diameter	(in)	2
Button Pressure	(lbs)	3
Closed Fist Operation	(y/n)	YES
Visual Contrast	(y/n)	YES
Contrasting Color Bands	(y/n)	NO
Audible Walk Indicator	(y/n)	YES
Button Locator Tone	(y/n)	NO
Directional Info	(y/n)	YES

Provide 2" wide color coding with 1" wide dark borders located directly above control button.

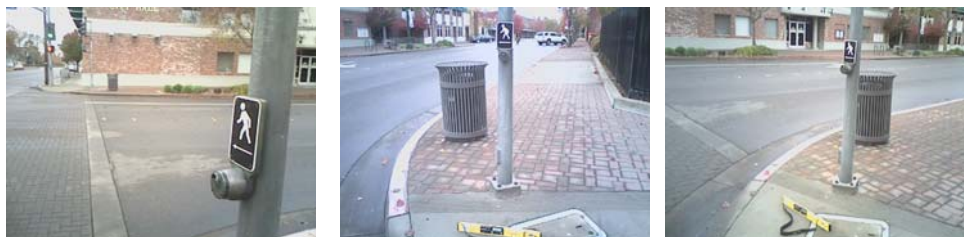
PCODE	PA19A
ADAPROW	R404.2
ADA-1991	4.3.7
CSAS	1118B.4.1
Unit Cost	\$2650.00
Priority	3
Severity	3

Accessible Path	(y/n)	YES
Clear Floor Space	(y/n)	NO
Clear Floor Slope	(%)	10.8
Clear Floor X Slope	(%)	2.2
Button Ht.	(in)	47.75
Button Reach	(in)	0
Button Diameter	(in)	0.5
Button Pressure	(lbs)	4
Closed Fist Operation	(y/n)	NO
Visual Contrast	(y/n)	YES
Contrasting Color Bands	(y/n)	NO
Audible Walk Indicator	(y/n)	NO
Button Locator Tone	(y/n)	NO
Directional Info	(y/n)	YES

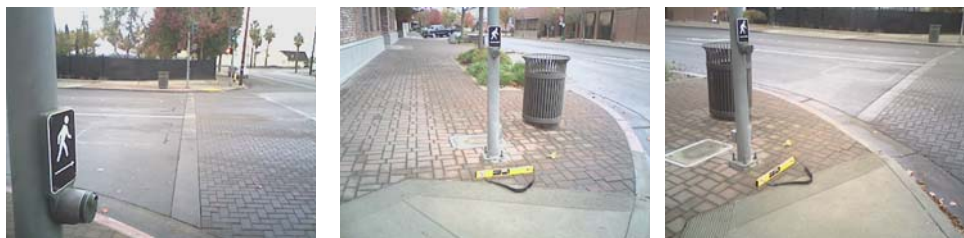
PCODE	PA19A
ADAPROW	R404.2
ADA-1991	4.3.7
CSAS	1118B.4.1
Unit Cost	\$2650.00
Priority	3
Severity	3

Accessible Path	(y/n)	YES
Clear Floor Space	(y/n)	NO
Clear Floor Slope	(%)	2.7
Clear Floor X Slope	(%)	1.4
Button Ht.	(in)	45.75
Button Reach	(in)	0
Button Diameter	(in)	0.5
Button Pressure	(lbs)	4
Closed Fist Operation	(y/n)	NO
Visual Contrast	(y/n)	YES
Contrasting Color Bands	(y/n)	NO
Audible Walk Indicator	(y/n)	NO
Button Locator Tone	(y/n)	NO
Directional Info	(y/n)	YES
